**NC-Choice Home Inspection Service**

Doc #: 2511-21001 Inspector: Donald C. Bedner

Inspection Date: 11/11/2025

Dwelling Address: 2500 Happy Home Lane  
Greensboro, NC 27000

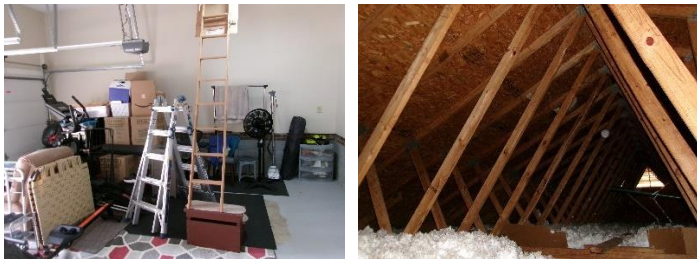
Step #	Component	Comments
1401	Access	Suggestion. Attic access provided by pull downs stairs at garage and ceiling hatch at hall. Attic was entered at garage and viewed from hatch at hall access. Extra support and additional ladder needed to access attic & stairs. Client should use caution using stairs.
