# **Inspection Report**

# **Nexus Home Inspections LLC**

> Property Address 123 Main Street, Hittsville, NY 12345

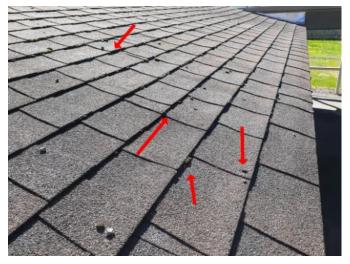
Monitor/Maintenance: Very minor moss covering was observed on the roof. While mostly cosmetic and not immediately harmful, this condition can indicate a moisture-related condition. This condition may also be seasonal depending on tree/leave coverage and the position of the sun during the changing seasons. The client should consult a roofing contractor or roofing supply company regarding maintenance related issues and products that can reduce this condition.

Minor moss

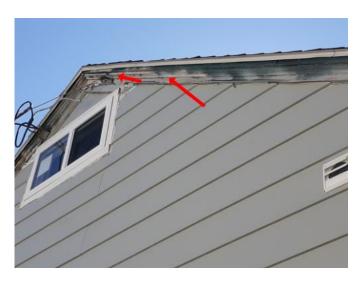
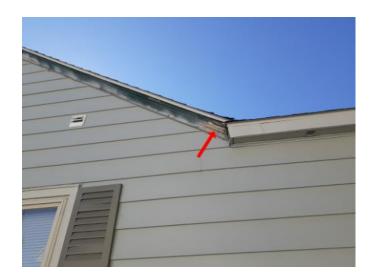
2.2) Flashing Conditions

**Repair/Replace**: The trim on the right-hand side of the home appears to need scraping and painting, the trim should be checked for any deterioration also. It is suggested that a "Licensed General Contractor" be contacted for further evaluation and repair.

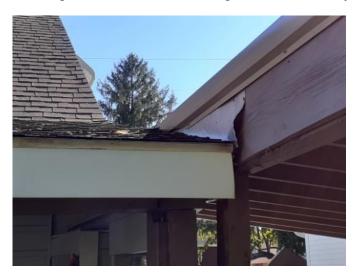
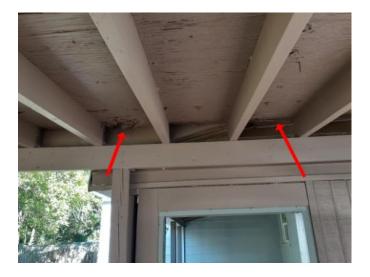
# 5.3) Roof Conditions (if detached)

Monitor/Maintenance: There appears to have been some previous water damage to the carport ceiling. Recomend monitoring this area for any more water damage and intrusion.

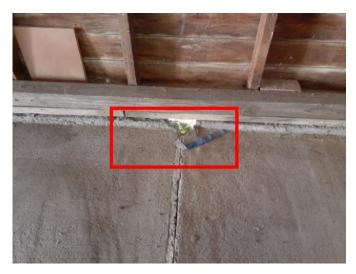
5.6) Floor Conditions

Repair/Replace: Recommend repair of the garage foundation where a hole is visible to the exterior.

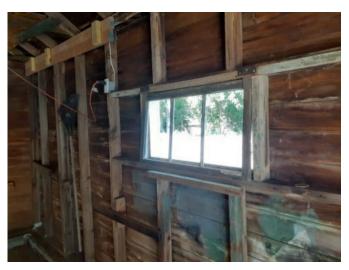
5.7) Window Conditions

Repair/Replace: Garae window was broken at the time of inspection. It is suggested that a "Licensed Electrical Contractor" be contacted for further evaluation and repair.

Glass panes missing

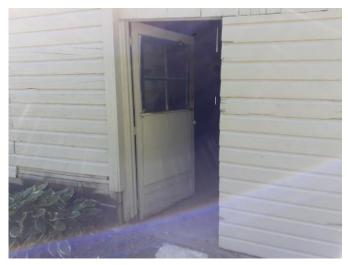
# 5.8) Door Conditions

Repair/Replace: The rear door and wall of the garage were not secure. The door could not be closed and the wall is loose from the foundation. It is suggested that a "Licensed General Contractor" be contacted for further evaluation and repair.

Door not closing

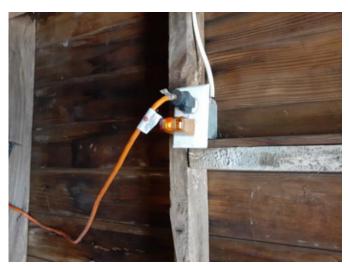
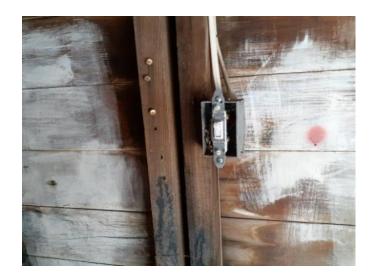
# 5.10) Electrical Conditions

Safety Concern: The outlet in the garage was showing an open ground and there was cover missing on the light switch. It is suggested that a "Licensed Electrical Contractor" be contacted for further evaluation and repair.

Open ground

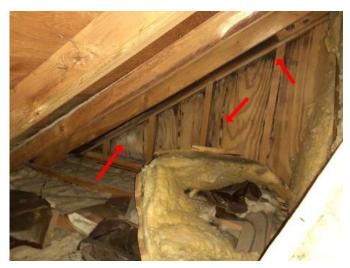
# 6.2) Attic Conditions

Monitor/Maintenance: There appeared to be a mold/mildew like substance in the attic area. There also appears to be some wood the has separated. If there is a concern for this area it is recommended the client have the area tested by a licensed mold technician.

Possible mold/mildew like substance

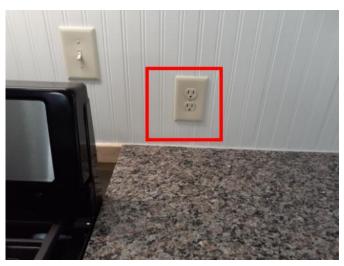
### 8.7) Electrical Conditions

Repair/Replace: One outlet showed the hot and neutral where reversed.

Hot neutral reversed

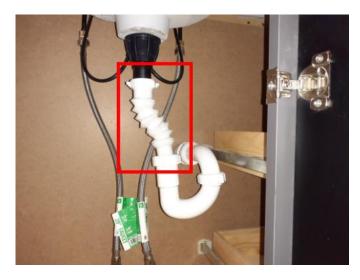
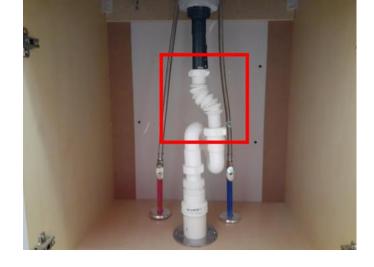
### 9.11) Sink Conditions

Repair/Replace: Flex drains should be changed to standard rigid drains as these drains are known to clog easier and backup. It is suggested that a "Licensed Plumbing Contractor" be contacted for further evaluation and repair.

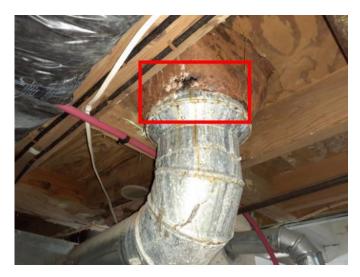
**11.2) Distribution Conditions**

**Repair/Replace:** Deteriorated register. It is suggested that an "HVAC Contractor" be contacted for further evaluation and repair.

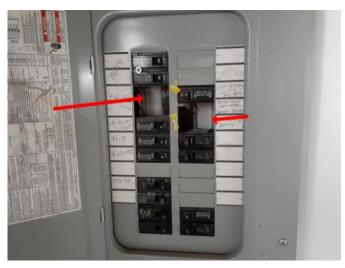
Safety Concern: The panel was missing covers where breakers were not installed. Recommend the installation of standard plastic covers for safety.

Missing covers

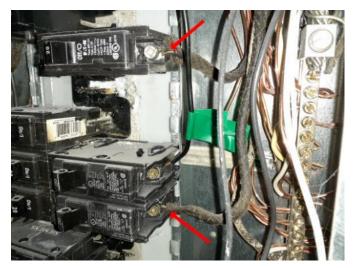
Safety Concern: Aluminum wiring was present. This type of wire was in thousands of homes before 1980. Although not a problem in all homes, it has been known to cause problems in some homes. Aluminum wiring connections and terminations should be coated with an approved antioxidant and special type of connector to prevent corrosion and heat build-up at outlets and switches. The client is advised to consult a licensed electrician for further information and/or evaluation.

Appears to be aluminum wires

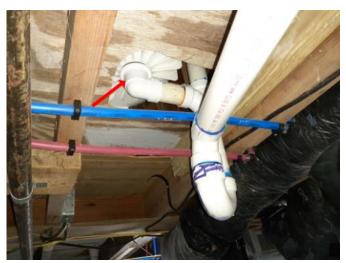
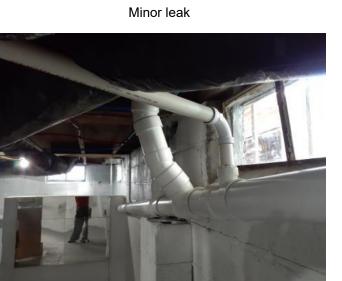
### 13.3) Drain Line Conditions

Repair/Replace: There was a very minor leak noted under the tub drain in the basement. It is suggested that a "Licensed Plumbing Contractor" be contacted for further evaluation and repair.

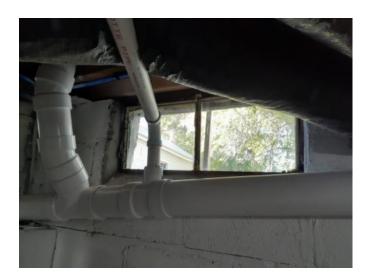
Repair/Replace: Most of the basement windows did not shut properly and one window was missing the glass panes. It was also noted that tape appeared to be holding some of the panes in. It is suggested that a "Licensed General Contractor" be contacted for further evaluation and repair.

Missing glass panes

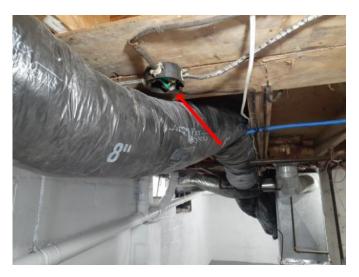
Safety Concern: Two junction or switch box covers were missing. Recommend installation of covers for increased safety.

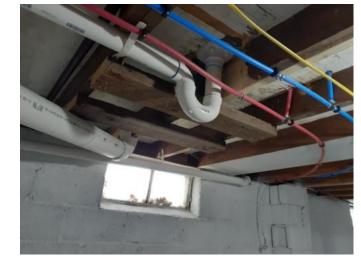
Monitor/Maintenance: There was a cut stringer board where new plumbing was added for the rear bathroom. Recommend monitoring this area for any sagging, squeaking, or softness in the floor. This area may need resupporting at some point.

Cut stringer
