JL Home Inspection Home Inspection Report

123 Easy Street, Nice Town IL Inspection prepared for: Customer Inspection Date: 10/28/2009 Time: 8:30 AM

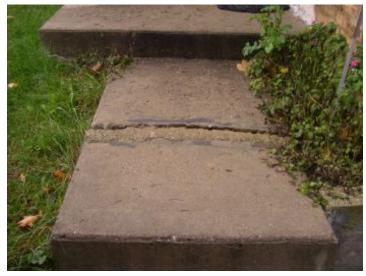
Cracks and heaved/settled areas observed by front door. Eventual replacement is recommended

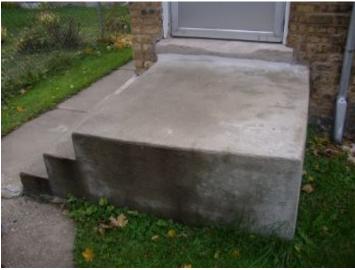
Whenever three or more stairs are present a handrail is usually required. (rear stairs)

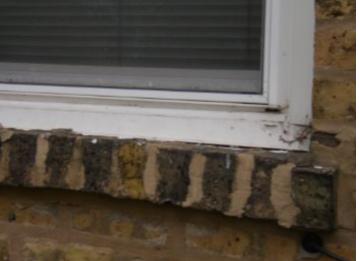
Some brick windows sills are pitched toward the house allowing water to pool and possible water intrusion into the walls

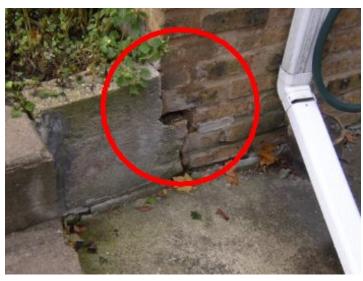
Missing/Deteriorated mortar observed, suggest tuckpointing as necessary.

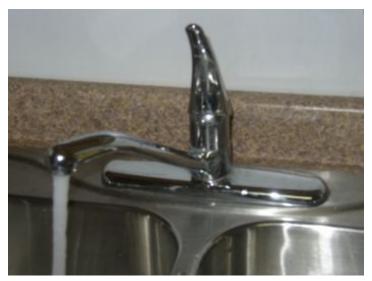
Faucet is loose, basement

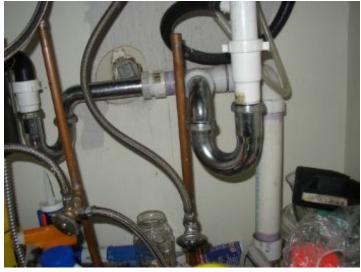
Drain trap is at term life, replace trap assembly

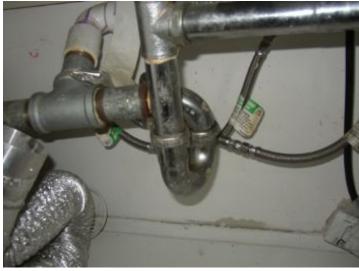
Drain trap is at term life, replace trap assembly

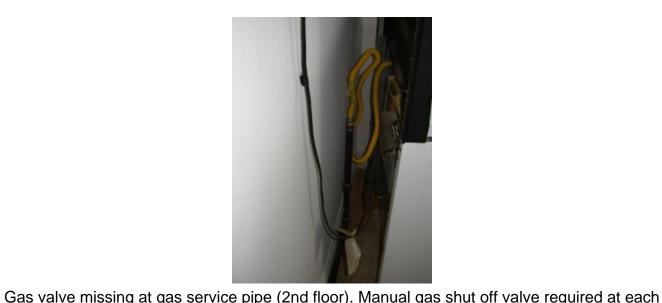
- Recommend replacing all flexible gas lines every 4 -8 years
- Functioned at time of inspection
- Gas valve missing at gas service pipe (2nd floor). Manual gas shut off valve required at each appliance.

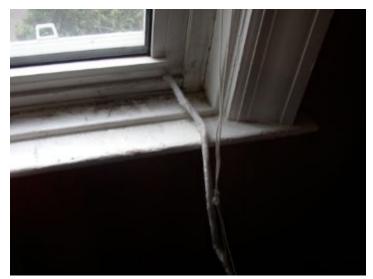
Weatherstrip	oing has come loose on bottom of windows, repair / replace as needed.
	6. Electrical Conditions
	Observations:

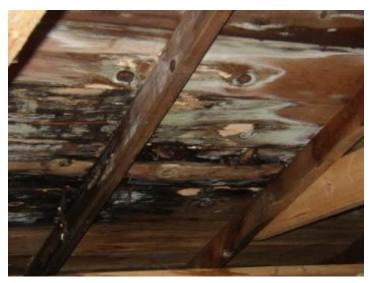
ence of water penetration observed and roof sheathing is rotted.
	8. Garage Electrical Condition

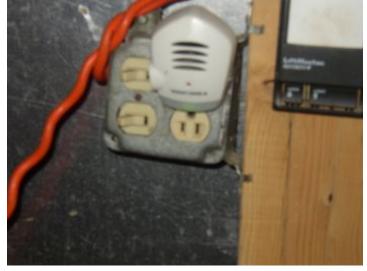
Recommend installing a GFCI electrical outlet, any outlet in garage, on the exterior or within six feet of water should be a GFCI type.

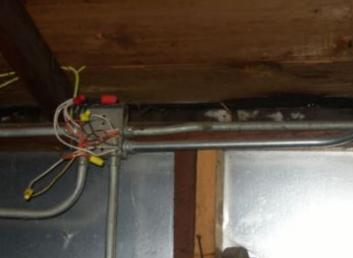
Open junction boxes were observed. Secure wires and install covers

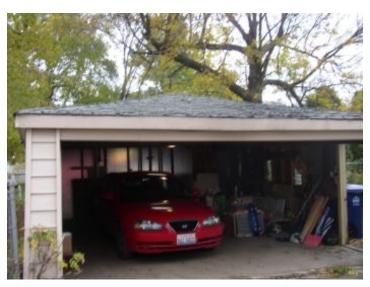
Roof is leaking. Replace roof

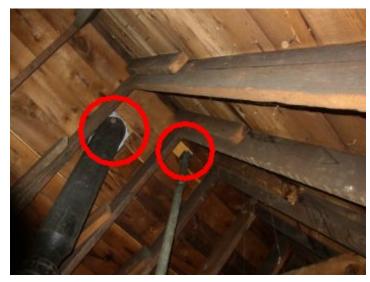
Light shows through the plumbing vents which may indicate a leak. Repair flashing

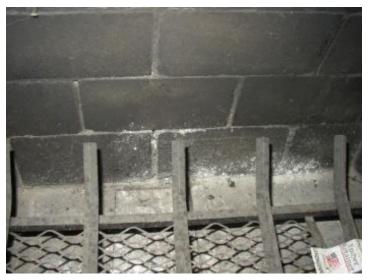
It is recommended that you have a qualified chimney sweep perform a Level II inspection before using the fireplace, and that you have the chimney inspected and cleaned yearly. The sweep can install flue caps and a spark barrier if needed.

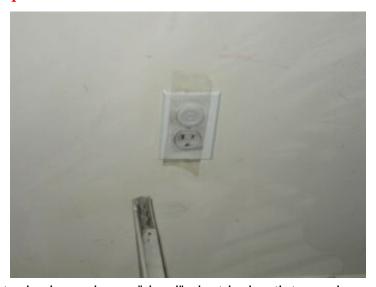
1st master bedroom has a "dead" electrical outlet, repair as needed.

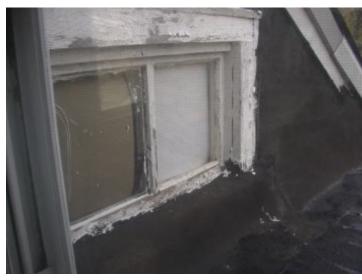
2nd floor closets have a small window, older wood single pane windows, recommend replacement

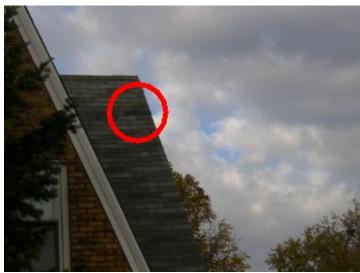
- Suggest trimming all trees and vegetation away from roof to prevent damage to roofing materials.
- No staining observed inside on ceiling and/ or attic
- Typically roof life expectancy is approximately 20 years
- Some shingles have damage or have blown off. The roof is past its expected life. Recommend replacement

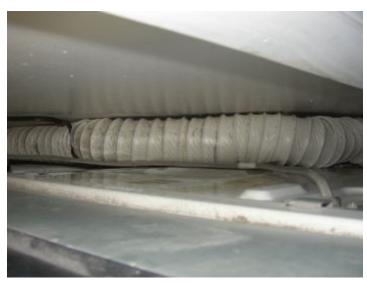
Dryer vent hose should be solid metal type. Plastic could burn and foil corrugated type clog easily.
