**BUILDING SURVEY**

**Gateway and Lodges To Haigh Hall Park  
Wigan Lane  
Wigan  
Lancashire**

Date of Inspection: 19<sup>th</sup> July 2016

**Re: Haigh Hall Gateway and Lodges, Wigan, Lancashire  
Building Survey**

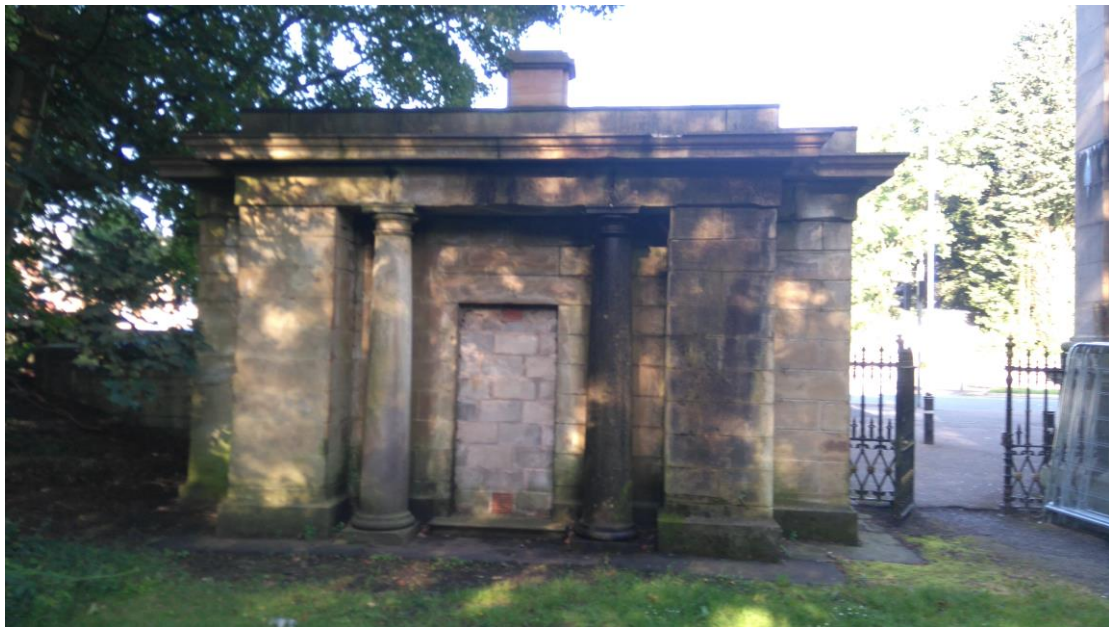
Photograph 2: Rear Elevation of Lodge 2

Generally the stonework displays evidence of weathering. This is shown through delamination and erosion of the stone. Missing mortar was noted from between the joints and vegetation growth was noted particularly at high and low level. Some of the stonework exhibits salt crystallisation which can be an indicator of penetrating damp. There is an open joint between the lodges and the flanking stone walls.

To lodge 2, the rear left hand column and adjacent wall was noted to be dark in colour with algae and other organic matter on the surface. Above this the joints between the stones were noted to not have any mortar in them, suggesting that penetrating damp and saturated stone has occurred in this corner of the building.

It is advised for all vegetation is removed from the joints and that they are repointed using a lime based mortar. Given the narrow nature of the joints, this may require a flow agent additive and putty with a birds mouth opening installed over the joints.

Repointing of the joint between the walls and the adjacent walls should be undertaken to prevent water ingress and subsequent deterioration of the walls.

It is advised that any stone that has eroded to an unsatisfactory standard should be cut out and replaced, on a like for like basis by a capable and qualified stone mason.

It is advised for the stone to be cleaned of all algae in localised areas, using a small steam unit.

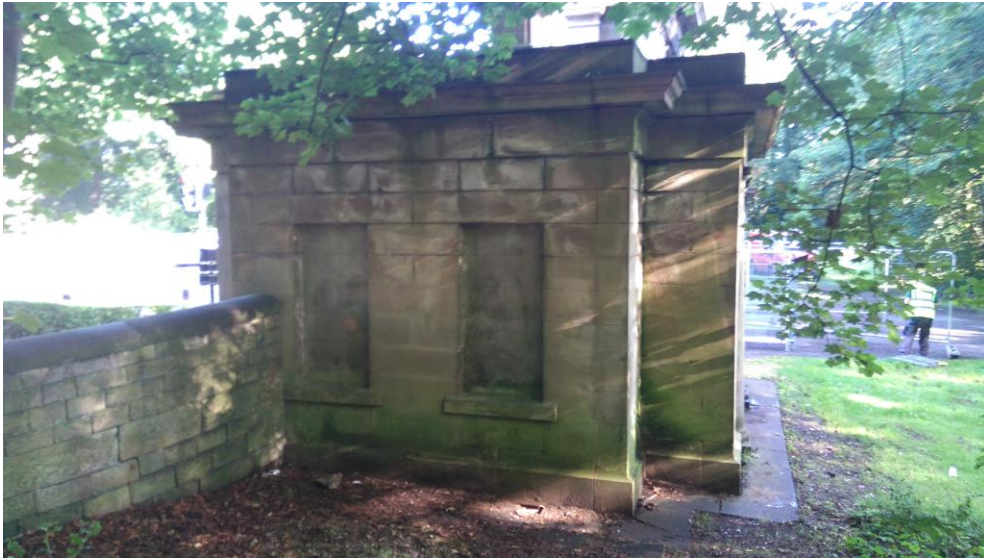
Photograph 3: Side Elevation of Lodge 2

Generally the stonework displays evidence of weathering. This is shown through delamination of the stone as well as vegetation growing in some joints. Around the windows, some of the stone has cracked and fallen away. Some of the stone at high level exhibits salt crystallisation which can be an indicator of penetrating damp. The iron fence has started to oxidise and the paint has started to peel away.

It is advised that all vegetation is removed. It is also advised that repointing is undertaken and lime based mortar is used to match the existing.

It is advised for any stone that has delaminated to an unsatisfactory standard be removed and replaced, on a like for like basis. It is advised that where the stone has cracked the affected stone be cut out and replaced on a like for like basis.

It is recommend that the stone is cleaned of salt crystallisation, using a small steam unit.

Once the paint has been tested for lead, it is advised that the cast iron gate has all loose paint and rust removed, using wire wool or wire wheel. Following this they should be decorated with an under coat and two coats of a good quality gloss paint.

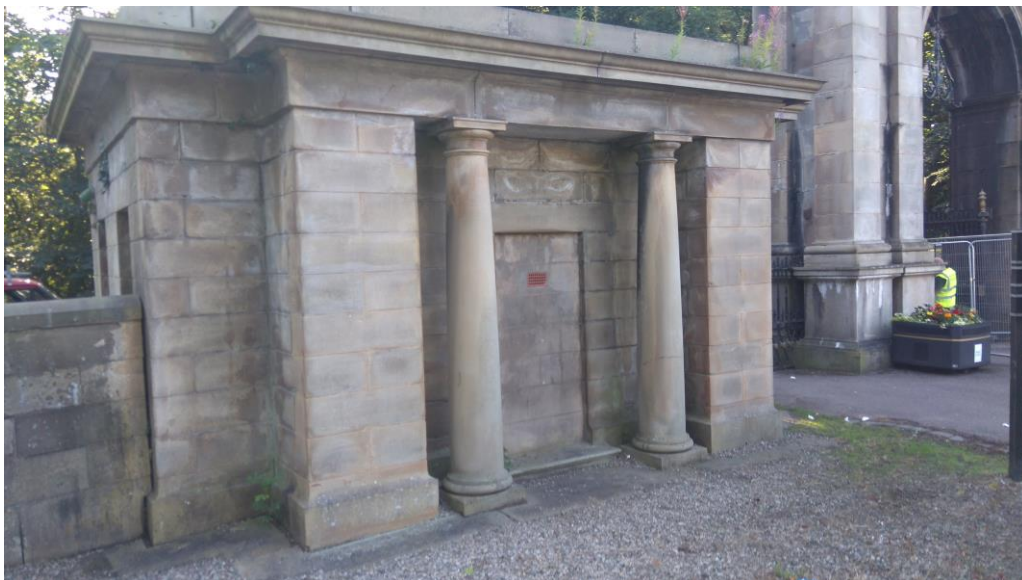
Photograph 4: Front Elevation of Lodge 1

Generally the stonework displays evidence of weathering. This is shown through erosion and delamination of the stone as well as vegetation growth in some joints. This is particularly evident at high level. There is also vegetation growing at high level including ferns and saplings at mid height and algae and other organic matter the base of the elevations. Some of the stones exhibit salt crystallisation to the surface which may be an indicator of penetrating damp. There is a large gap at the junction of the lodges and the flanking stone walls.

It is advised that all vegetation is carefully removed. It is also advised that repointing is undertaken and lime based mortar is used to match the existing. Given the narrowness of the joints a temporary putty seal with a birds mouth may be required along with a flow agent additive to the mortar mix.

It is advised for any stone that has delaminated to an unsatisfactory standard be cut out and replaced, on a like for like basis.

It is advised that the stone is cleaned of salt crystallisation in localised areas, using a small steam unit.

To Lodge 1 it is proposed that in the medium to long term that that the concrete blocks are removed from the opening and new hardwood frames and doors are supplied and installed in keeping with the age and character of the buildings. The reinstatement of the door in Lodge 2 will require the removal of a fire place and may require listed building consent.

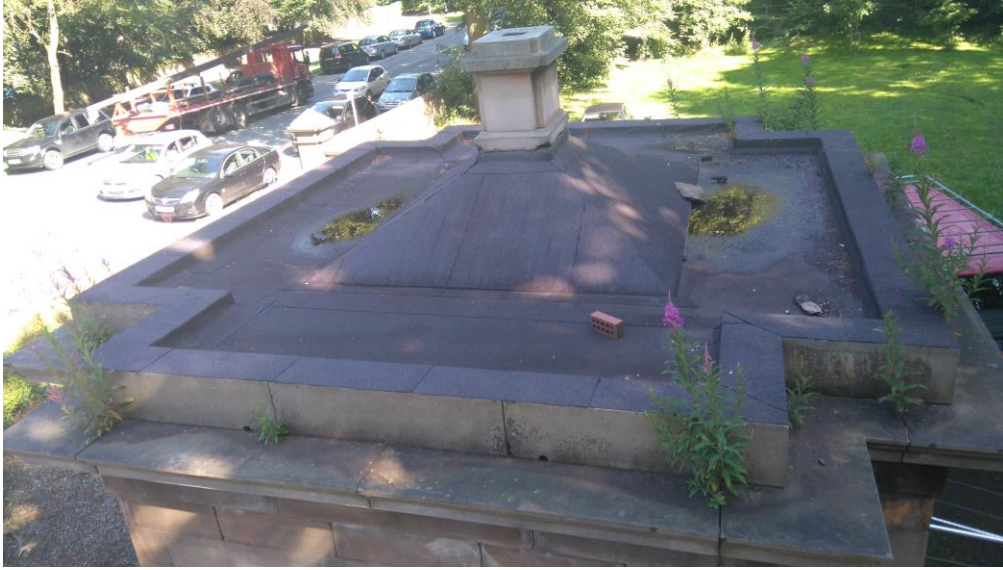
Photograph 5: Roof Covering Lodge 1

Overall the condition of these roofs were found to be reasonable. Vegetation growth was noted to some of the joints to the parapet wall. Open joints around the parapet wall have been noted.

To Lodge 1 we noted loose items on the roof including a brick and a section of stone. To Lodge 2 we noted a significant build up of moss and leaf debris upon the surface of the roof covering.

In the short term, it is advised that all vegetation is carefully removed from the open joints that repointing is undertaken and lime based mortar is used to match the existing. As previously mentioned, putty and a flow agent may be required.

To Lodge 2 it is proposed that all moss and organic matter is removed and an external drainage outlet is created. To Lodge 1 we propose removing the loose stone, brick and associated debris currently located upon the surface of the roof covering.

As the Lodge roof structures were understood to originally have a slate roof covering, it is advised that the temporary flat roofs are removed and that natural slate roof coverings are reinstated. Due to the additional weight of these we would advise that the existing timber joists are assessed and replaced if required. In addition we note that building regulations may require that a breathable membrane and insulation are installed, in addition pressure treated timber batons and code 4 lead flashings may also be required.

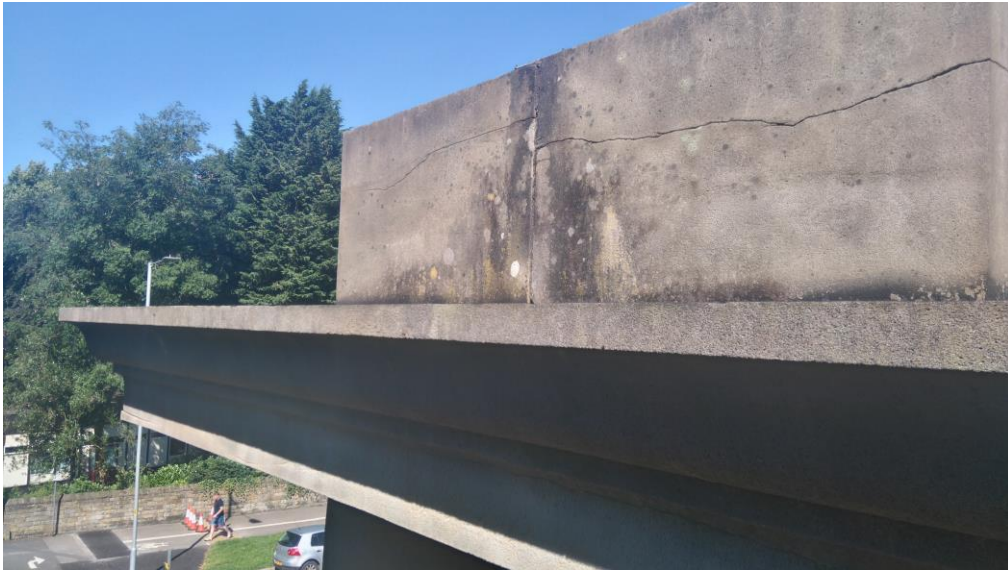
Although a detailed inspection from the mobile elevated working platform was somewhat restricted it appears that this roof is in poor condition and requires attention. There is a variety of vegetation growing in the open joints as well as potentially through the asphalt covering. There were no formal drainage points or guttering noted as part of our inspection. The parapet wall may have been attached with iron cramps and these have started to oxidise and cause horizontal cracks to the parapet stones.

Photograph 7: Horizontal cracking to coping stones in arch at high level

It is proposed that the cracking to the coping stones is monitored and the size and extent measured in order to set a baseline for regular future assessments.

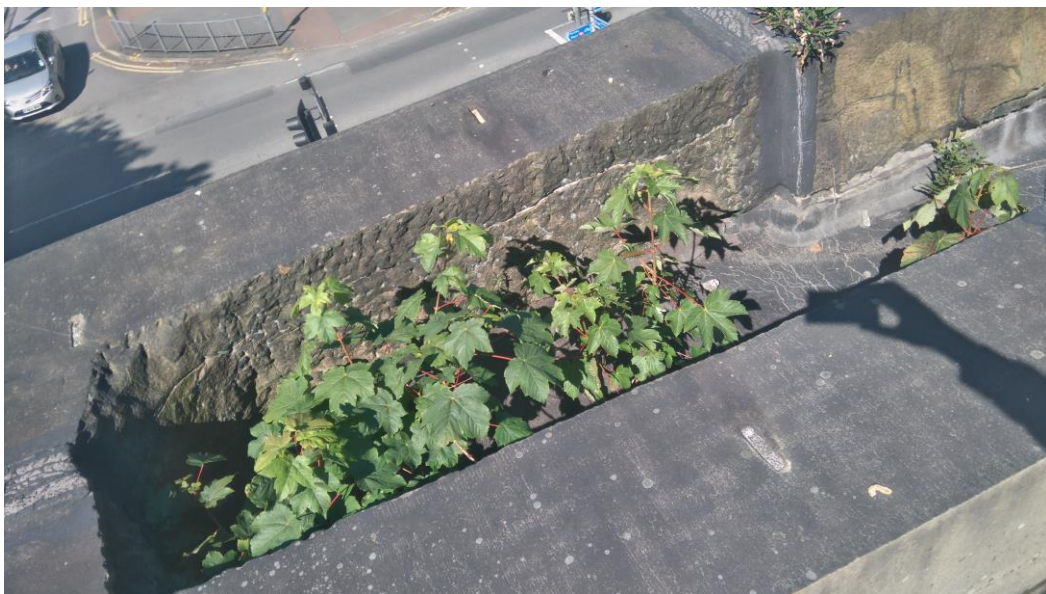
Photograph 8: Saplings / Vegetation growth on asphalt archway roof

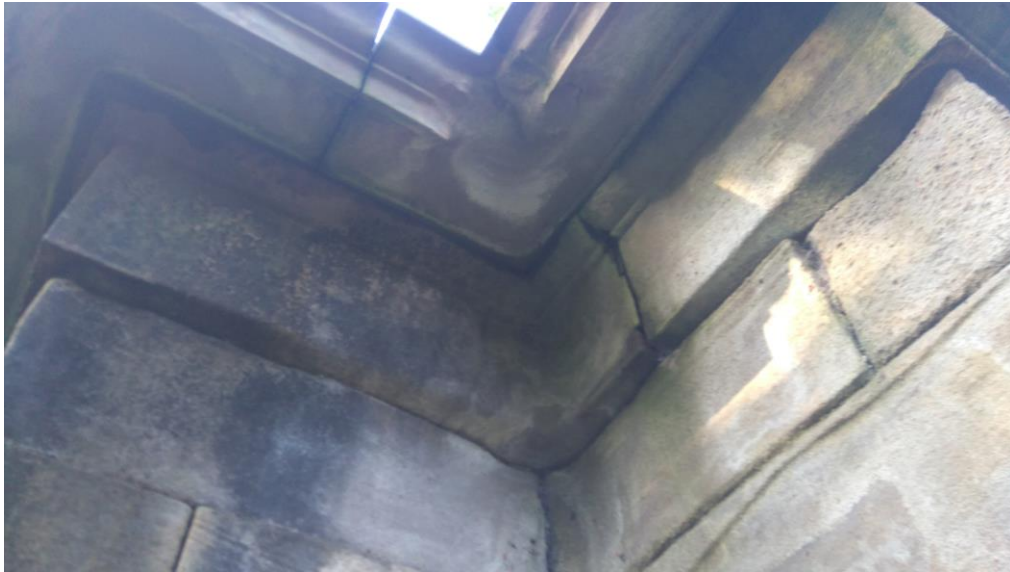
Photograph 9: Erosion Of Stonework / missing pointing

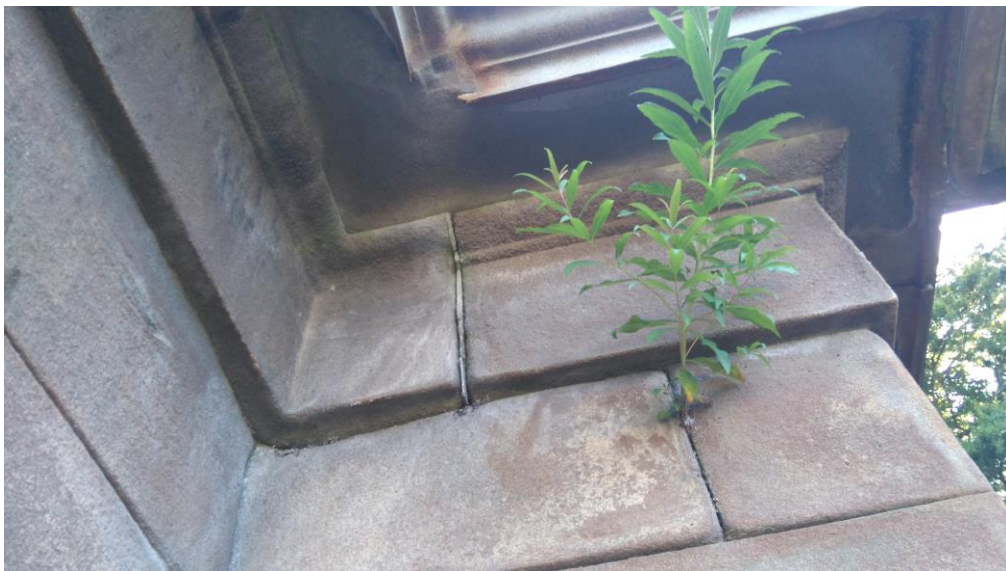
Photograph 10: Missing pointing / vegetation growth

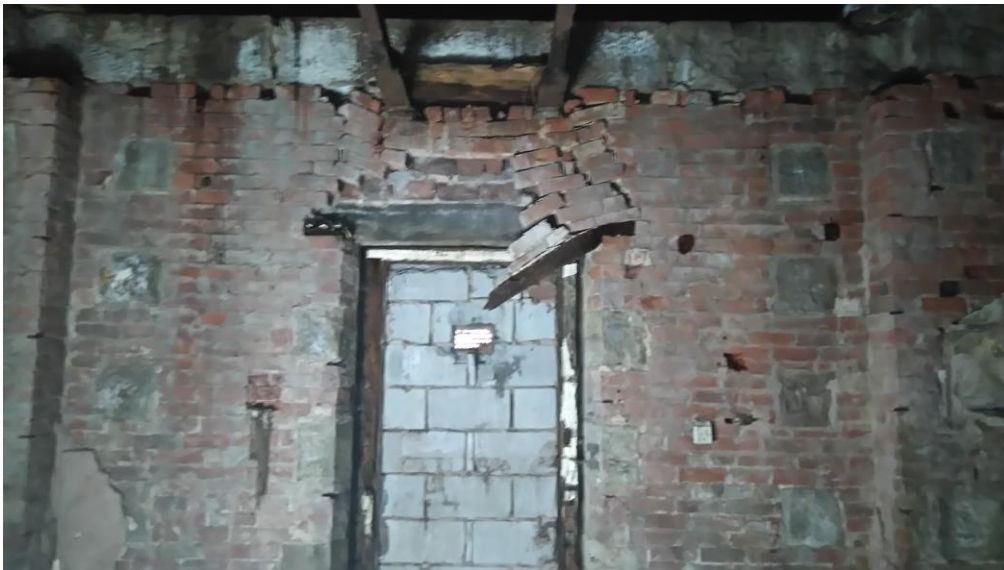
In Lodge 1 the timber lintels above the former window and door openings have failed. As this in turn supports the weight of the iron beams, chimney stacks and brickwork. The plastered finish has failed in large areas. There is evidence of mould growth and potential wet or dry rot to the underside of the roof structures.

Photograph 12: Lodge 1 - Failed Timber Lintel / Unstable brickwork

It is recommended that the chimney and supporting beams are dealt with as soon as practically possible as this is a high risk item. This could be done by temporally supporting

the weight of the beams and chimney while replacing the failed timber lintel with a more suitable alternative lintel.

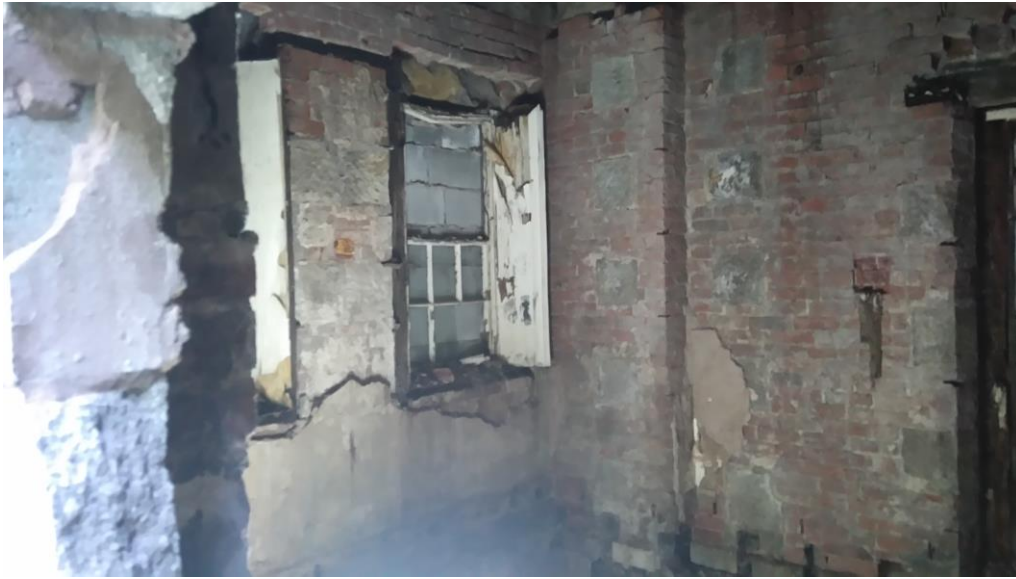
In lodge 1 the sash windows exhibit severe wet rot and possible dry rot.

Photograph 13: Lodge 1 - Wet Rot To Timber Window Frames

It is advised that further investigations are undertaken to establish the full extent of the deterioration to the timbers including but not limited to the roof structure and the windows.

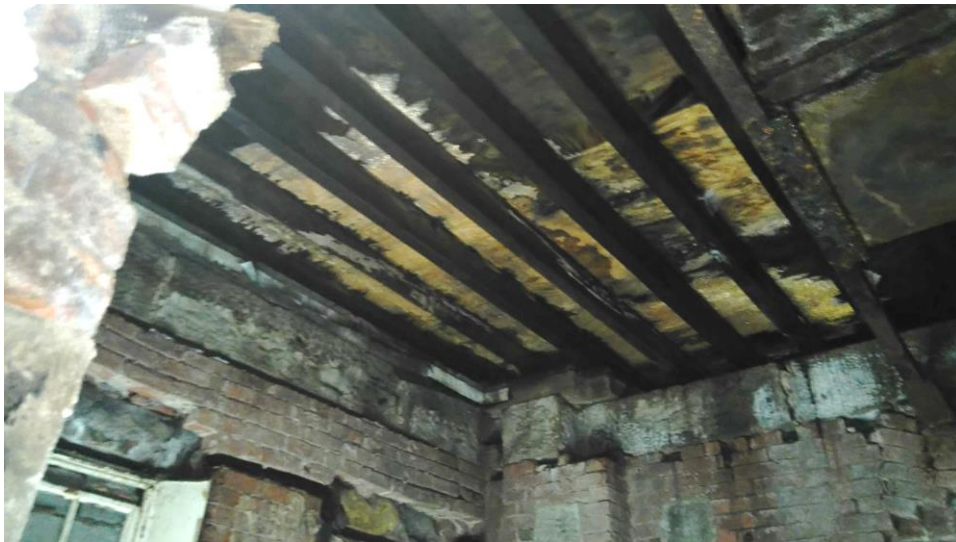
Photograph 14: Lodge 1 - Mould to underside of roof structure / Cast iron beam upon unstable brickwork

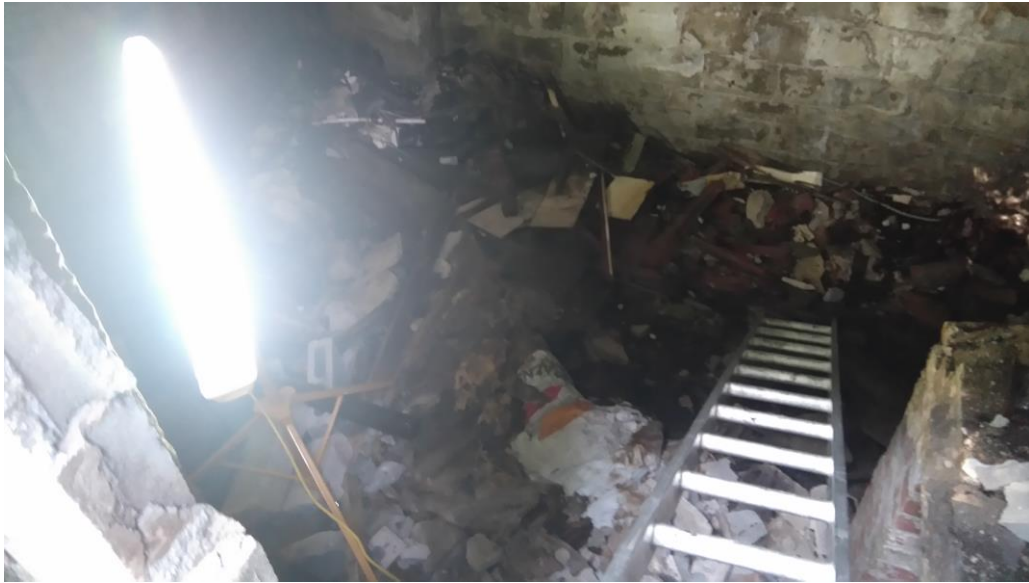
The condition of the ground floor areas is unsatisfactory. The timber suspended floors exhibit severe wet rot and possible dry rot and have collapsed into the basement.

Photograph 15: Lodge 1 - Timber Joists / Debris in Basement Area

It is suggested that the floor is completely replaced with a new timber suspended floor.
