# Reserve Fund Study

Whitehorse Condominium Corporation No.124

November 30, 2020

**Reserve Fund Study for Whitehorse Condominium Corporation No.124**

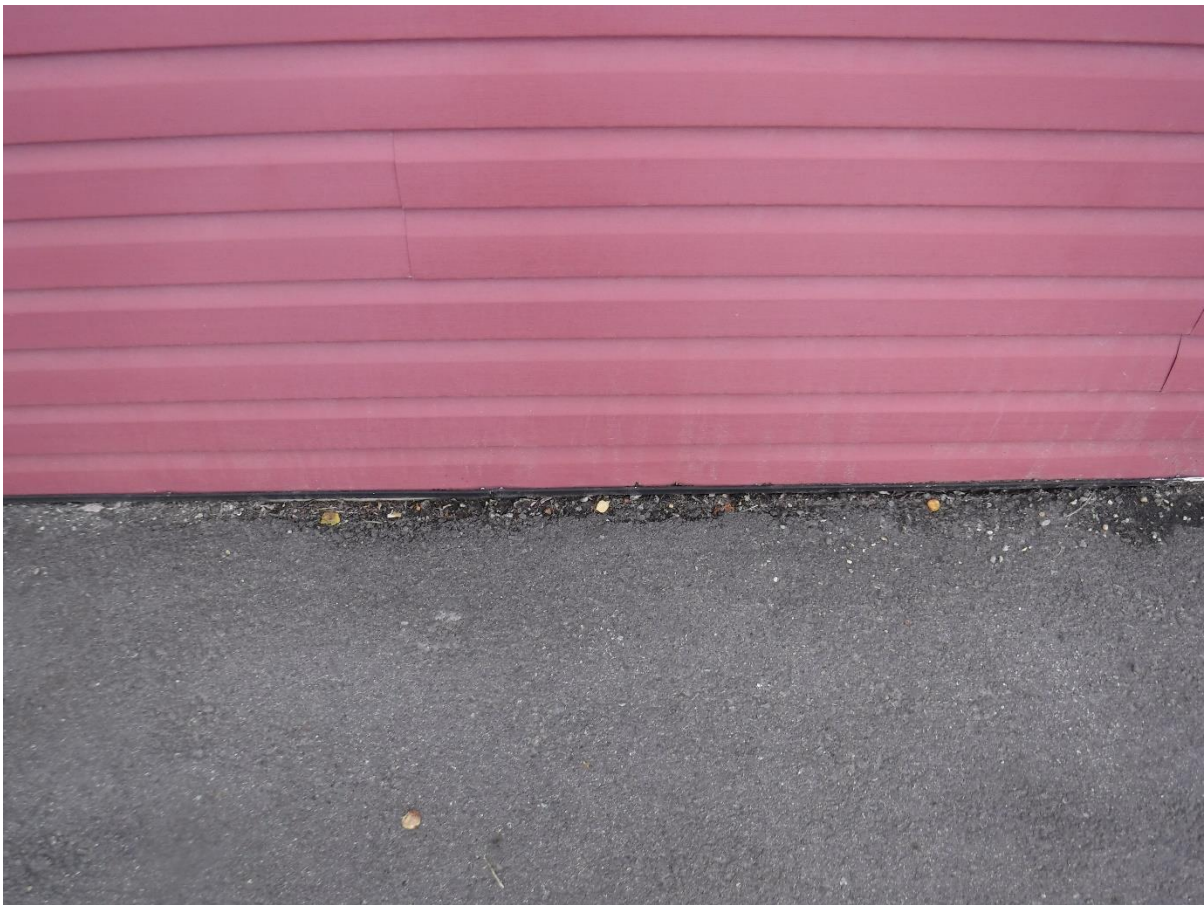
| Reserve Component: Structural and Architectural Component – 1. Foundation Repairs | | |
|---|---|---|
| <b>Condition Analysis</b> | Satisfactory condition. The property manager noted a concern with one part of a building where water ingress is a concern. | |

A gap between the asphalt and the foundation at the north end of Building A has been highlighted by the property management company for repair work.

- c. Investigate and address possible water accumulation at the footings at the north end of the complex. Make sure that water is not accumulating at the building footings.
- d. Cracks in the asphalt. (These should be filled to prevent further deterioration).
- e. Cracks in the concrete sidewalk.<sup>1</sup>

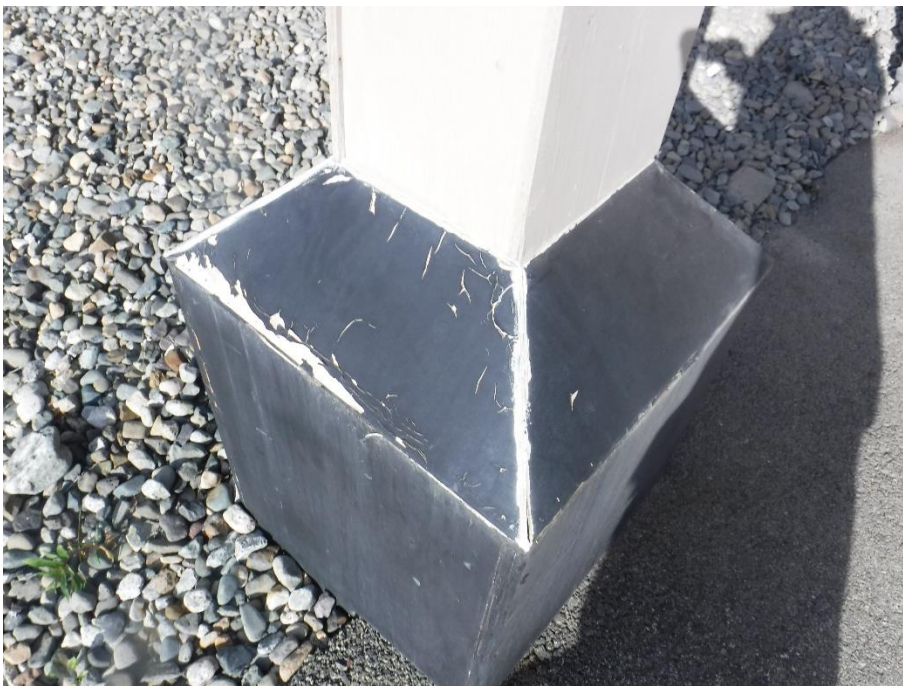
A south-facing post. The paint is peeling away. The south facing trim surfaces wear more quickly.

- a. Repair the fence posts at the front of the complex;
- b. Some southern-facing trim components need paint/repairs;

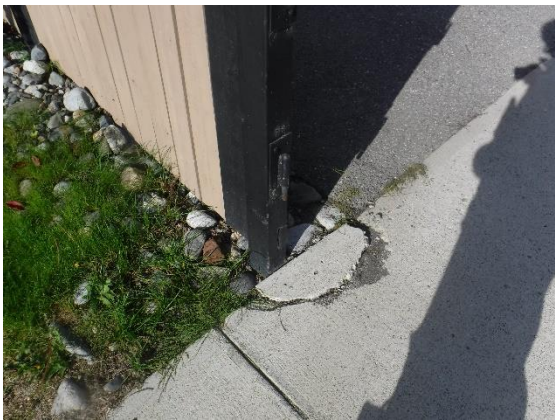
| Reserve Component: Site Improvements – 23. Sidewalks and concrete finishes | | |
|---|---|---|
| <b>Deficiency Analysis</b> | No major deficiencies noted. A few small cracks have appeared. Very little spalling. Some damage near the north-west gate. | |

Damaged sidewalk by a gate post.

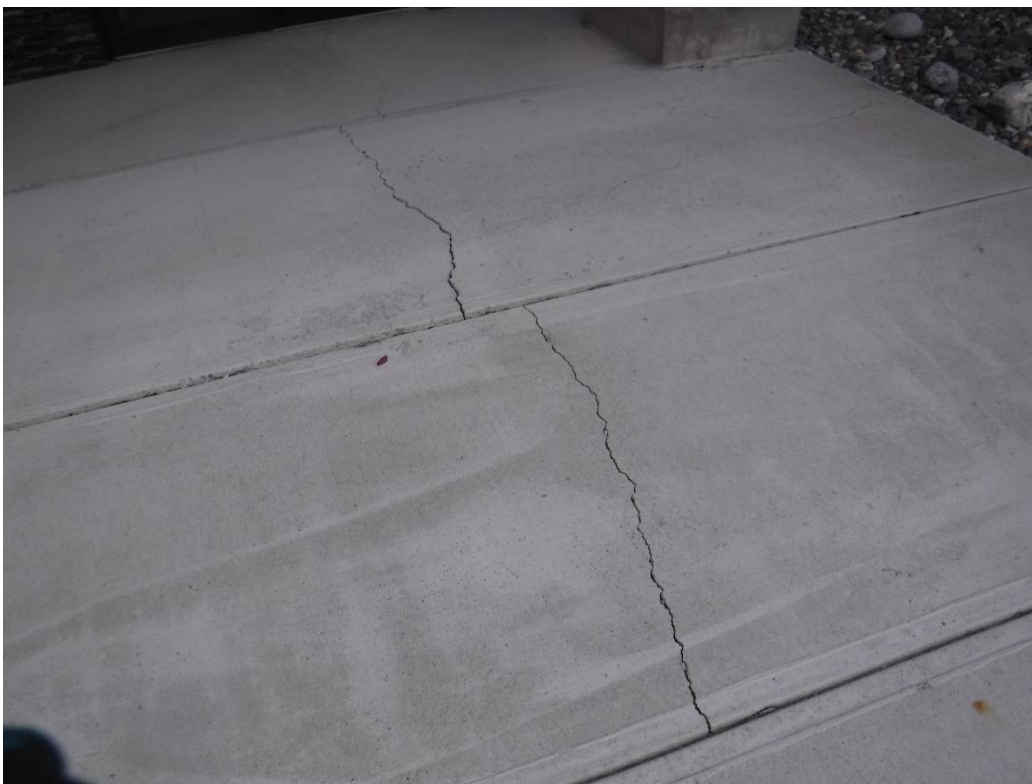
Small cracks in the sidewalk by a front door.

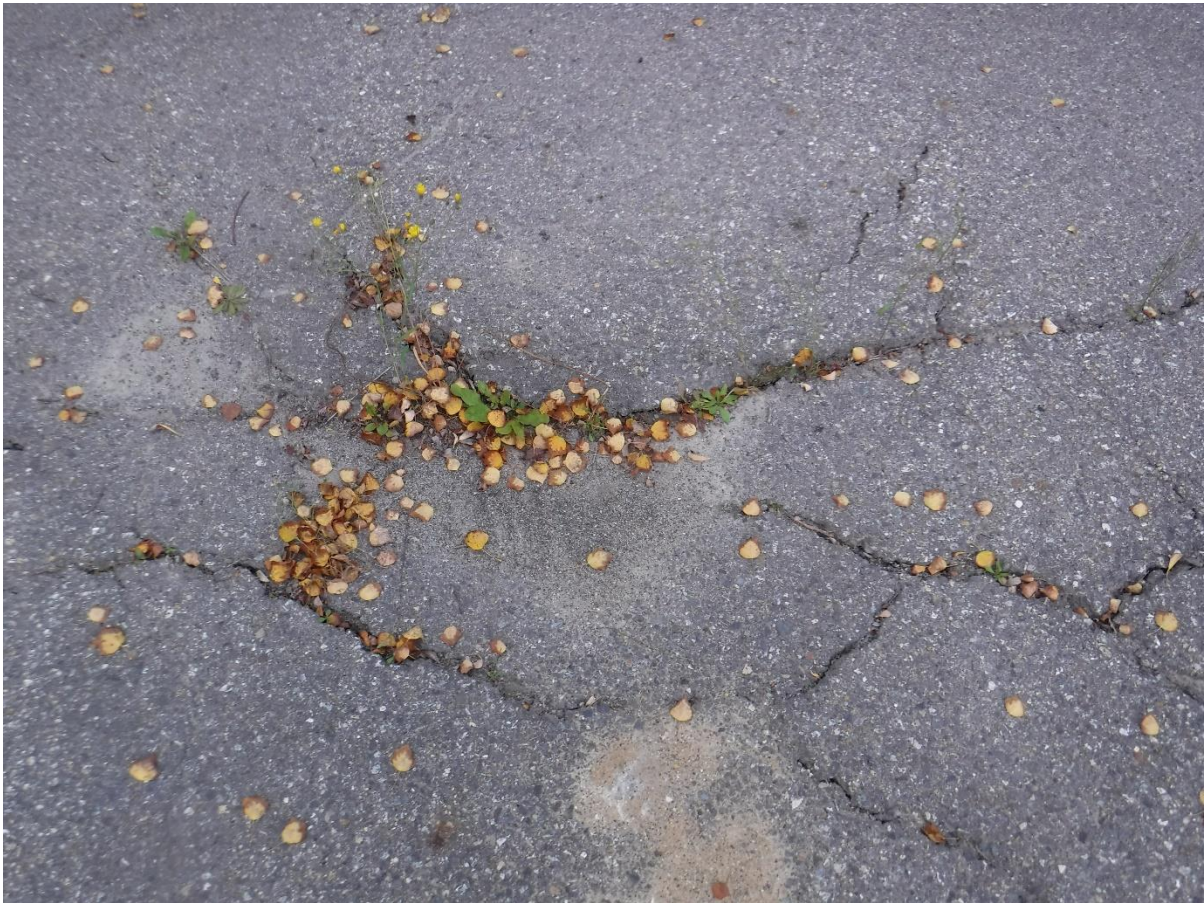
- the **foundations** of one side of Building B were not properly filled, resulting in frost heaves. This fault was remediated in 2012;
- **the drainage system** could not cope with the water that flowed into one of the catch basins, so a sump pump and piping was added around 2012;
- the **parking lot** at the north end of the complex is showing signs of subsidence near the catch basin and numerous cracks in other places. The subsidence is an indicator of inadequate compaction; while the cracks are likely from frost heaves—stemming from using poor sub-grade fill and/or of having poor drainage.

An area of subsidence in the asphalt. Now cracks have appeared and weeds are starting to grow through the cracks.

In light of the above it is recommended that CC124 look over the pavement at the north end of the complex and **develop a plan to address the deterioration of the parking lot asphalt.** At a minimum the cracks should be filled each year. Sealing the pavement would also extend its life.<sup>2</sup> Capital expenditures to fix the pavement in places should be considered.

| Reserve Component: Site Improvements – 24. Parking Lot | | |
|---|---|---|
| <b>Deficiency Analysis</b> | Deficiencies noted above. The condo corporation should inspect the asphalt surfaces annually and patch any cracks. Due consideration should be given to sealing the asphalt to better protect it. | |

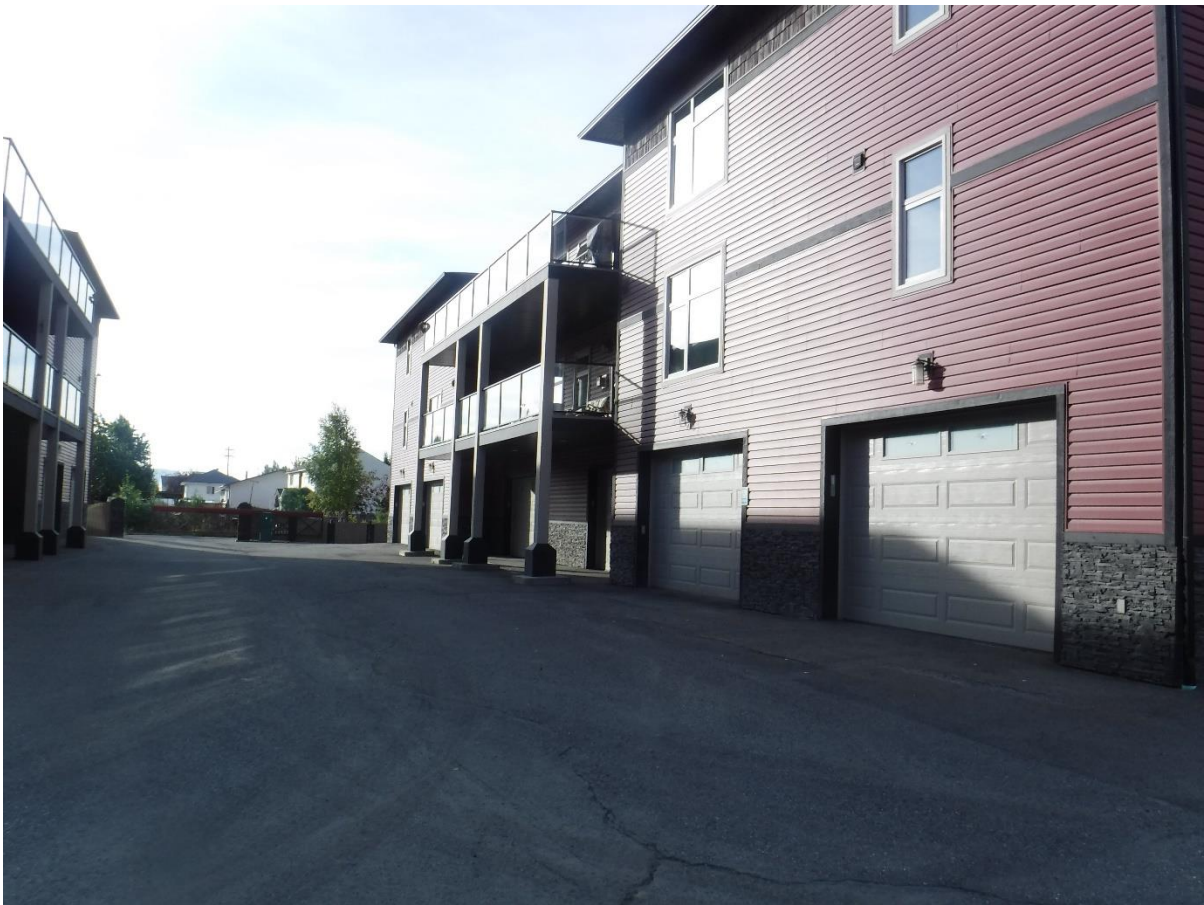
Same shot, but with Building B visible on the right. Cracks visible.

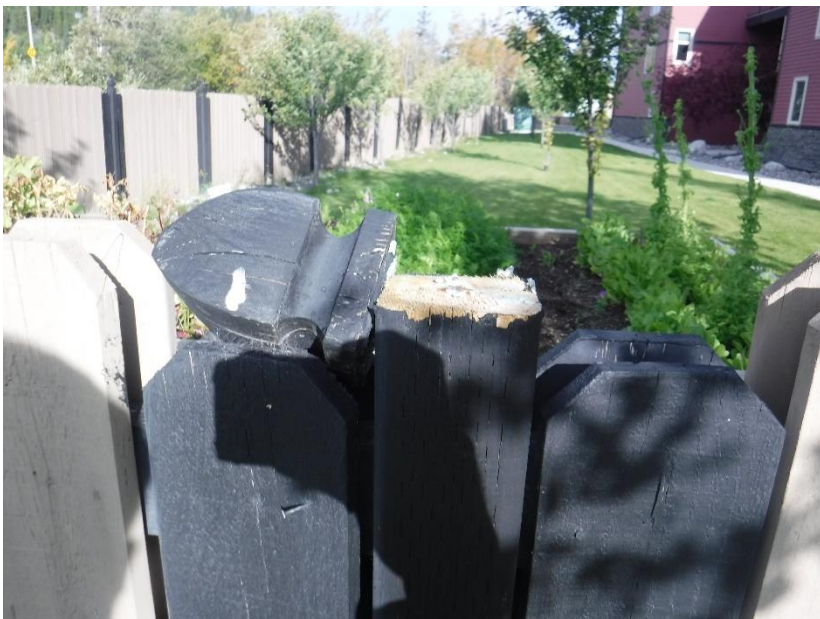
| Reserve Component: Site Improvements –25. Wooden Fence | | |
|---|---|---|
| <b>Deficiency Analysis</b> | The fences are in good condition. Some of the ornamental post tops at the front of the complex have deteriorated badly. | |

This ornamental top of the fence post has broken off.

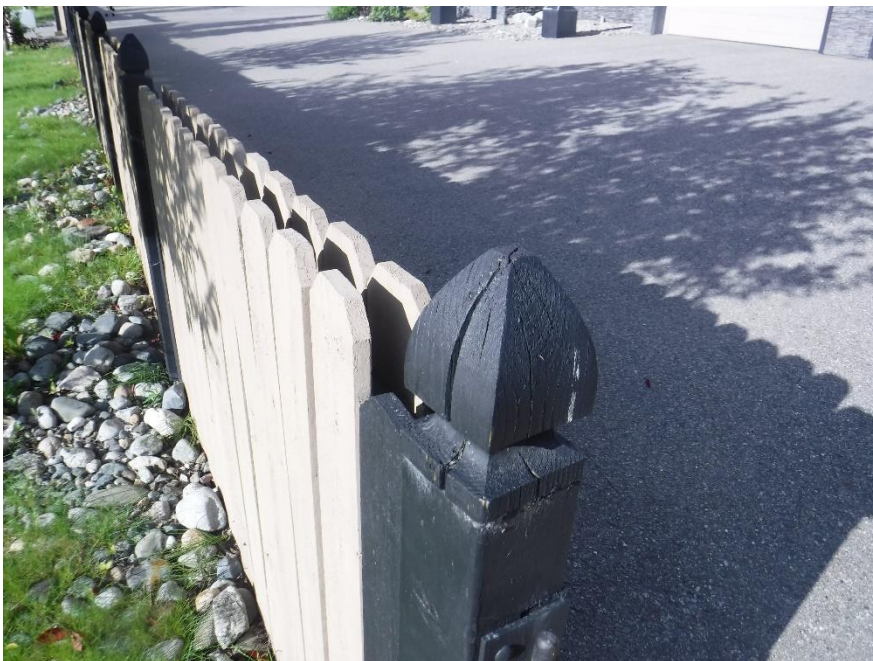
Big cracks in this fence post top.
