ISSUED FOR USE  
EBA FILE: W14103028-01

Lansing Point Condo Association  
111-134 Seine Square  
Whitehorse, YT Y1A 3C3

**Subject:** Geotechnical Observations – Building B Foundation Recommendations  
134 Seine Square, Whitehorse, YT

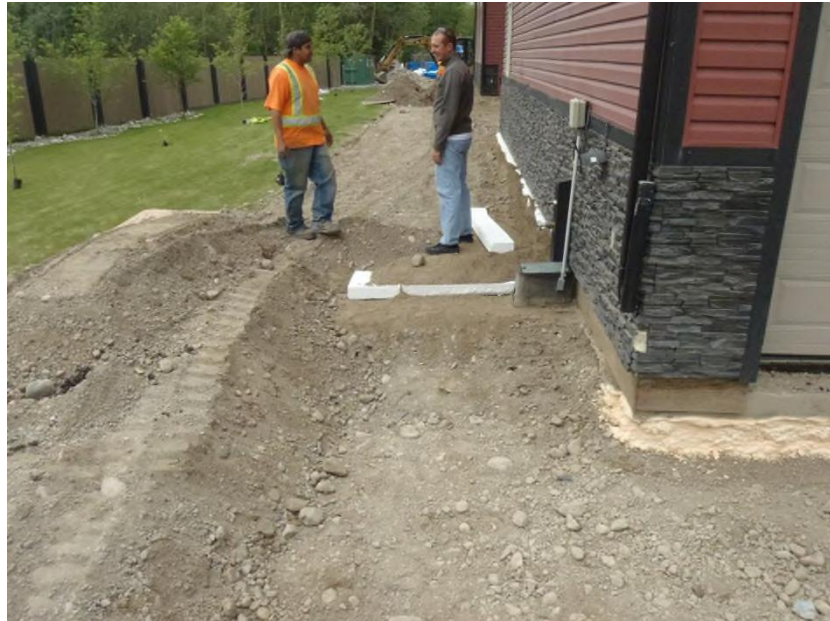
**Photo 1**

Excavation of perimeter soils to allow for placement of the bedding sand and insulation. (July 12, 2012)

The perimeter area along Building B was excavated approximately 2.4 m from the exterior edge of the building and exterior deck columns, down a minimum depth of 200mm from the bottom of the concrete perimeter footings to allow for the placement of 75 mm of bedding sand (Photos 1 and 2). 100 mm of rigid board insulation was then placed sloping away from the exterior edge of the concrete footing out 1.8 m on the prepared bedding sand surface and covered with 75 mm layer of bedding sand. An additional 100 mm of insulation was placed at the corners of the building 1.8 m in each direction from the corner (shown on Figure 1). The 100 mm of insulation was also placed vertically along the exterior side of the concrete footings up to the bottom of the exterior siding in the landscaped areas (Photo 3) and to the underside of the asphalt in the paved areas.

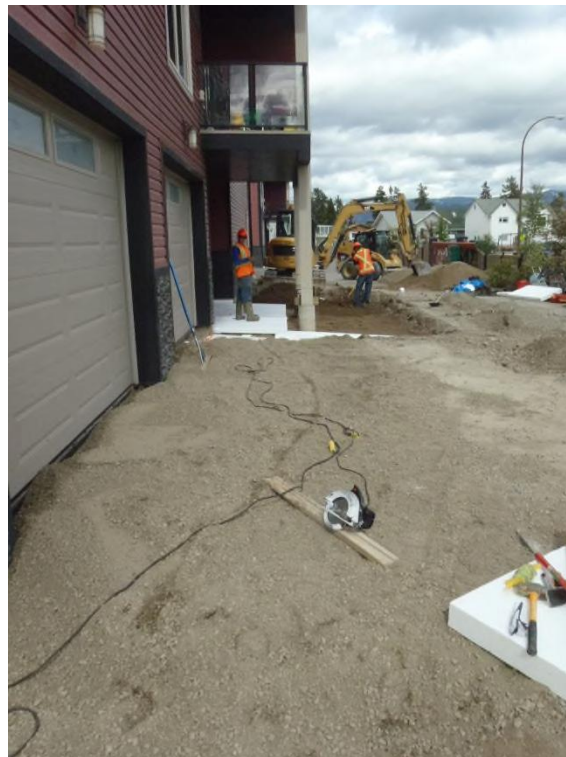
**Photo 2**

Additional excavation around the deck column to allow for placement of the bedding sand and insulation. (July 13, 2012)

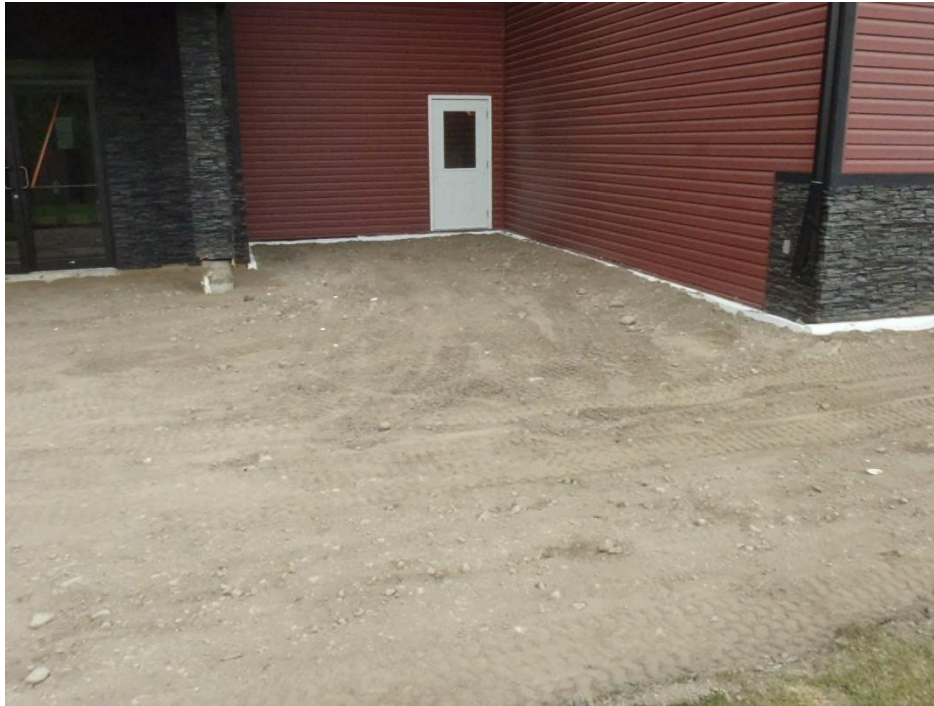
**Photo 3**

Vertical rigid board insulation placement along the perimeter of the concrete footings. (July 13, 2012)

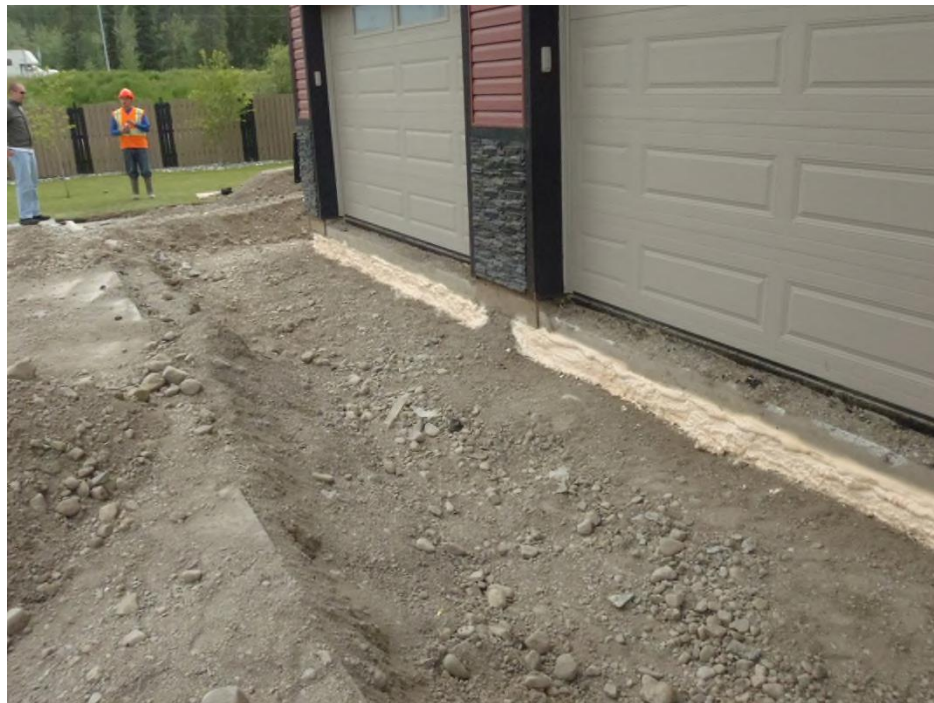
**Photo 4**

Excavation under the garage door openings to allow for the placement of spray foam insulation. (July 12, 2012)

At the entrance and garage doorways the soil beneath the perimeter footing was removed to create a void that was about 150 mm deep, 300 mm wide and extended 300 mm beyond the width of the entrance way (Photo 4). This void was filled with high density spray foam insulation and tied-in with the horizontal perimeter rigid board insulation.

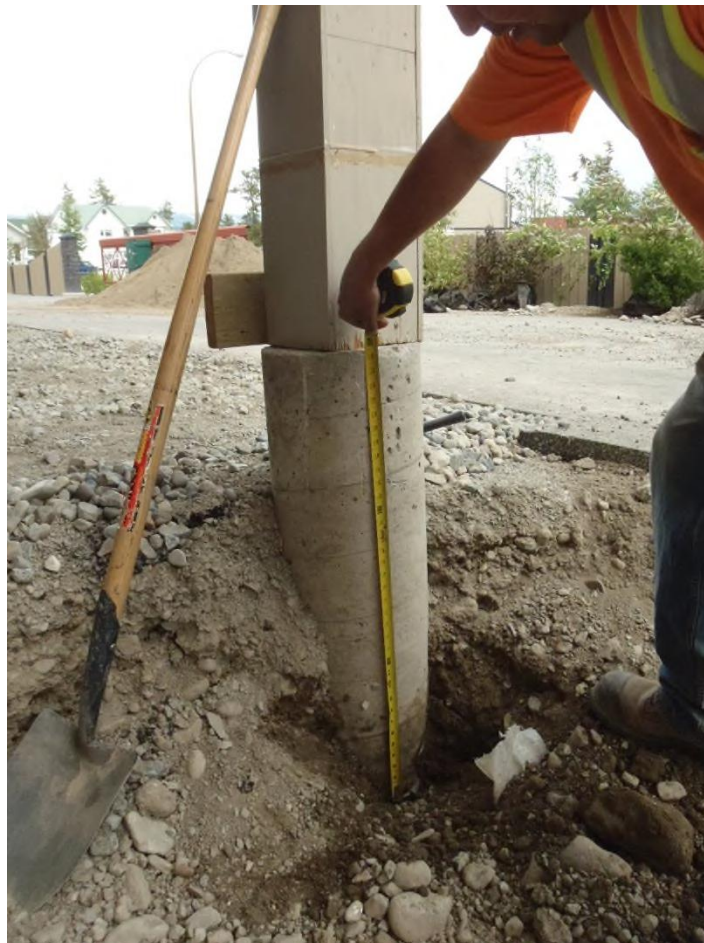
**Photo 5**

During the excavation of the soils surrounding the deck column foundations along the south eastern side of Building B (Photo 5), it was determined that the concrete foundations consisted of unsupported 300 mm (12") concrete sono-tubes to an approximate depth of 600 mm (24"). After reviewing the 2006 design drawings EBA determined that the column foundations were not constructed to the design requirements which were to be 200 mm (8") concrete sono-tubes to a depth of 1.5 m (5') supported by a 600 mm x 600mm (24" x 24") by 200 mm (8") thick concrete spread footing. Based on these finding EBA contacted Mr. Marsh of Marsh Engineering to review the existing dimensions of these foundation columns and determine if they met the structural requirements to support the deck columns. Mr. Marsh concluded that the existing concrete sono-tube foundations were under designed and would require additional spread footing support. Mr. Marsh completed a review of the column design loads and determined that each concrete sono-tube would require a concrete spread footing 900 mm x 900 mm (36" x 36") by 300 mm (12") thick dowelled into the concrete sono-tube. Marsh completed detailed drawings and specifications (attached in Appendix A) for the construction of the spread footings.

Concrete sono-tube supporting deck columns. (July 12, 2012)

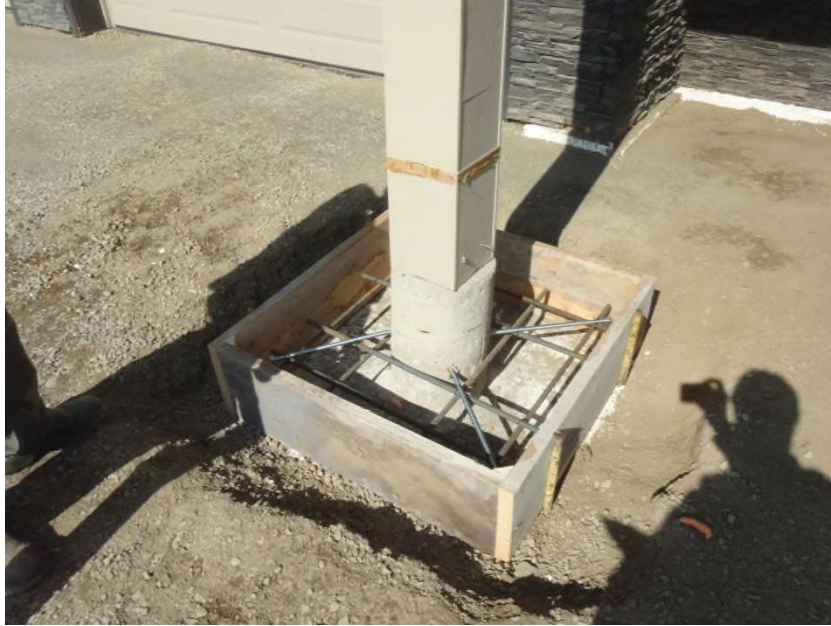
**Photo 6**

Dowel and rebar placement for the concrete spread footings. (July 26, 2012)

The spread footings were constructed on top of the rigid board insulation to the required dimensions specified in the Marsh Engineering drawings (Photos 6 and 7).

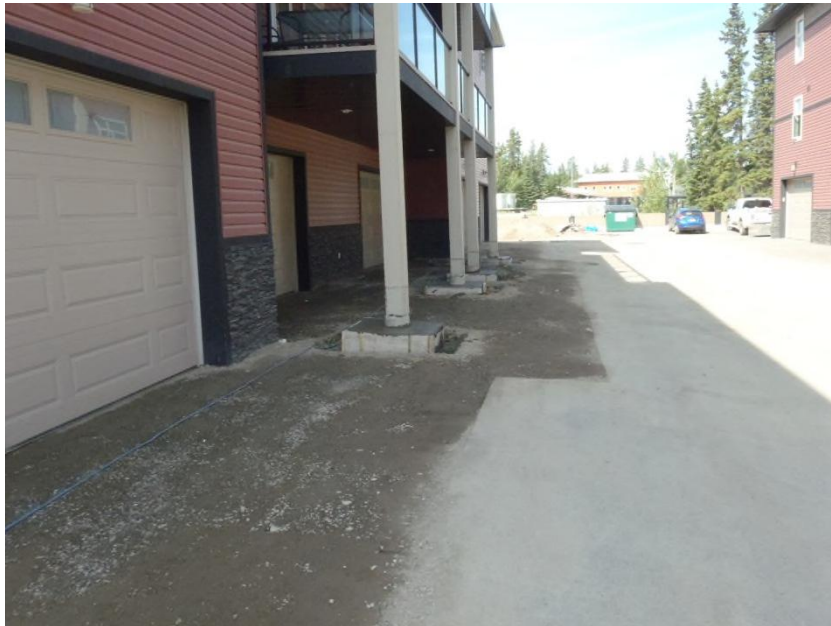
**Photo 7**

Concrete spread footings for deck columns along the north eastern side of Building B. (July 26, 2012)

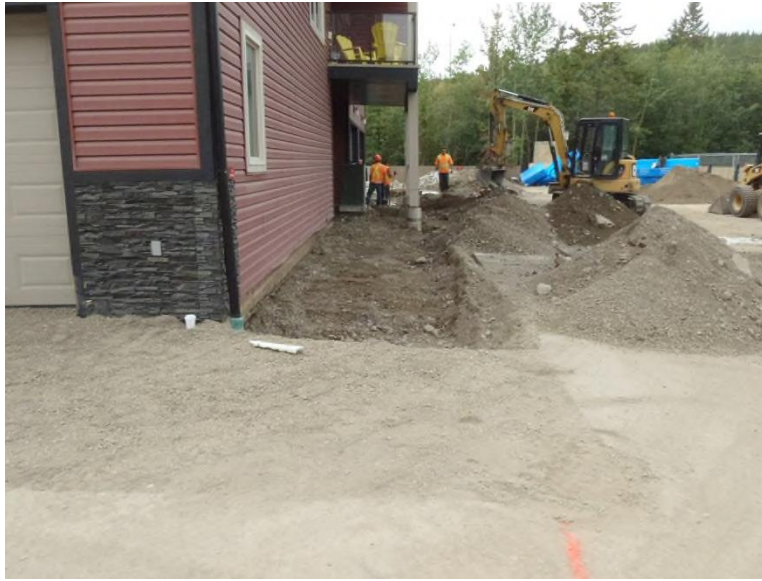
**Photo 8**

Further investigation of the deck column foundations along the north western side of Building B (Photo 8), where there had been evidence of over 100 mm of settlement, determined that there were concrete spread footings 900 mm x 900 mm (36" x 36") by 200 mm (8") thick at an approximate depth of 600 mm (24") (Photo 9). It was determined that the additional spread footing requirements would not be required for these columns but instead they would require continued monitoring for settlement and appropriate adjustments made to correct any future settlement.

Concrete sono-tubes located along the north western side of Building B. (July 24, 2012)

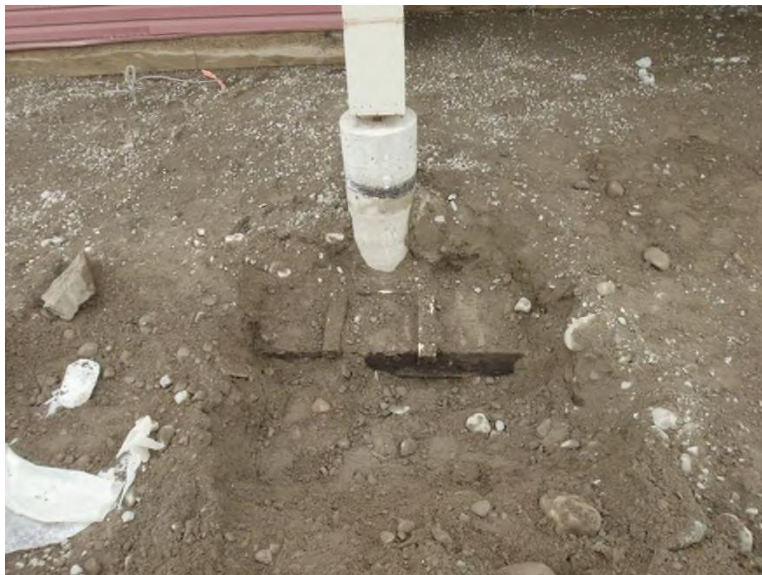
**Photo 9**

Existing concrete spread footings beneath the concrete sono-tubes along the north western side of Building B. (July 24, 2012)

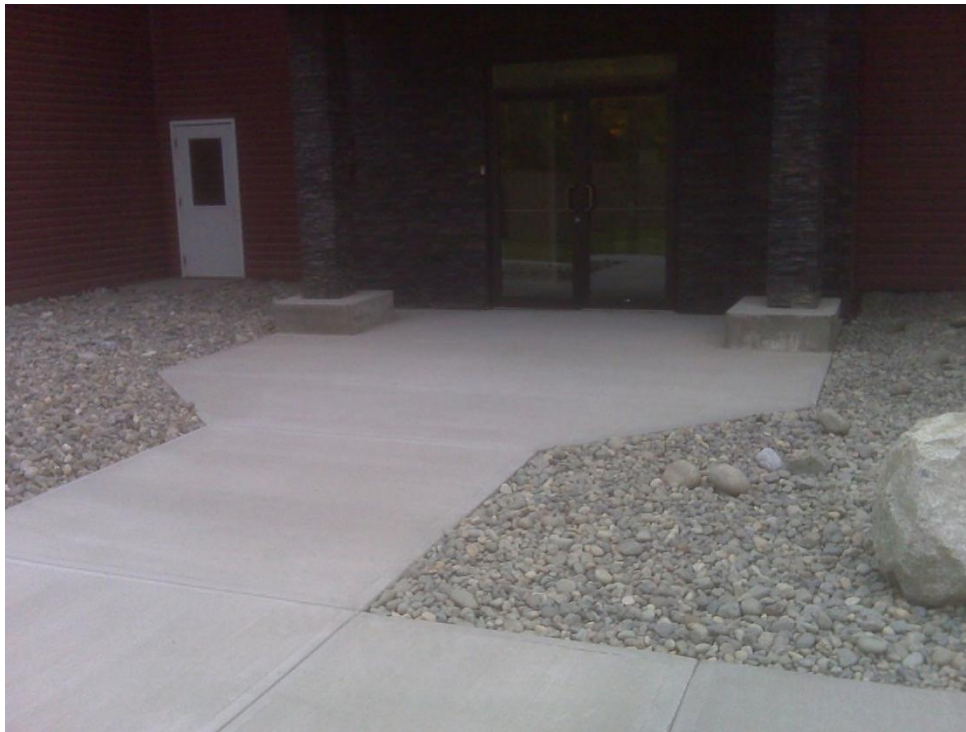
**Photo 10**

The front entrance to Building B located along the south western side. (August 22, 2012)

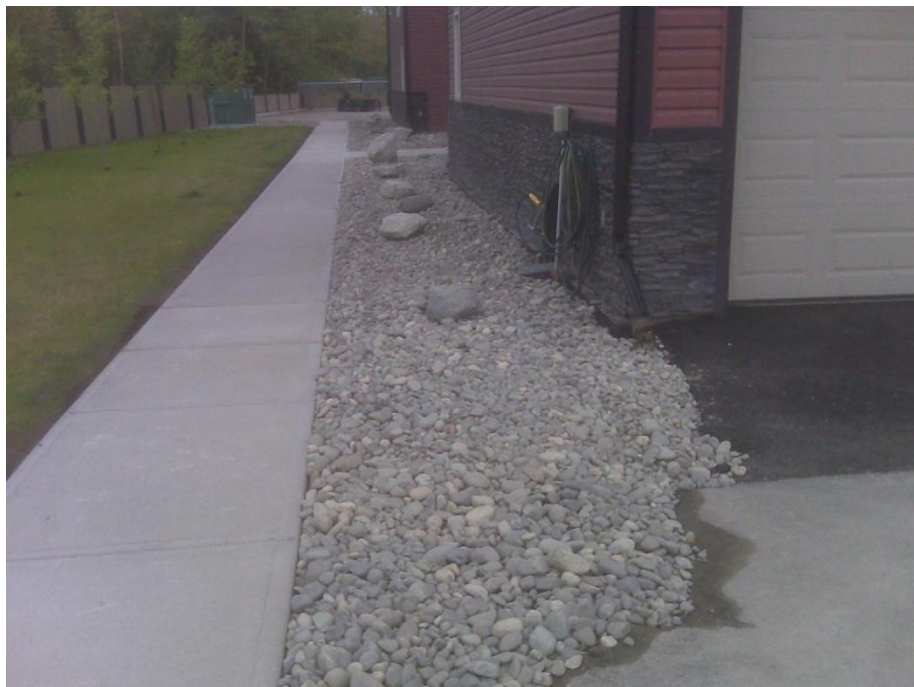
**Photo 11**

Looking northwest at the south western side of Building B. (August 22, 2012)

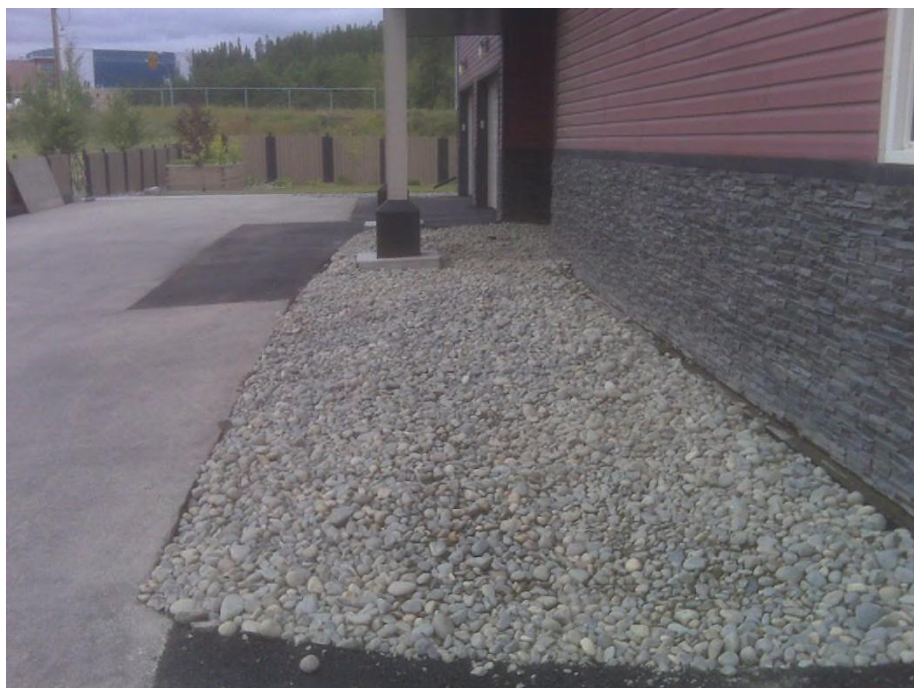
**Photo 12**

Looking southwest at the south eastern side of Building B. (August 22, 2012)

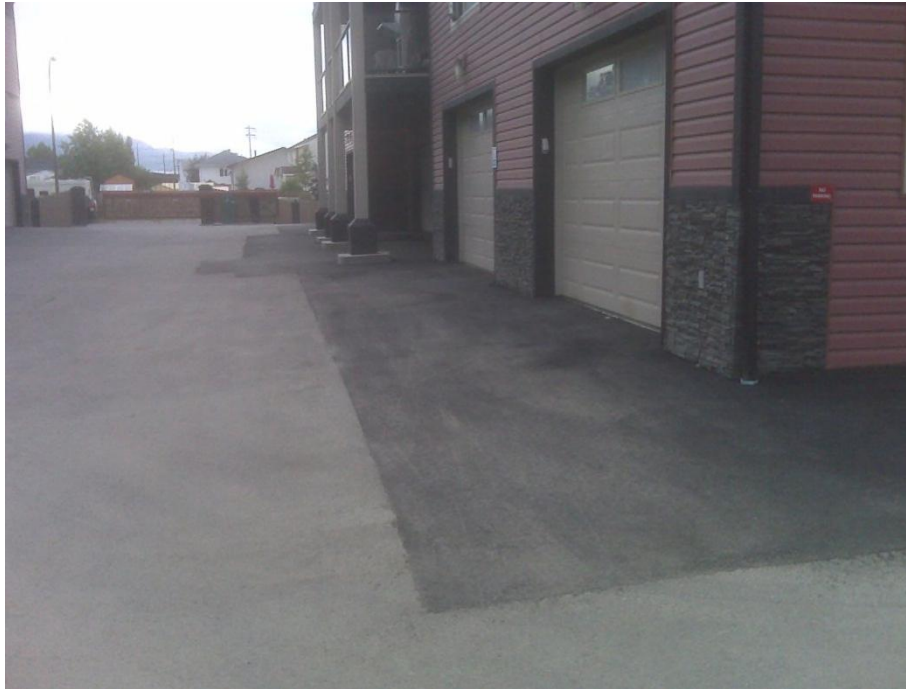
**Photo 13**

Looking southwest at the north eastern side of Building B. (August 22, 2012)

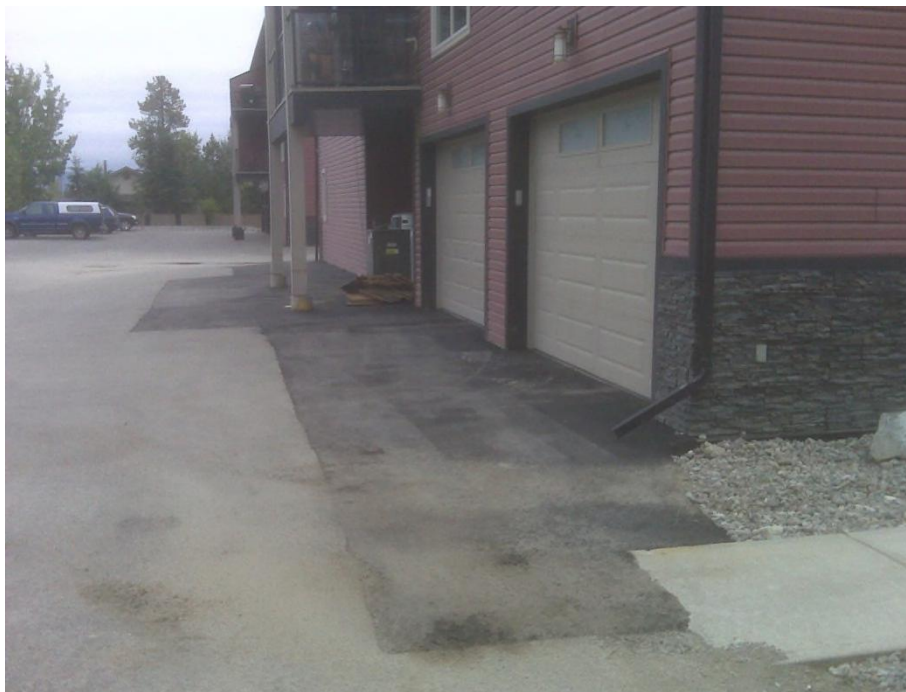
**Photo 14**

Looking northeast at the north western side of Building B. (August 22, 2012)
