July 24, 2023

File: AM2.ENG01005

Condo Corp. 124  
105 Copper Road  
Whitehorse, YT Y1A 2Z7

## **Lansing Point Condominiums Preliminary Geotechnical Evaluation Whitehorse, Yukon**

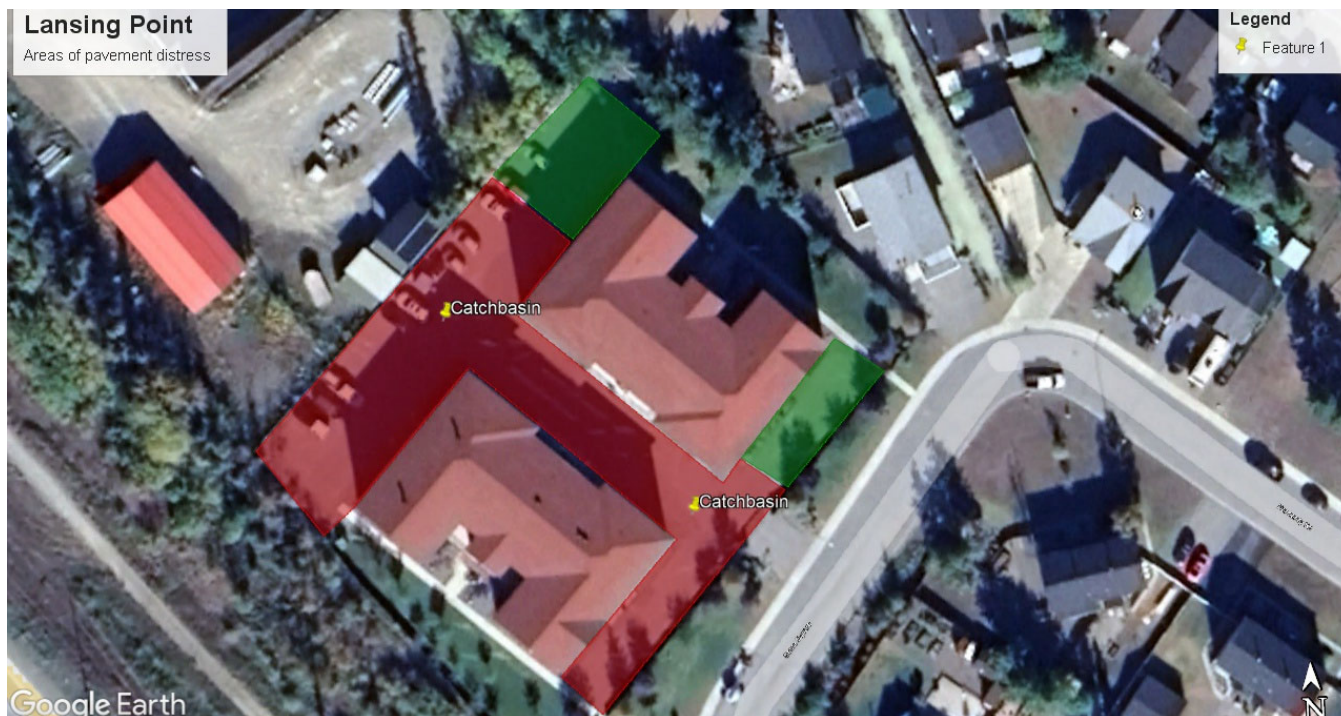
AM2 evaluated the state of the asphalt surface at all the parking areas and found cracking within all the red areas in Figure 2.

**Figure 2: Google Earth image showing pavement cracking areas in red and areas of little to no cracking in green**

Pavement cracking was most pronounced in the northwest corner and around the northern catch basin. The following photos show areas of significant damage.

CC-124 can likely avoid subexcavation where the existing asphalt surface has not cracked, as identified in Figure 2. These areas have not heaved significantly enough to crack the asphalt, suggesting that the below conditions do not promote frost heave. Evidence for the performance comes from drilling borehole BH23-02 and encountering medium-grained sand with trace silt, which pushes the groundwater elevation deeper and is an NFS material. During subexcavation, a geotechnical engineer should evaluate the areas to provide final recommendations of where subsurface conditions meet the guidance provided in this report.

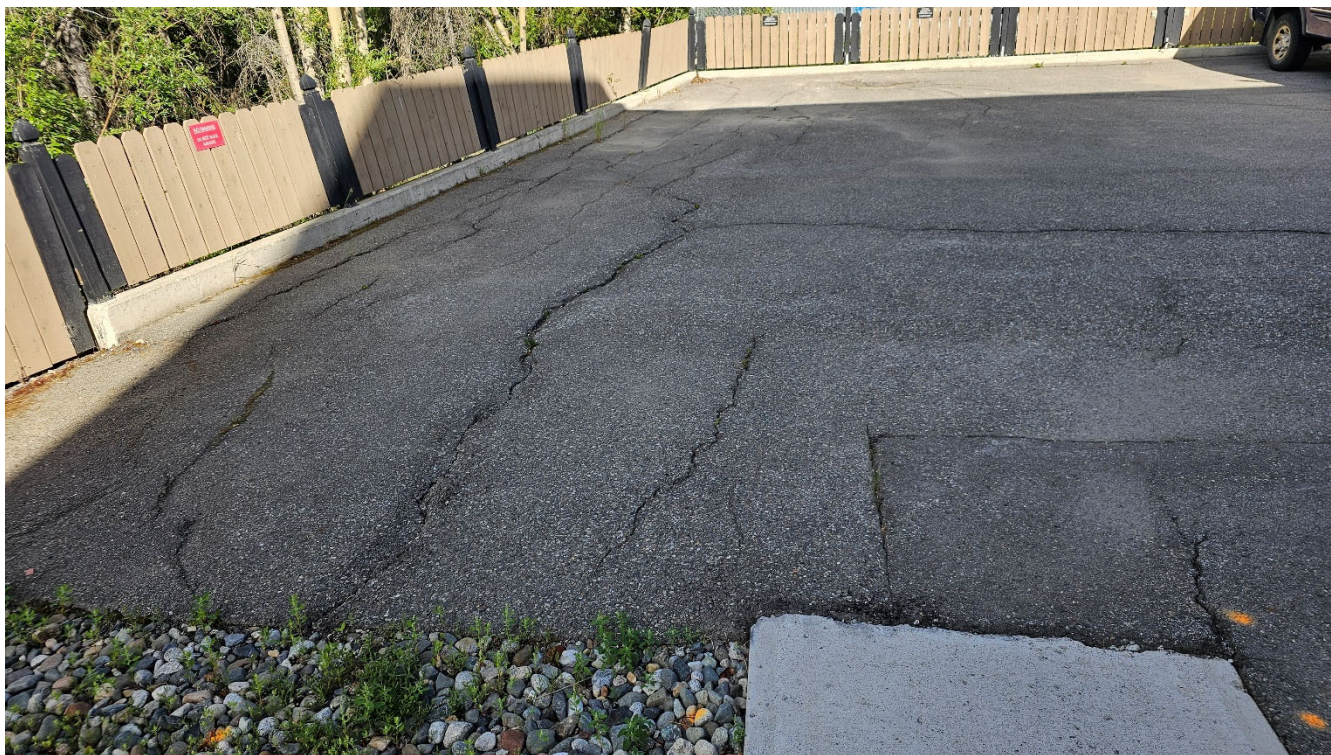
**Photo 1: Pavement cracking in northwest corner**

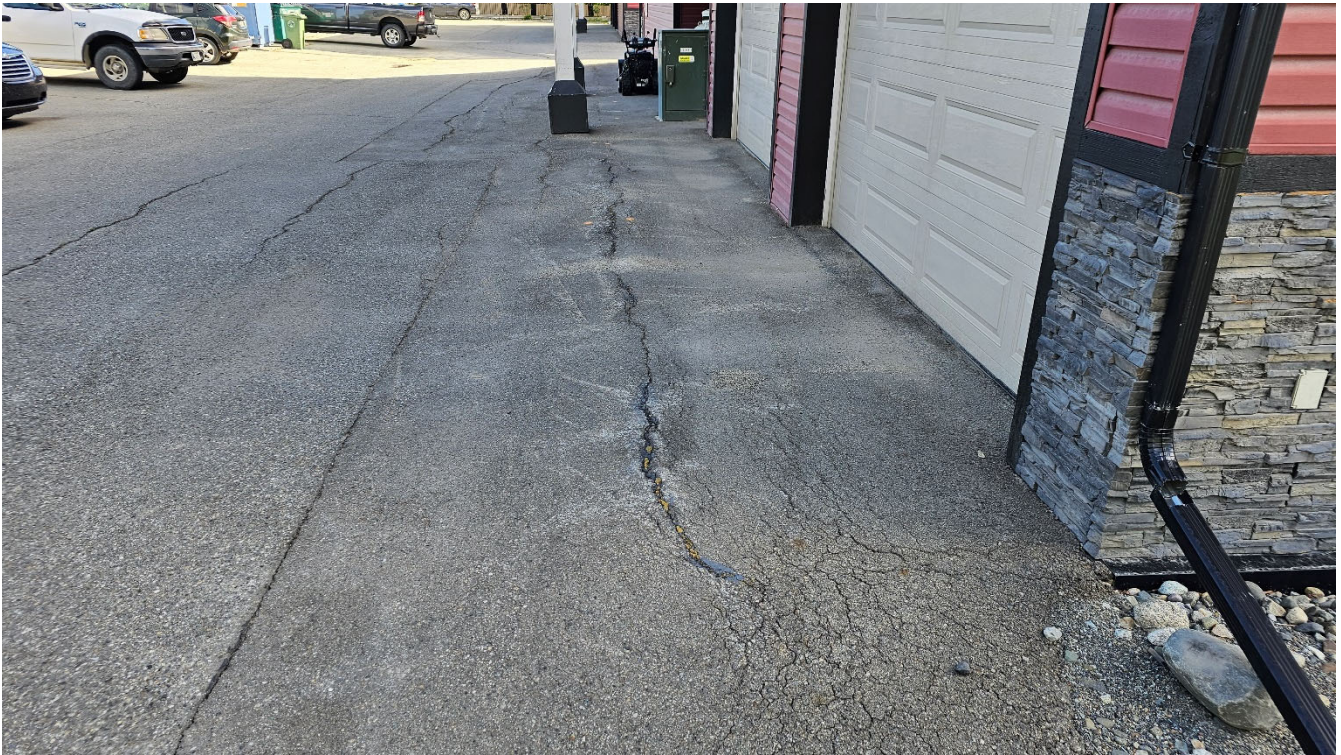
**Photo 2: Pavement cracking along 2012 remedial repairs**

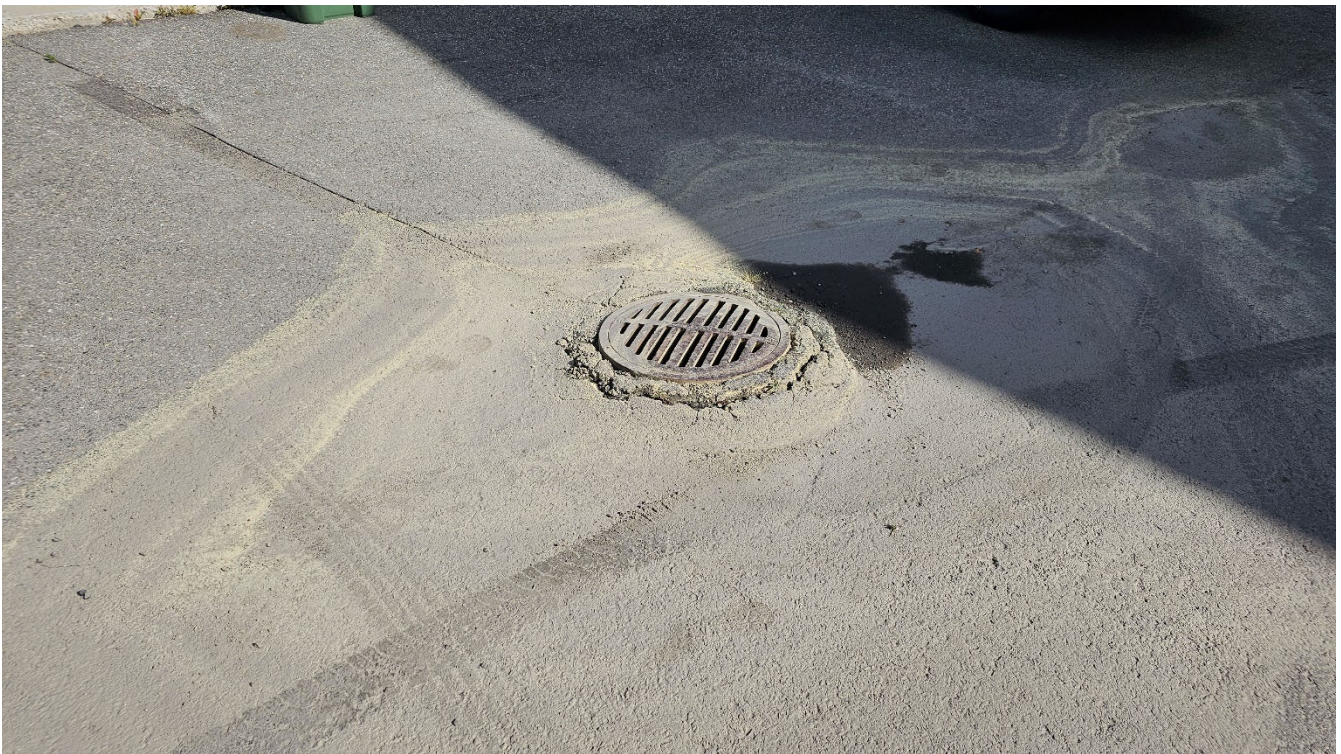
**Photo 3: Heave/settlement around northern catch basin**

The catch basin in Photo 3 exhibits ground settlement around the structure or the structure itself has heaved. Water was noted in the catch basin at the elevation of the outlets, which are approximately 1 m below the surface.

The manhole barrels should be pumped out using a vac truck to remove sediment and prepare them for remedial measures. After the water and sediment is removed, the barrels should be sealed to prevent water migration into the rock pits. CC-124 will have to manage storm and melt water by pumping out the manholes and directing the water to the City of Whitehorse storm system. CC-124 should confirm whether the City will allow this water management procedure.

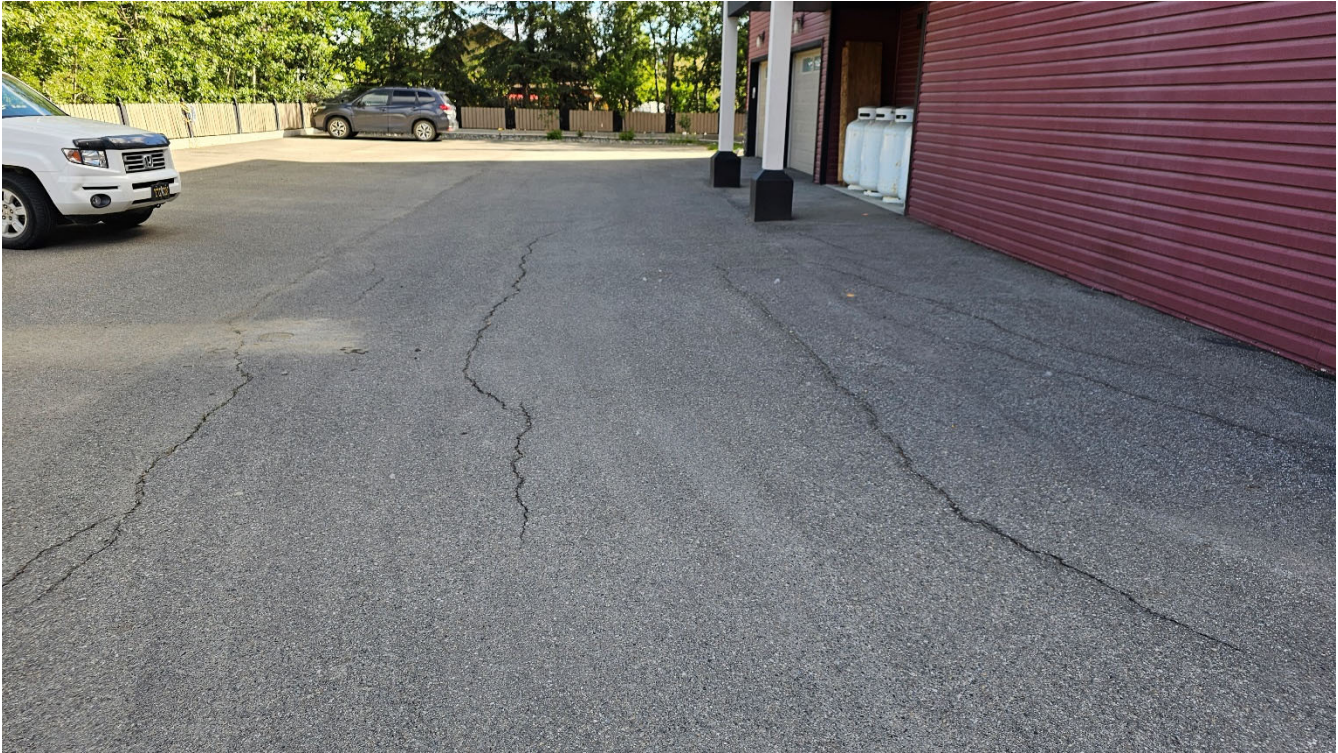
**Photo 4: Pavement cracking continuing towards borehole BH23-02 with BH23-03 in the foreground**

AM2 advanced borehole BH23-03 to evaluate soil conditions at the edge of the cracking and found suitable soils, yet heave occurs in the area. The distress could be driven by the heave/settlement of soils away from the borehole and generating overall movement.
