Reserve Fund Study

Whitehorse Condominium Corporation No.124
June 30, 2025

Reserve Fund Study for Whitehorse Condominium Corporation No.124

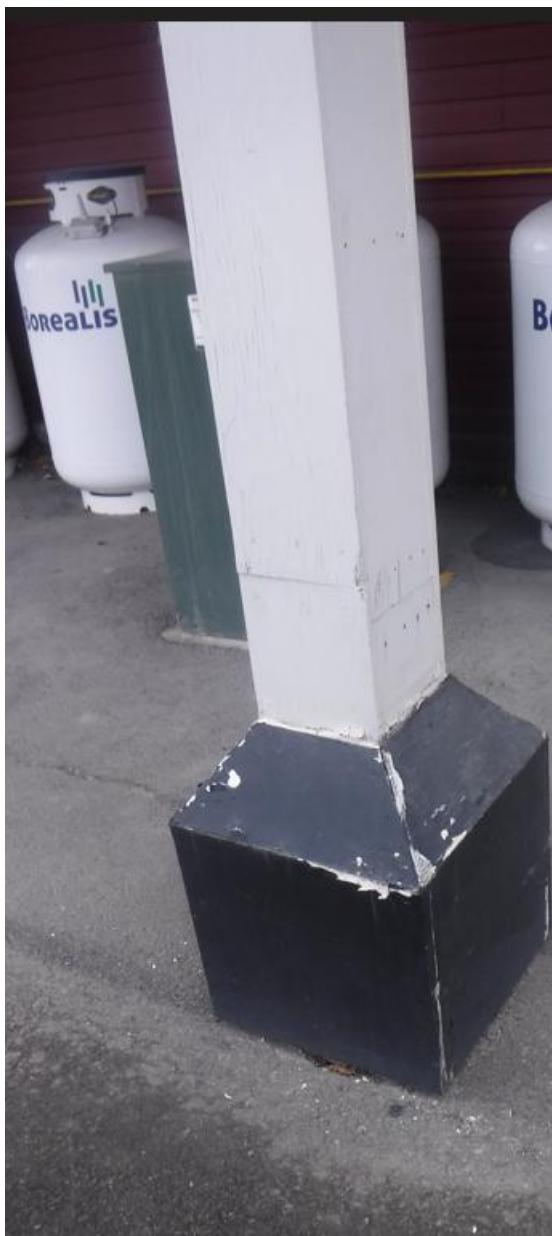
A support column wrap. The base wraps of balconies structural supports will be repaired in 2025.

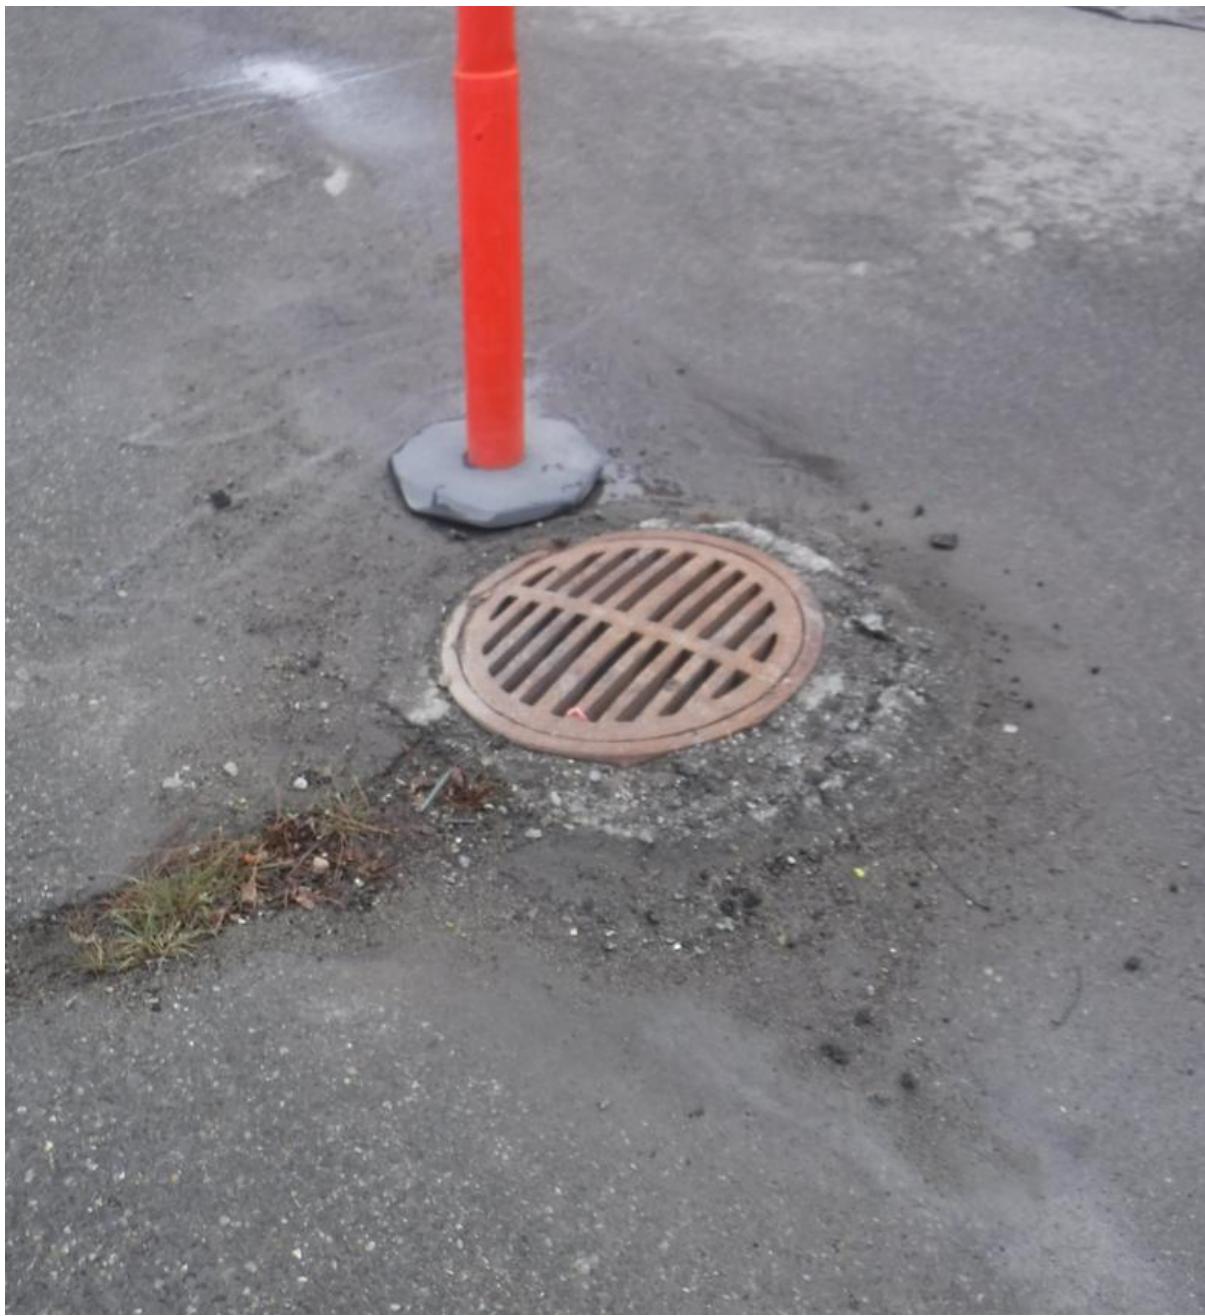
Reserve Component: Mechanical and Electrical Components – 20. Drainage System		
Physical Description	This component includes the drainage pipes, the catch basins and the sum pump.	
Financial Analysis	This component has had no expenditures 2021-2025 from the reserve account.	
Potential Deterioration	Deterioration can be caused due to poor soils, weather, especially precipitation, frost-freeze cycles. In Spring the melt water may overfill the catchment basins. Subsidence around the catchment basin.	
Condition Analysis	The originally designed system could not cope with large water volumes and flooded out. Eight years ago CC124 added an ancillary system – a sump pump and above ground pipes to remedy the system capacity problems. CC124 installed an underground pipe to the catch basin and drains the basin with a sump pump during the Spring melt. A geotechnical engineer has told CC124 that the erosion of the parking lot has been stabilized as a result.

Life Cycle Analysis	Date of Acquisition: 2008 Normal Life Span 15 years Effective Age 8 years Remaining Life Span 7 years	
Unit Quantity And Cost Estimates	Unit Quantity n/a Unit Cost Estimate n/a Current Repair or Replacement Cost Estimate \$7,000 allowance Estimated Year of Major Repair or Replacement 2032	
Deficiency Analysis	The original poor design of the drainage system caused the condo corporation to adapt a contingency measure – the sump pump and pipes. The system has been stabilized.

Subsidence and asphalt damage around a catch basin.

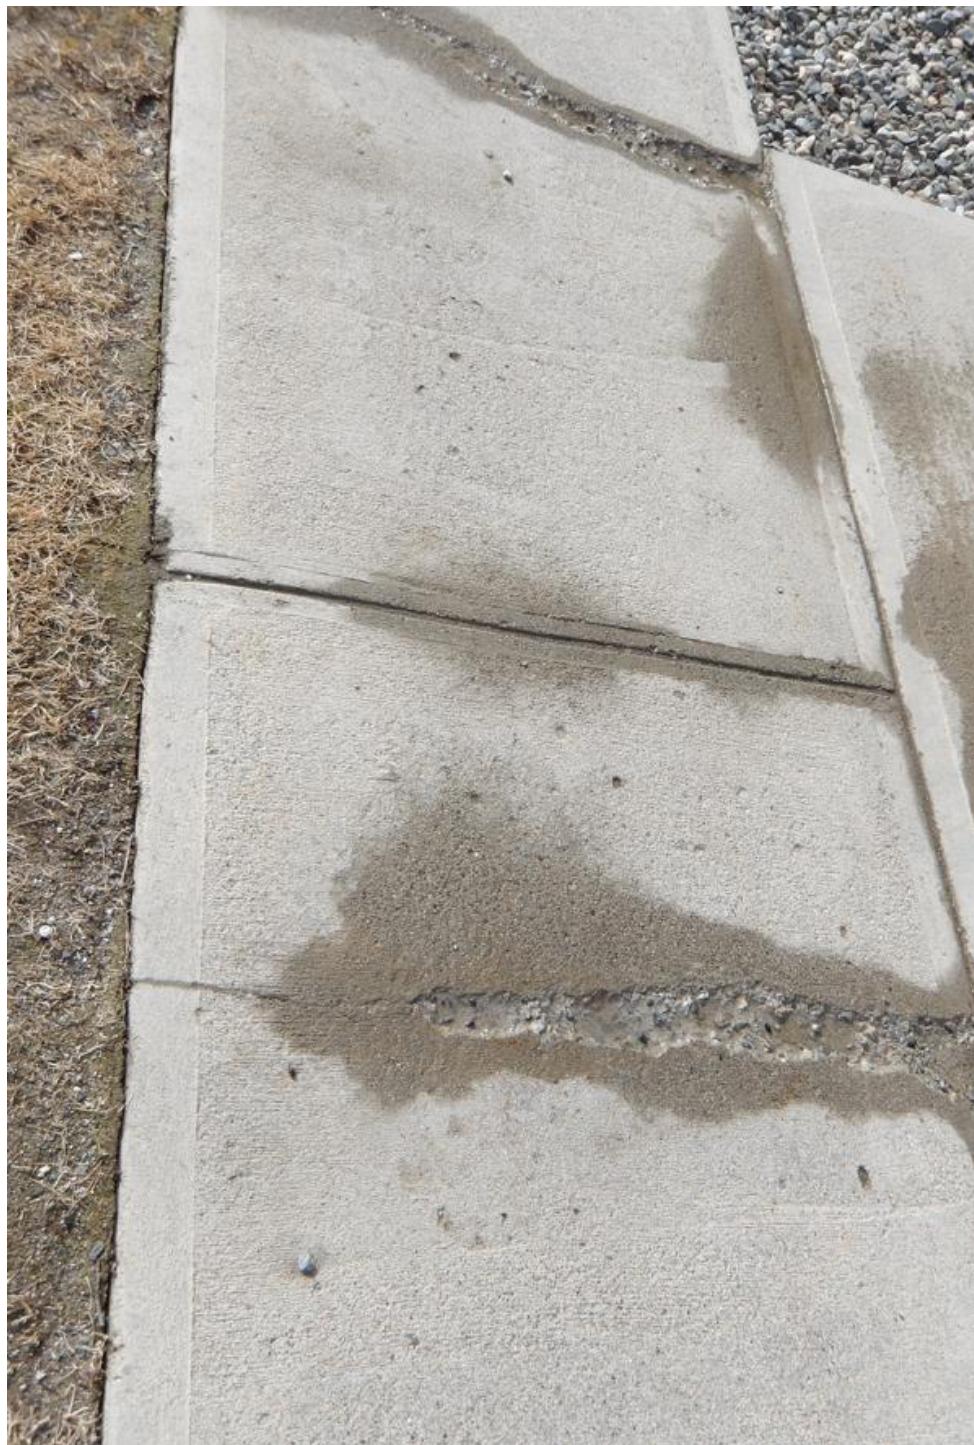
Estimated Year of Major Repair or Replacement	2051	
Deficiency Analysis	Deficiencies noted. Cracks have appeared in a few places.

Large cracks/erosion in these sidewalk sections.

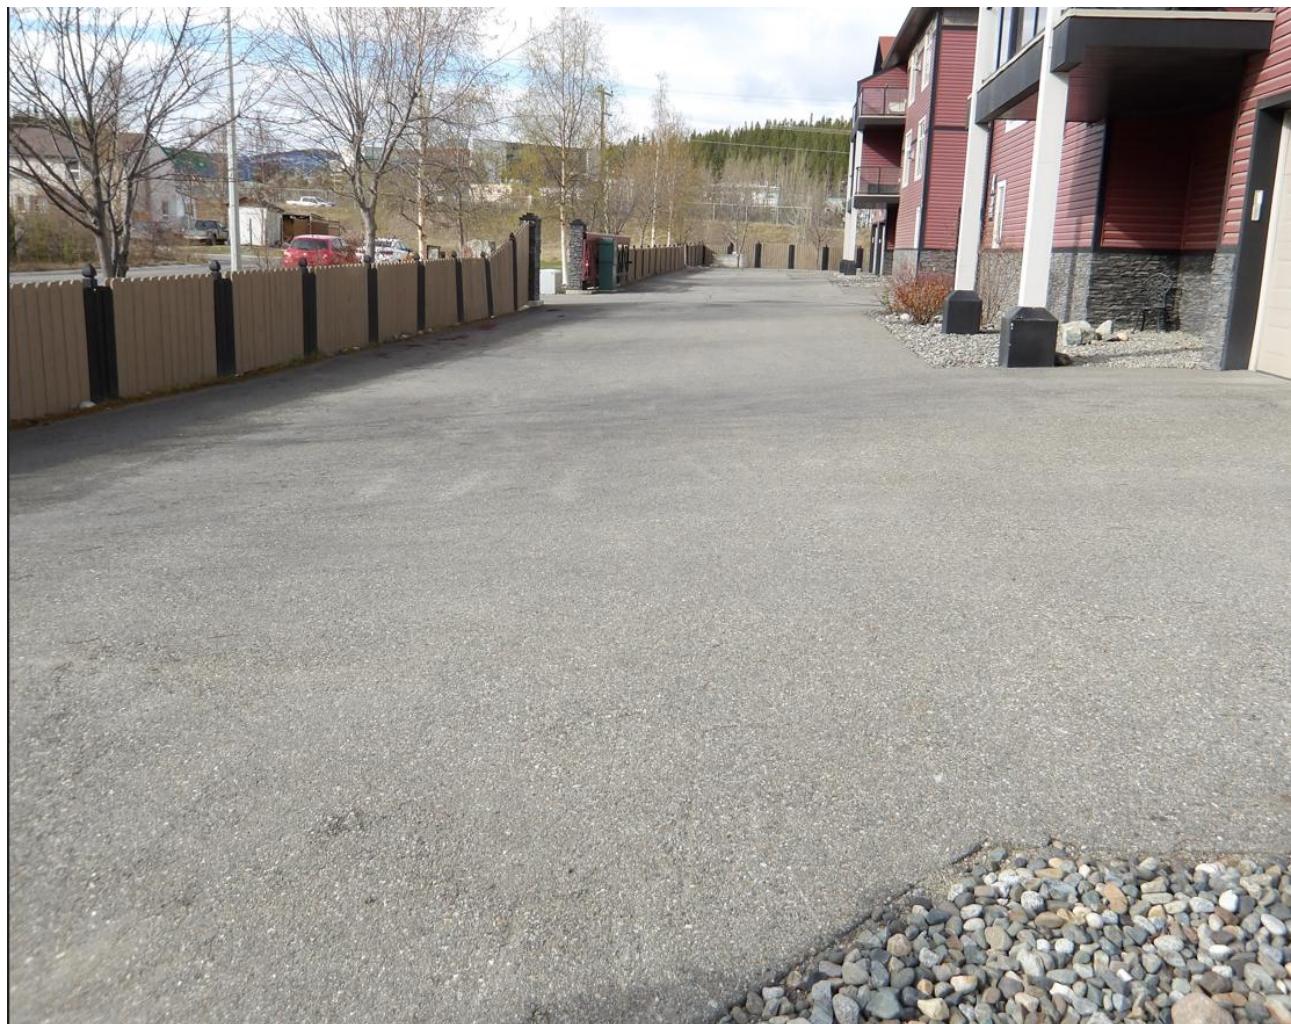
Some cracks here.

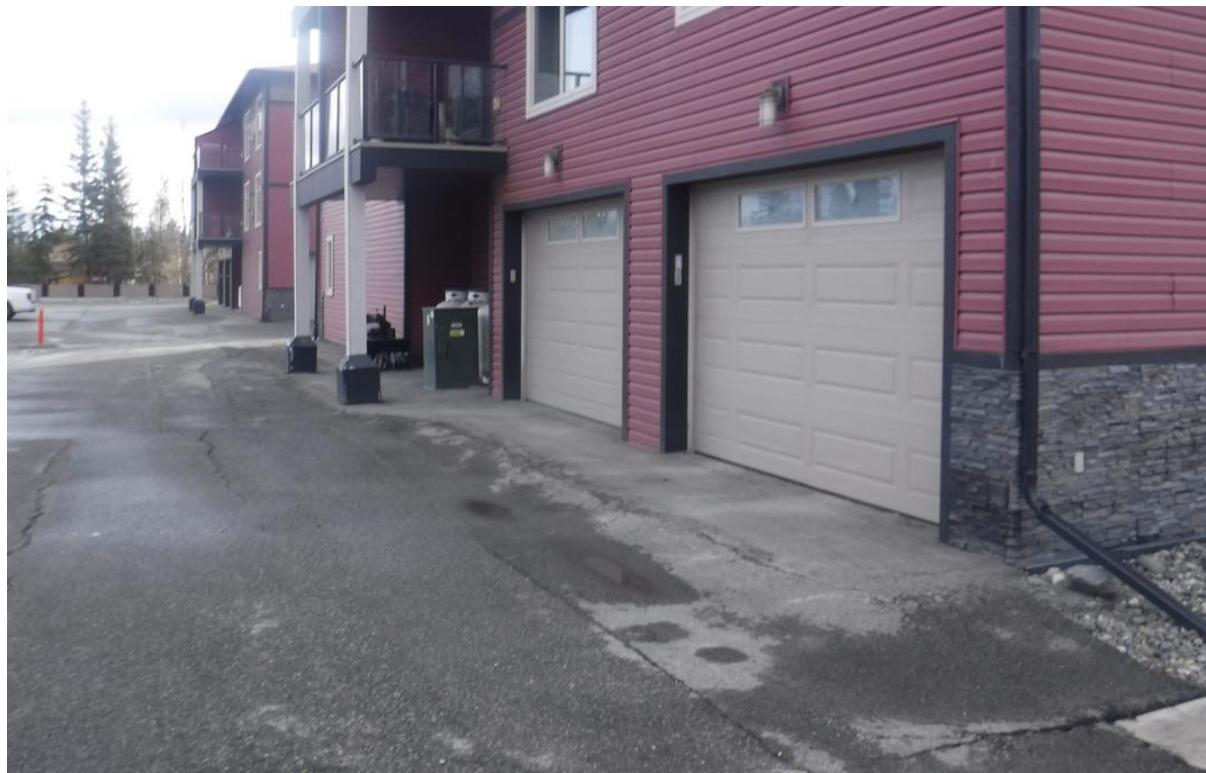
Condition Analysis	The north parking lot is in fair condition. Parts of the north parking lot are subsiding and sinking or cracking. Most of the other parts of the parking lot are in good condition.		
Life Cycle Analysis	Date of Acquisition:	2008	
	Normal Life Span	35 years	
	Effective Age	22 years	
	Remaining Life Span	13 years	
Unit Quantity And Cost Estimates	Unit Quantity	24,029 s.f.	
	Unit Cost Estimate	\$8.35/s.f.	
	Current Repair or Replacement Cost Estimate	\$200,646	
	Estimated Year of Major Repair or Replacement	2038	
Deficiency Analysis	Some deficiencies noted. The condo corporation is planning to repair some pot holes in two years. More could be done on repairing cracks.

North parking lot. Numerous cracks. These can be inexpensively filled.

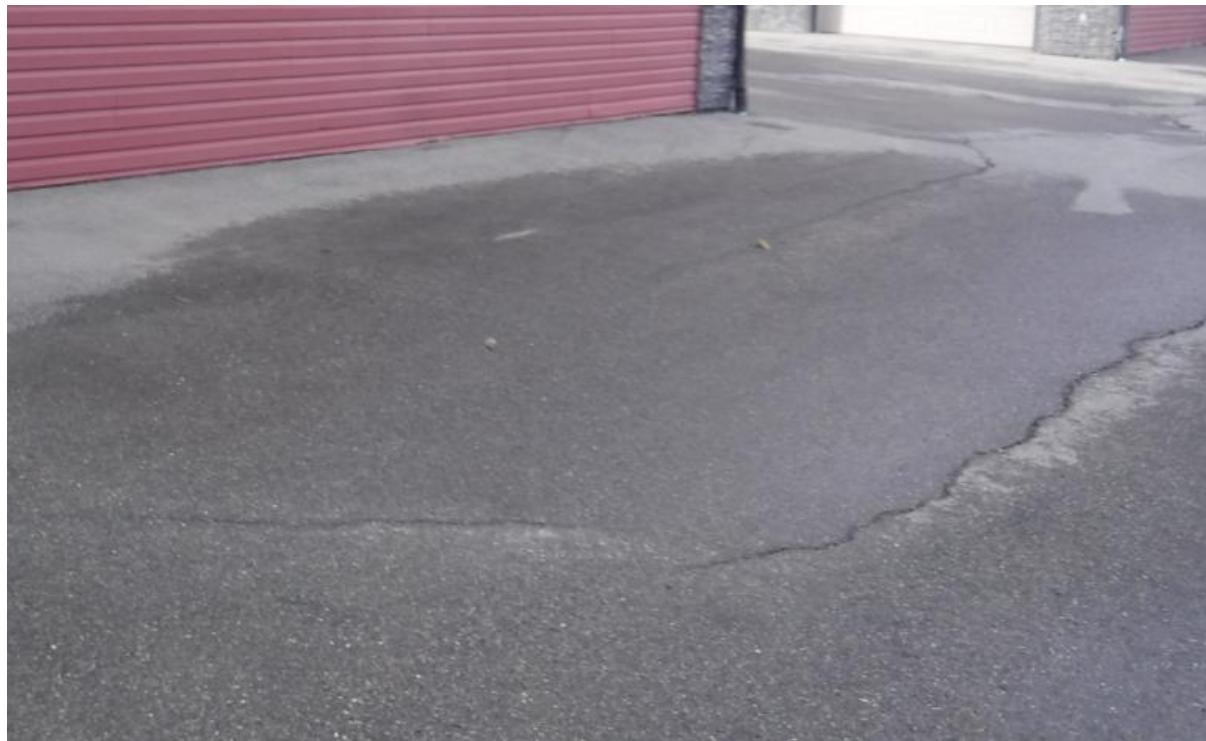
Long curved crack.

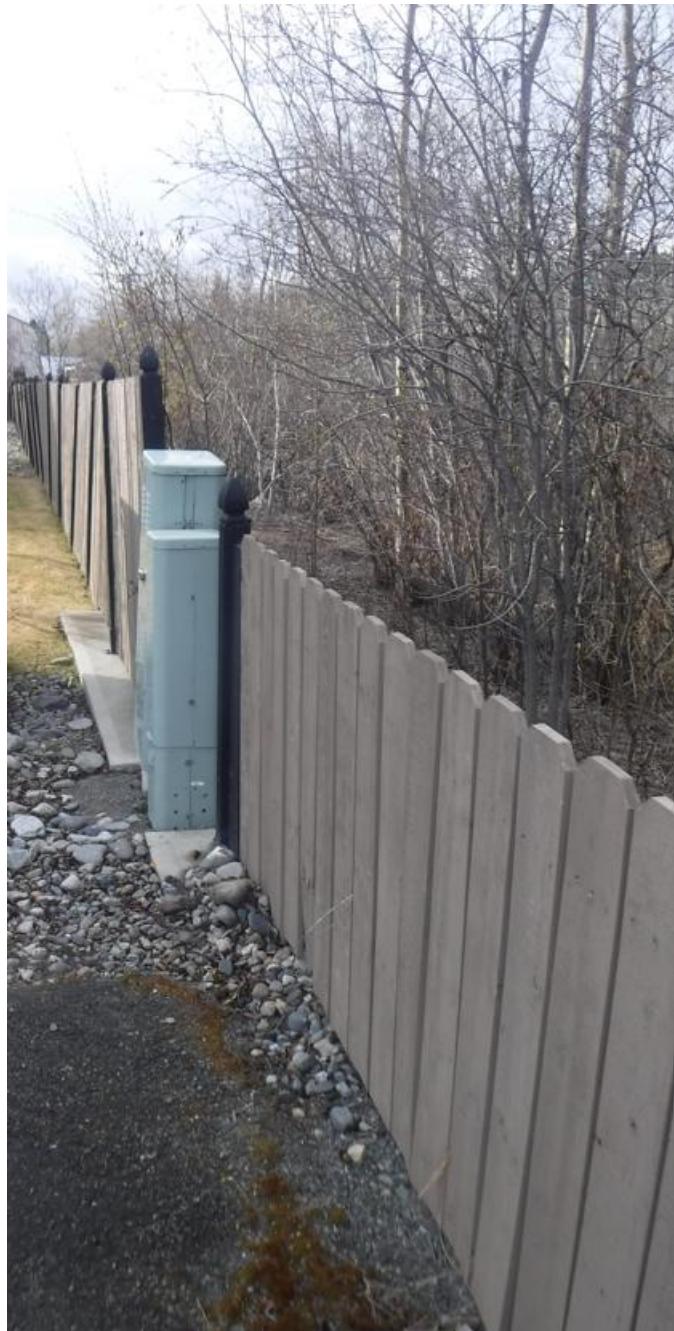
Section of fence on the west side of the property. The crooked section is scheduled for repair in 2025.

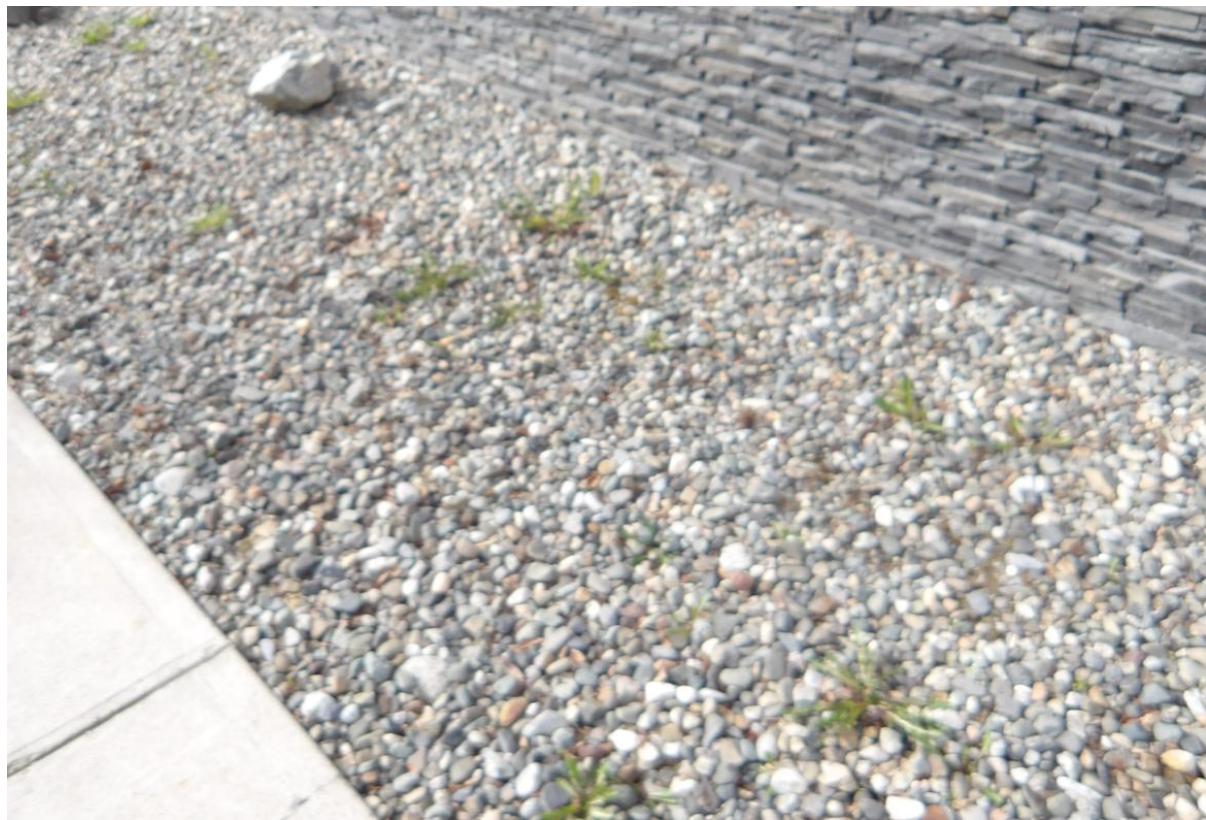
Some weeds have penetrated the weed barrier and poke through the rocks.
