Safety Promotion Feedback

Ref	Date	Airport / Route	Aircraft
ASR # 25/5/a	12 May 2025	LESB	Tecnam P2002-JF F-HFGX
Title:	WING TIP COLLISION		
Report Details	<p>While stationary on the ground with crew on board, engine OFF (Parking brake set, no propeller turning), our aircraft was lightly struck on the tail by the tip of the right wing of another aircraft Cessna C172n Skyhawk; EC-IGL belonging to PANAMEDIA flight school. The contact caused very light damage. Photographs were taken and TURMINA maintenance was notified immediately.</p> <p>We are currently in discussions with the flight school operating EC-IGL to determine the best course of action.</p>

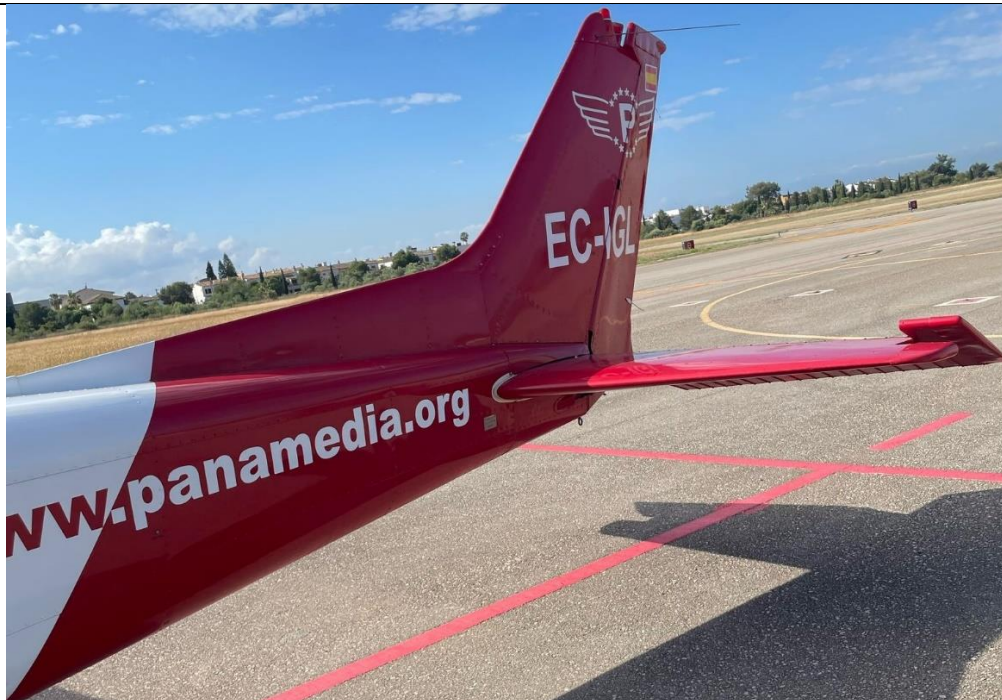
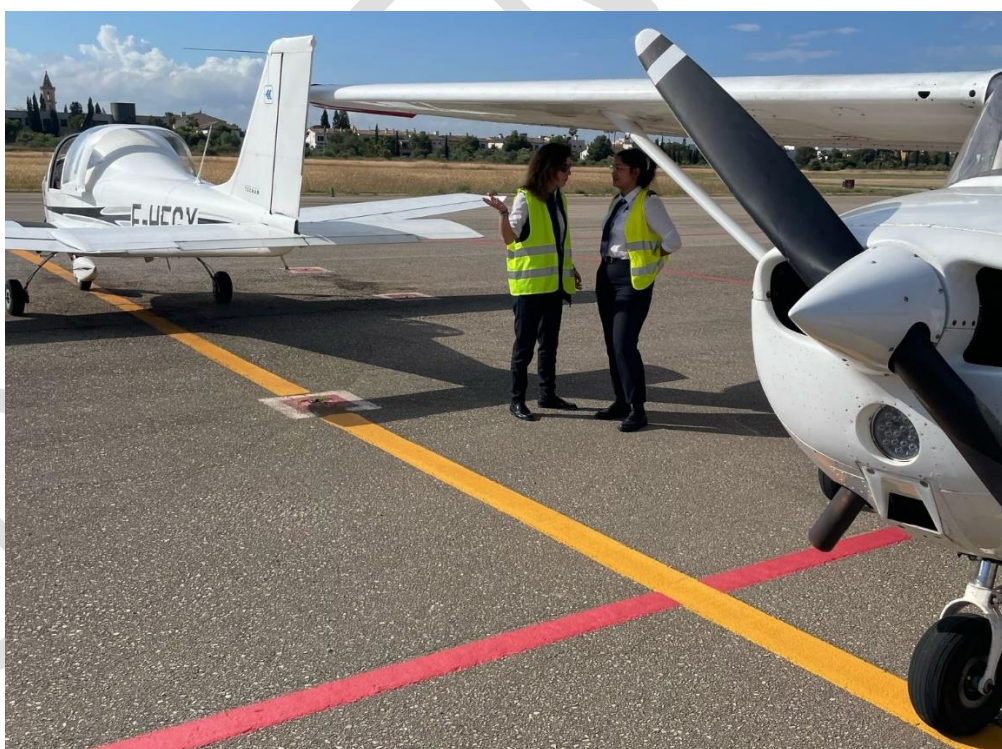
Root Cause	<p>Root cause:</p> <ul style="list-style-type: none"> (a) Loss of separation that resulted in a collision (but no damage) on the ground with another aircraft. (b) Human factors; pilot error <p>Pilot operating Cessna C172N Skyhawk registration EC-IGL (serial number 17267794), belonging to PANAMEDIA International flight school, taxied into Fly EPT Spain's TECNAM P2002-JF registration F-HFGX, which was parked and stationary. The taxiing pilot breached the minimum wing tip separation clearance minima. Investigation is currently on-going and awaiting PANAMEDIA's feedback.</p>		
Corrective Action	<ul style="list-style-type: none"> (a) From: PANAMEDIA International flight school - TBD (b) Post inspection from TURMINA maintenance confirm no damage. Aircraft Certificate of Airworthiness (CoA) remains valid 		
Preventative Action	<p>Operations Manual amended:</p> <p>Part B TECHNICAL, SECTION 3 - AIRCRAFT HANDLING, sub-section (6) Taxiing Procedures</p> <p>(i) Minimum wing tip clearance is 7.5 meters. If there is any doubt concerning reduced wing tip separation clearance, STOP the aircraft. Follow apron taxi centreline.</p>

ICAO's minimum Wing Tip clearance = **7.5** meters
If there is any doubt whatsoever concerning reduced wing tip separation, just STOP.
Follow apron taxi centerlines. Do NOT attempt a wing over.
