COASTAL EROSION
AT
GARDEN ISLAND SANDS BEACH
SOUTHERN TASMANIA

PRELIMINARY
GEOTECHNICAL REPORT
JANUARY 2023

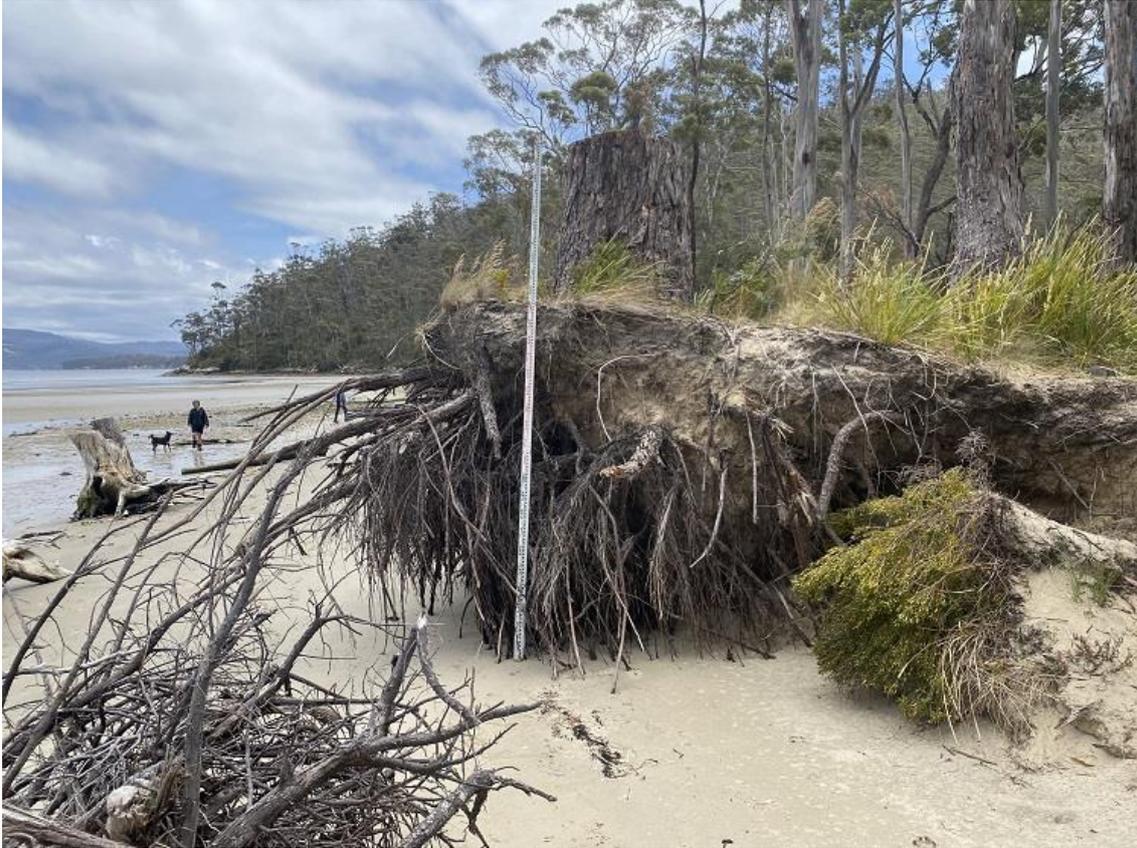
Coastal erosion of the beach has concerned residents for some time, and its landward retreat may be accelerating (Plate 1). Beach amenity is being lost and property is increasingly threatened.

Plate 1. View west-northwest along Garden Island Sands Beach in January 2022, showing active coastal erosion. Sharples (2023) has indicated the present scarp at the rear of the beach has retreated landwards 7 – 10m since 1948.

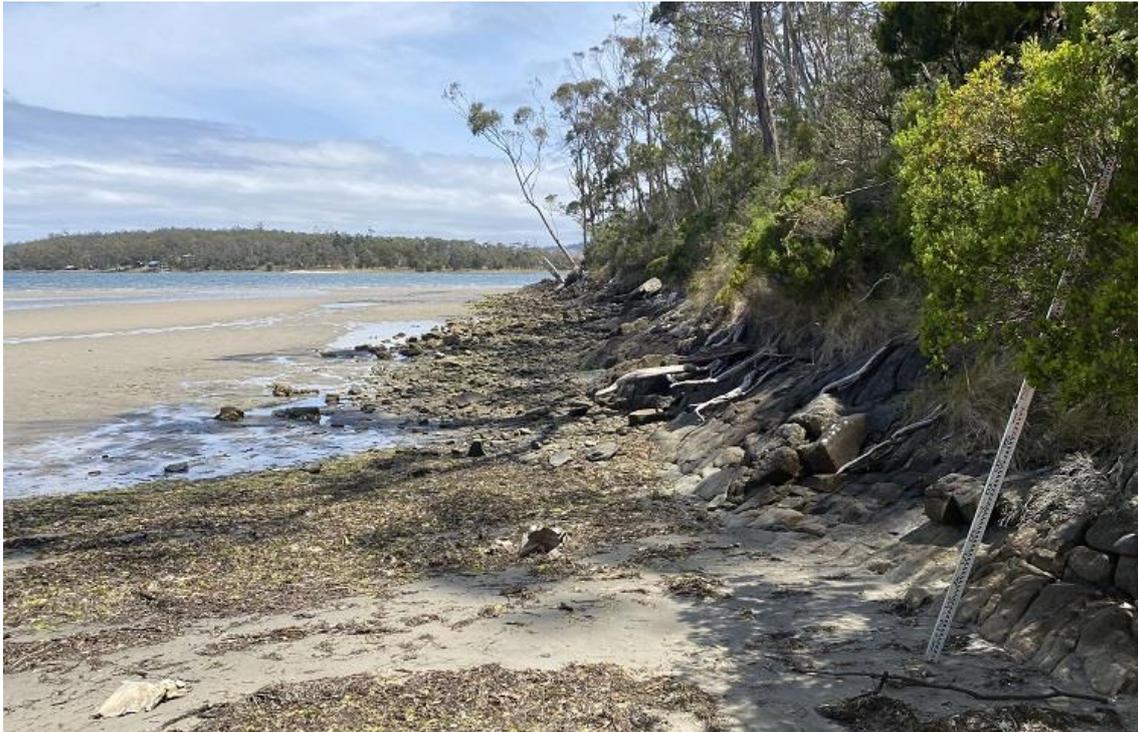
Plate 2 (above). View southwest from the western end of Garden Island Sands Beach, across the Huon River to Garden Island. Fractured, relatively fresh and unweathered dolerite bedrock crops out in the bank (arrowed, at right), and is exposed on a narrow wave-cut platform at low tide (arrowed, centre). The staff at right is 2m long. (Photo: 3 January 2022).

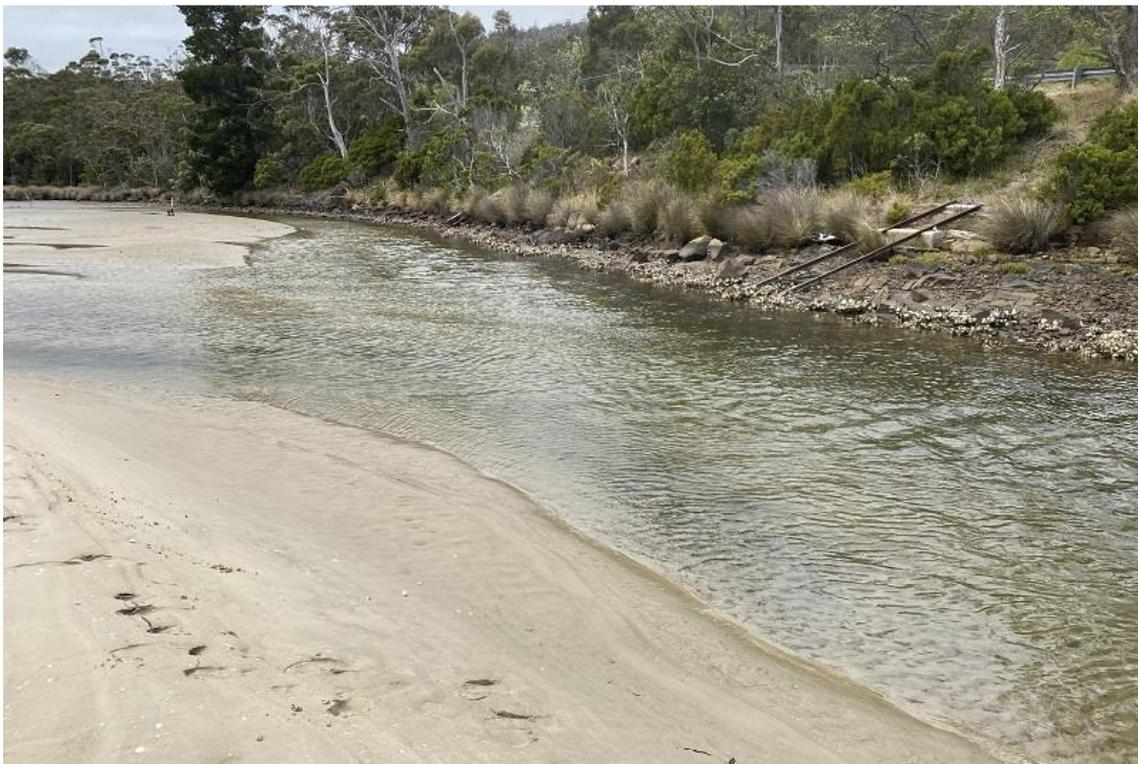
Plate 3 (below). View east towards fractured, relatively fresh and unweathered dolerite bedrock (arrowed) exposed on the eastern bank of Garden Island Creek at the eastern end of the beach. (Photo: 3 January 2022).

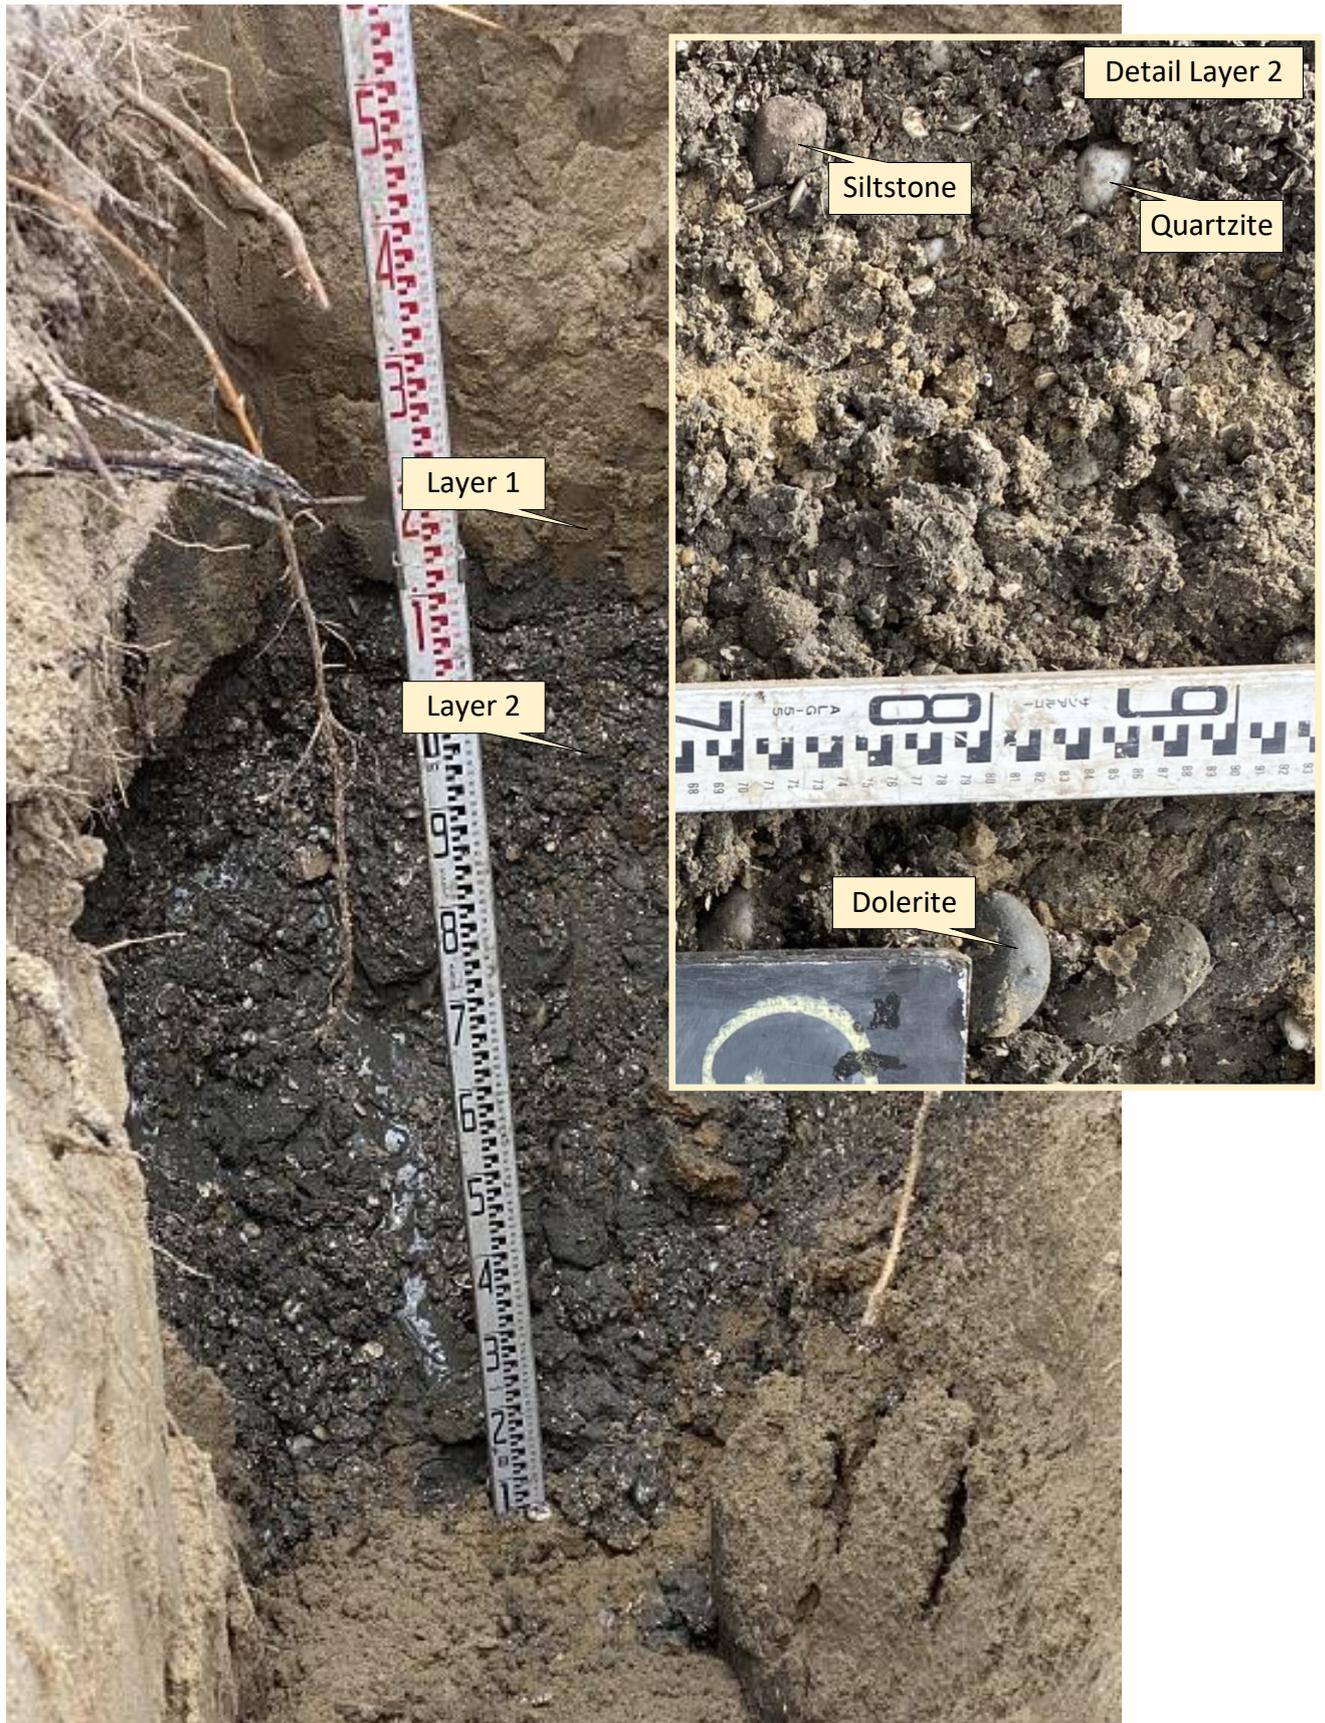
- Layer 1 (in Table 1): light greyish brown SAND (SP): fine-medium grained, generally shell-free, up to about a metre or so thick, overlying
- Layer 2: grey, light grey SAND (SP): fine-medium grained, trace-some silt, shelly, with up to 10% well-graded, well-rounded, low-high sphericity gravel⁹ (5 – 75mm) of quartzite, sandstone, siltstone and dolerite; at least 0.8 –1m thick.

Plate 4 Layers 1 and 2 sand in test pit B. The detail shows types of gravel present in Layer 2. Layers 1 and 2 materials are reasonably typical of materials in all six test pits, and by inference, beneath the full length of the beach. The large numbers on the scale are decimetres.
