# Poor Grounding in FT 991A Tuner Unit

## Grounding issues in Tuner Unit causes high SWR warning after tuning

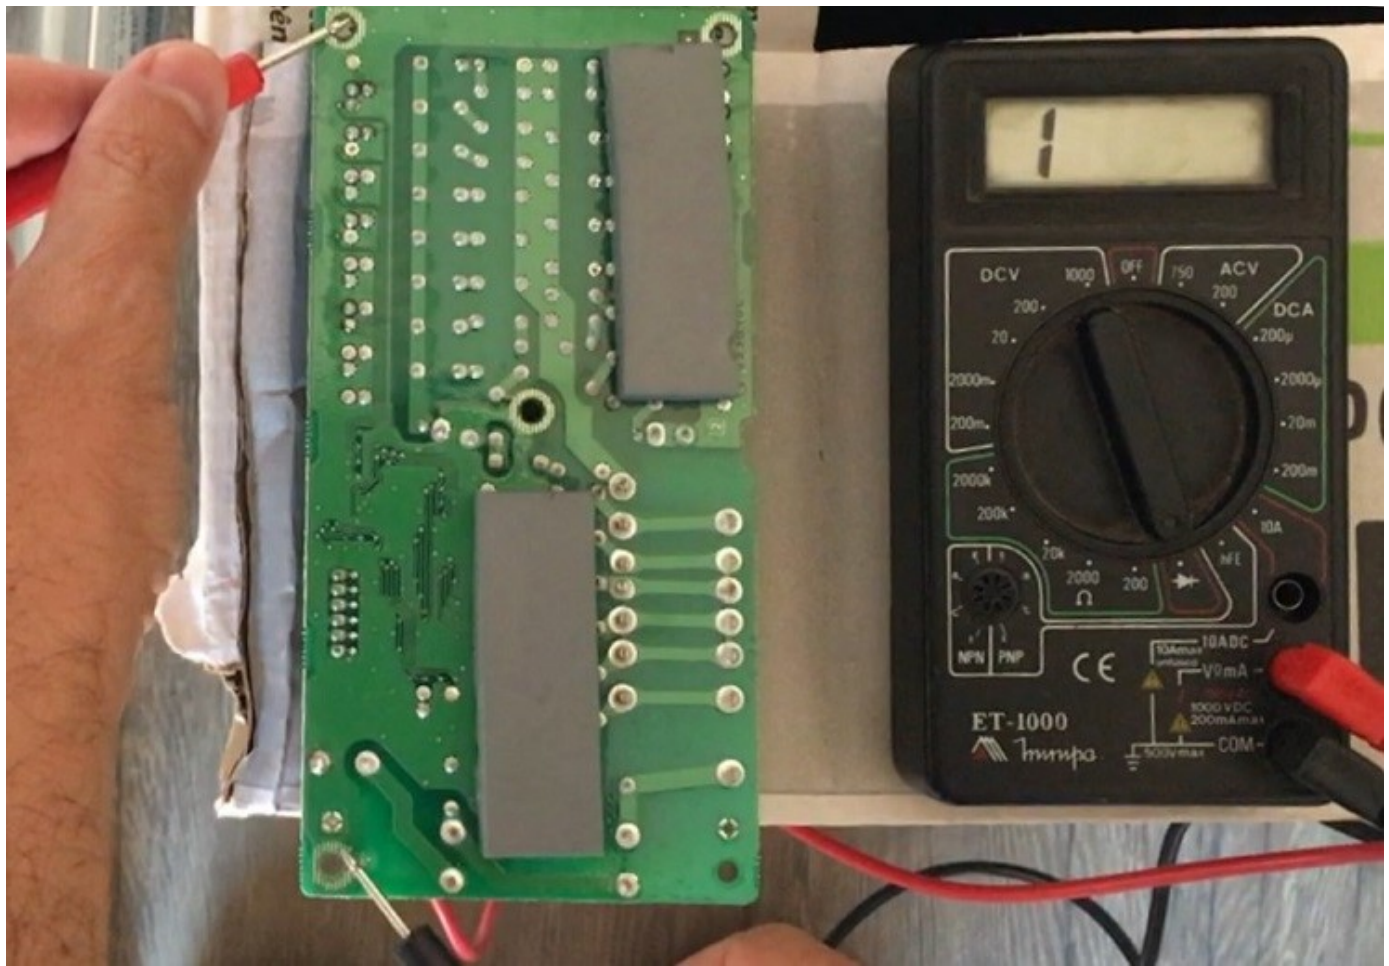
To my shock, it was indeed the case - at the bottom side of the board, the "soldered" contacts that are supposed to provide a better contact with the chassis, are all **covered by some kind of varnish/lacquer!**

*Continuity test 1 - No continuity*

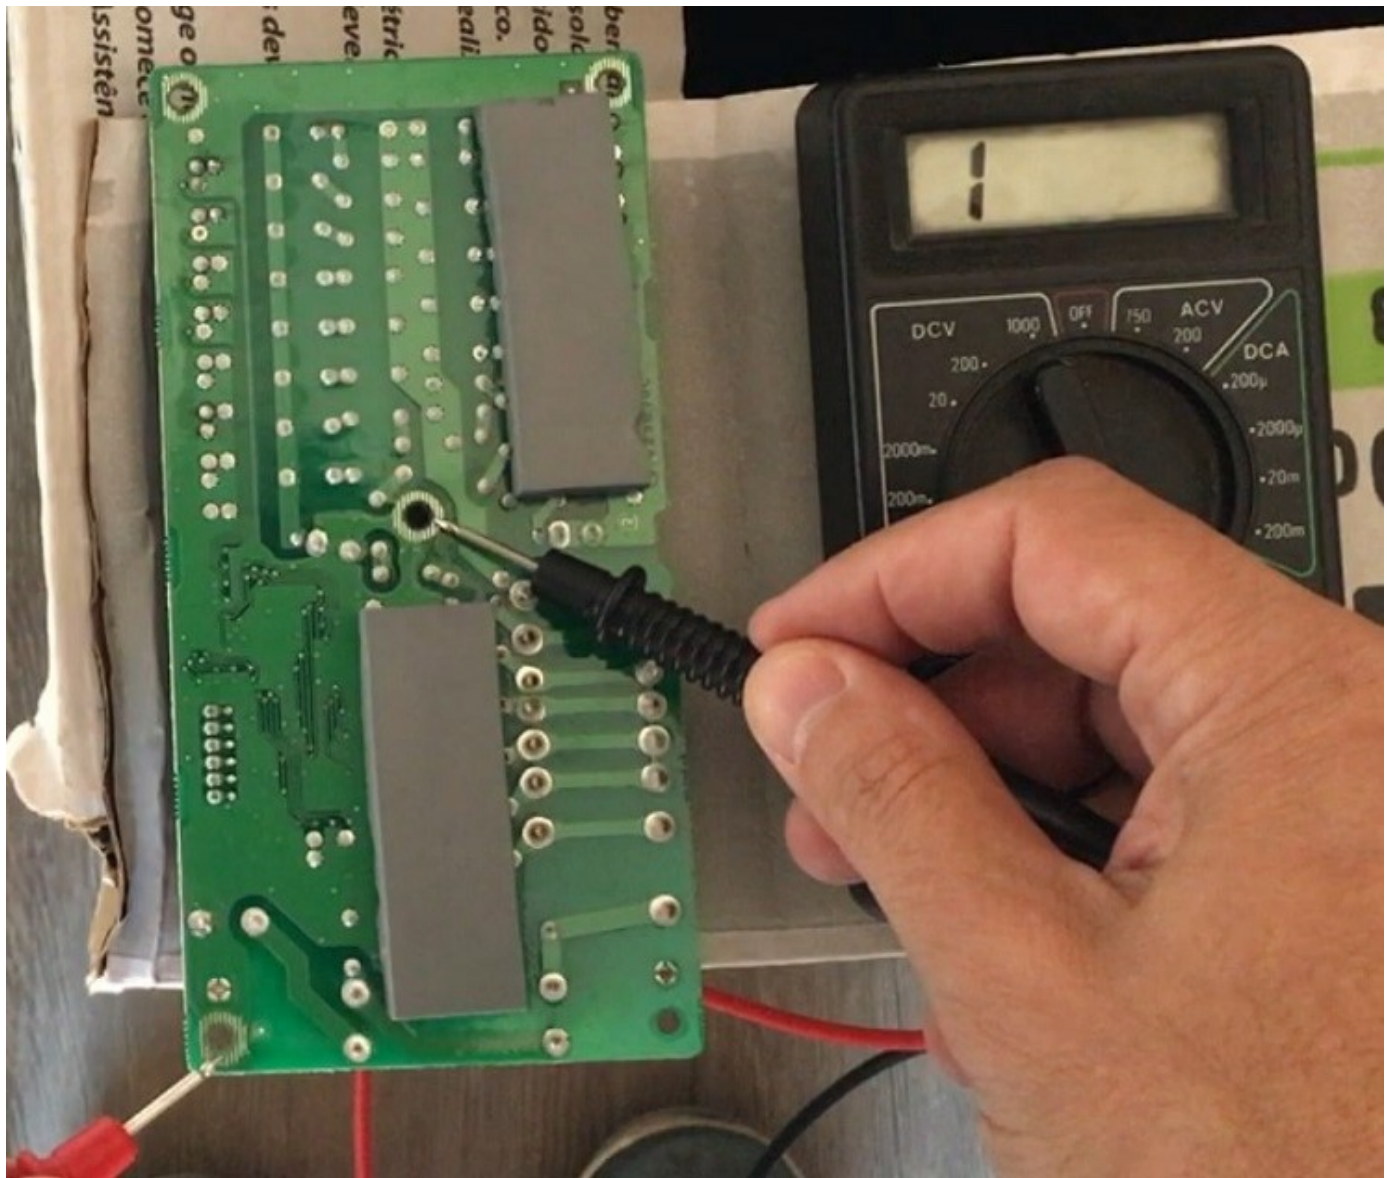
*Continuity test 2 - Trying other contacts. No continuity too.*

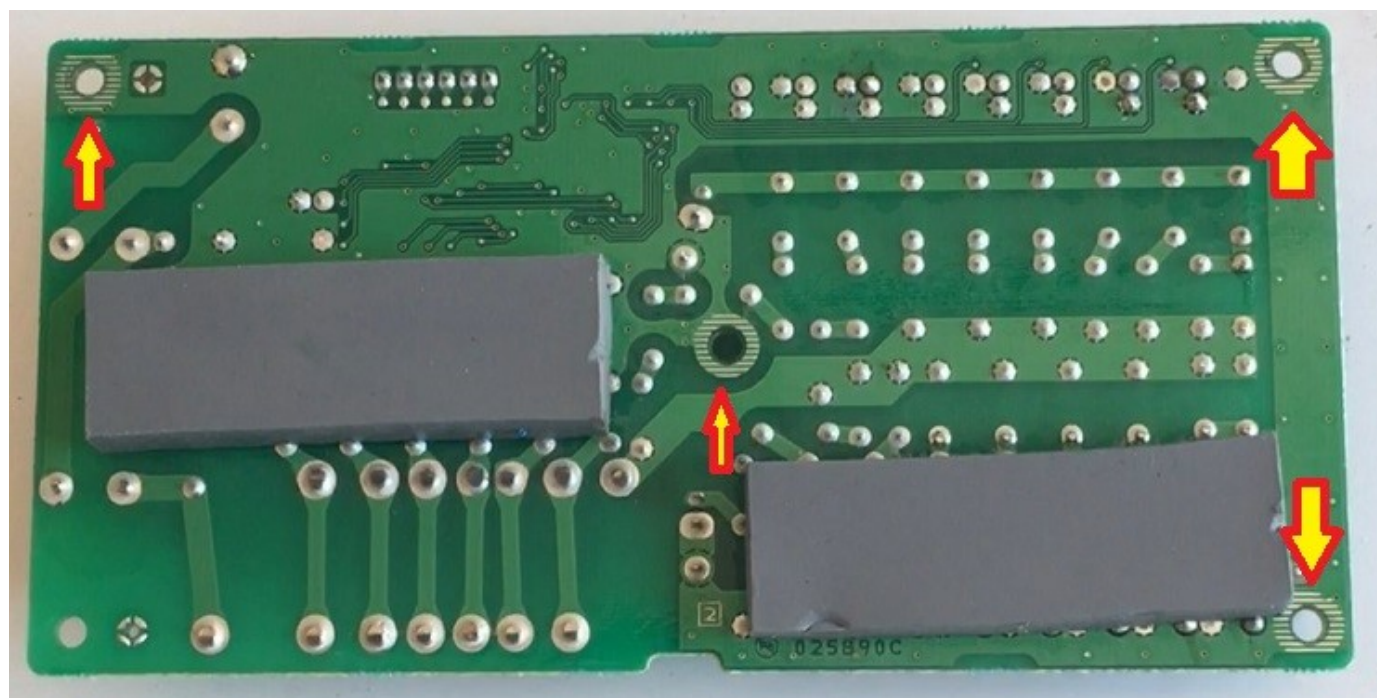
*FT-991A Tuner Unit - Bottom side. Arrow points the ground connections to the chassis*

Do the continuity tests on *all four* ground connections. If yours has no solder mask in any of them, reassemble your equipment. Otherwise... Keep reading.

This lacquer is *hard* to remove - I did not have isopropyl alcohol, don't know if is it effective to dilute it - So I removed it using a sharp and delicate knife, and gently removing the lacquer from the contacts, on all four contact points.

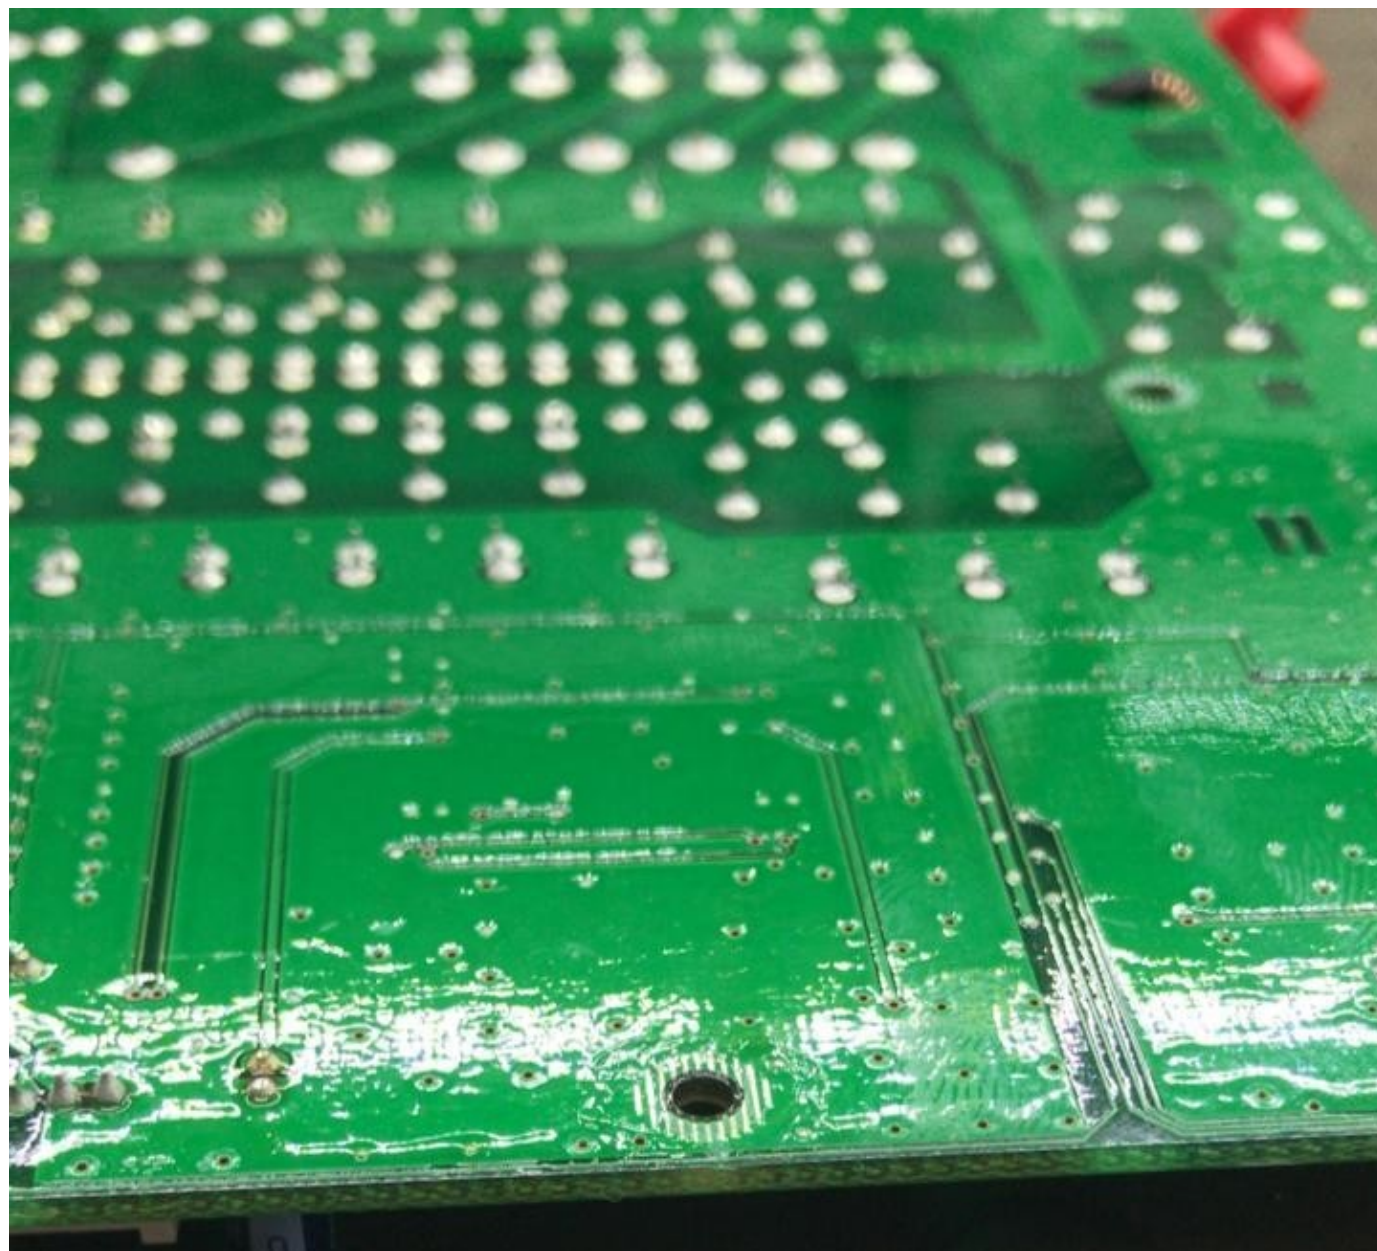
*FT-DX101D Tuner Unit - Poor grounding in Tuner Unit - Ground pads covered by varnish/lacquer.*

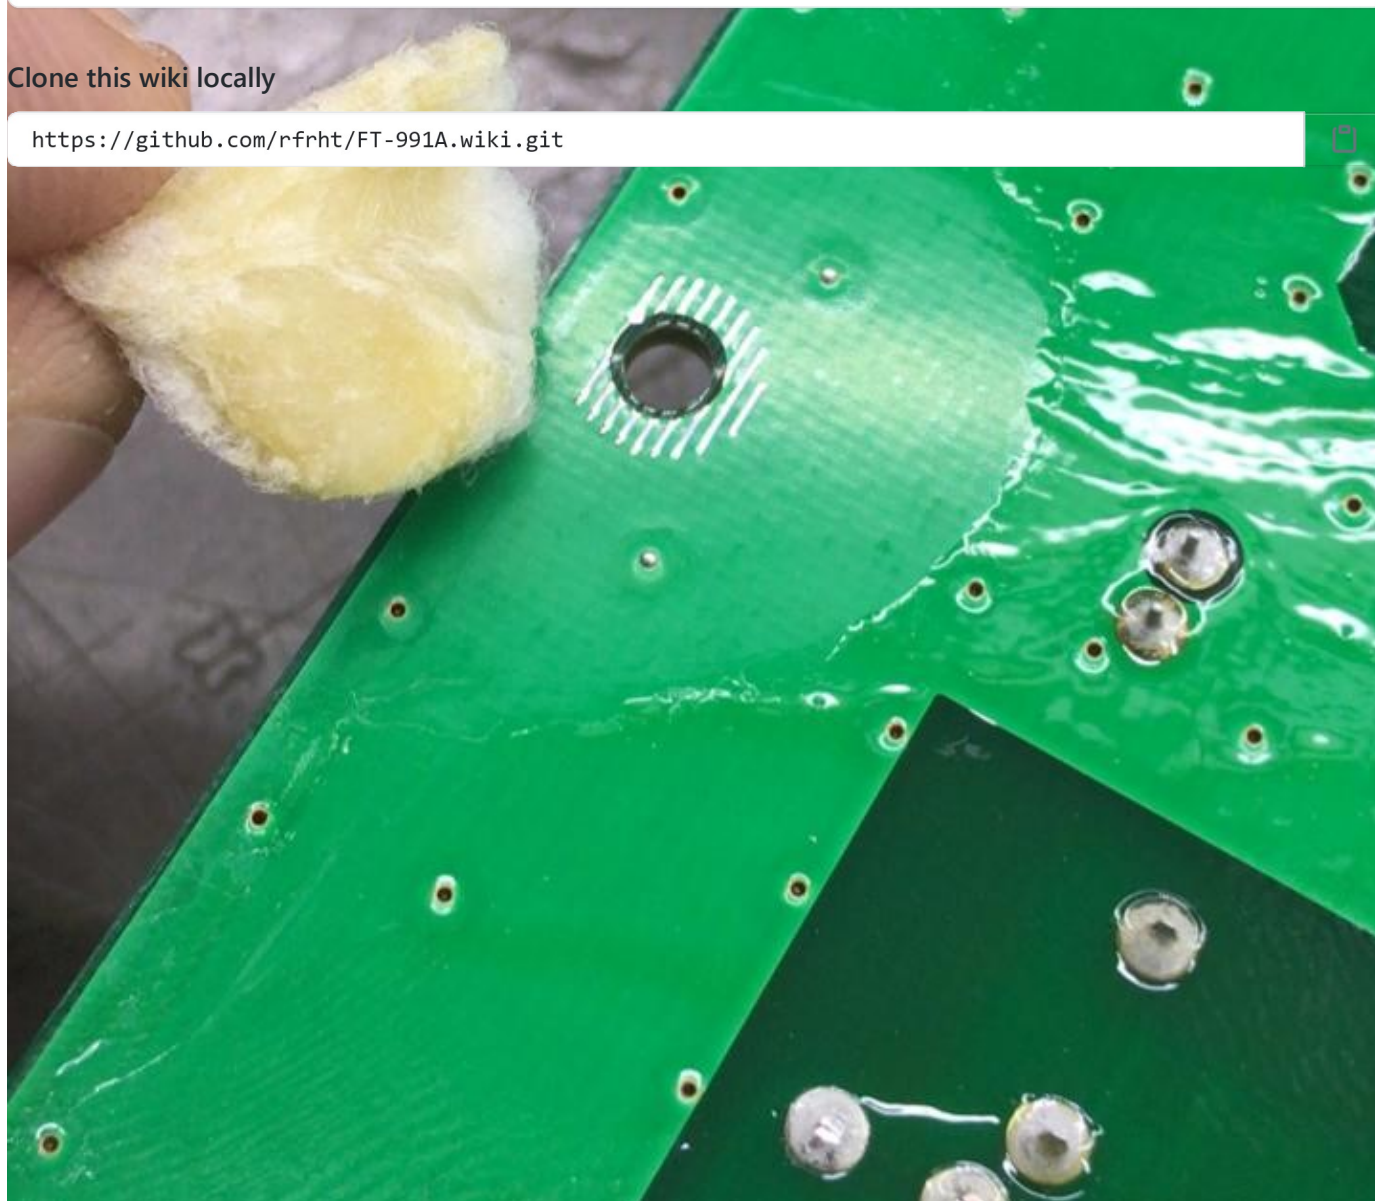
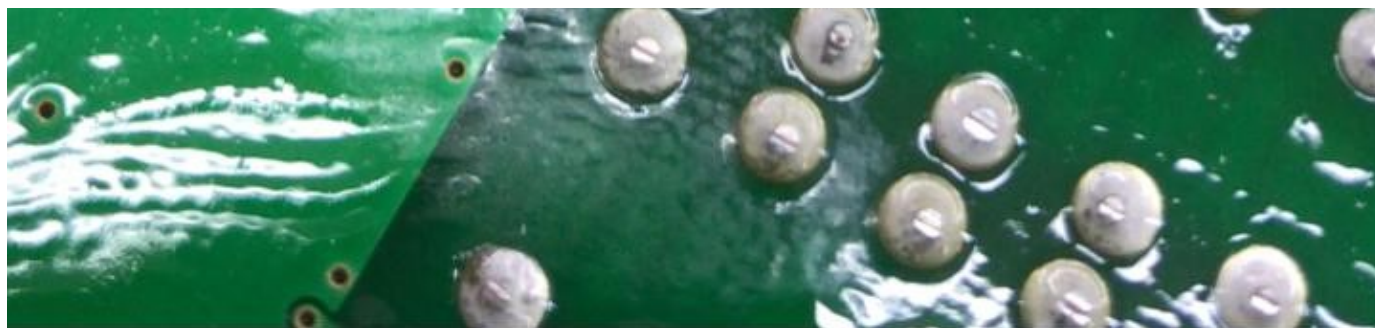
*FT-DX101D Tuner Unit - Poor grounding in Tuner Unit - Removing varnish/lacquer from grounding pads.*

So I would strongly recommend checking your brand new equipment, as well your 991/991A too - seems to be a poor manufacturing/QA/QE issue.
