Survey Report

23 & 24/03/2021
M/Y (CONFIDENTIAL)

| <i>Type:</i> | <u>Motor Yacht</u> |
| <i>Type of survey:</i> | <u>Condition survey</u> |

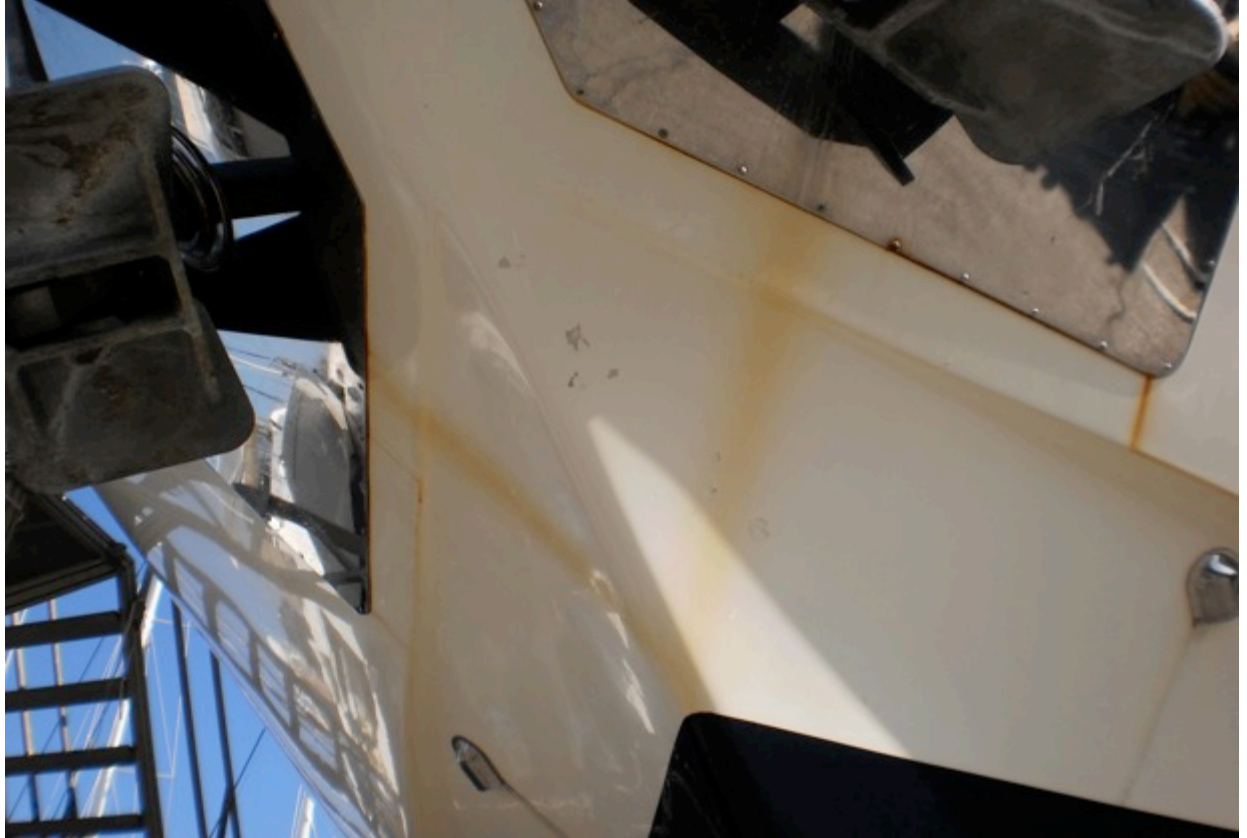
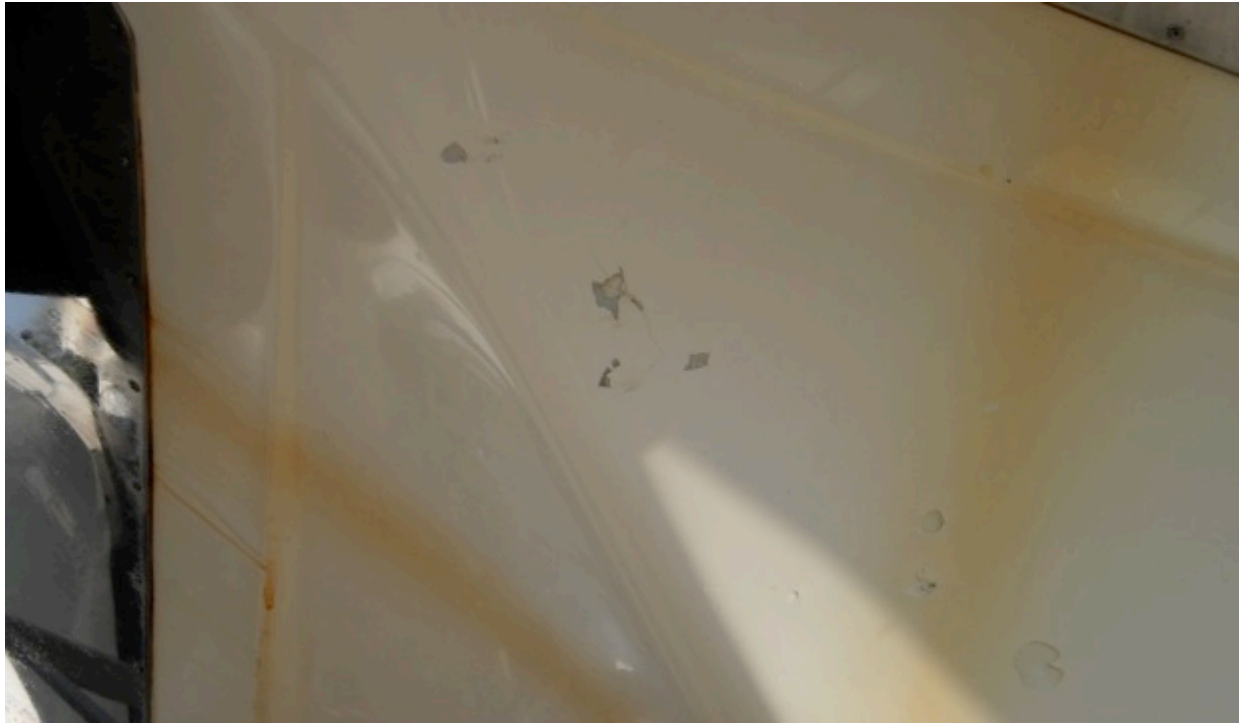
Photo 2

The vessel was seen in and out of the water on the same day. It must be noted that although the vessels hull bottom was clean a new coat of antifouling should be applied. (see photo 2)

- Anchor handling (see photo 2)
- Rope handling and normal wear and tear (see photo 3)

- all anodes to be replaced as necessary
- annual servicing of air conditioning
- the water maker needs 2 control boards changing and servicing of filter
- both engines needs to be serviced by authorised dealer and attended by an electrician as part of their annual maintenance schedule
- All fire fighting and lifesaving equipment is due for annual testing
- Starboard Search Light needs repair as necessary
- Below waterline cleaning and antifouling treatment.

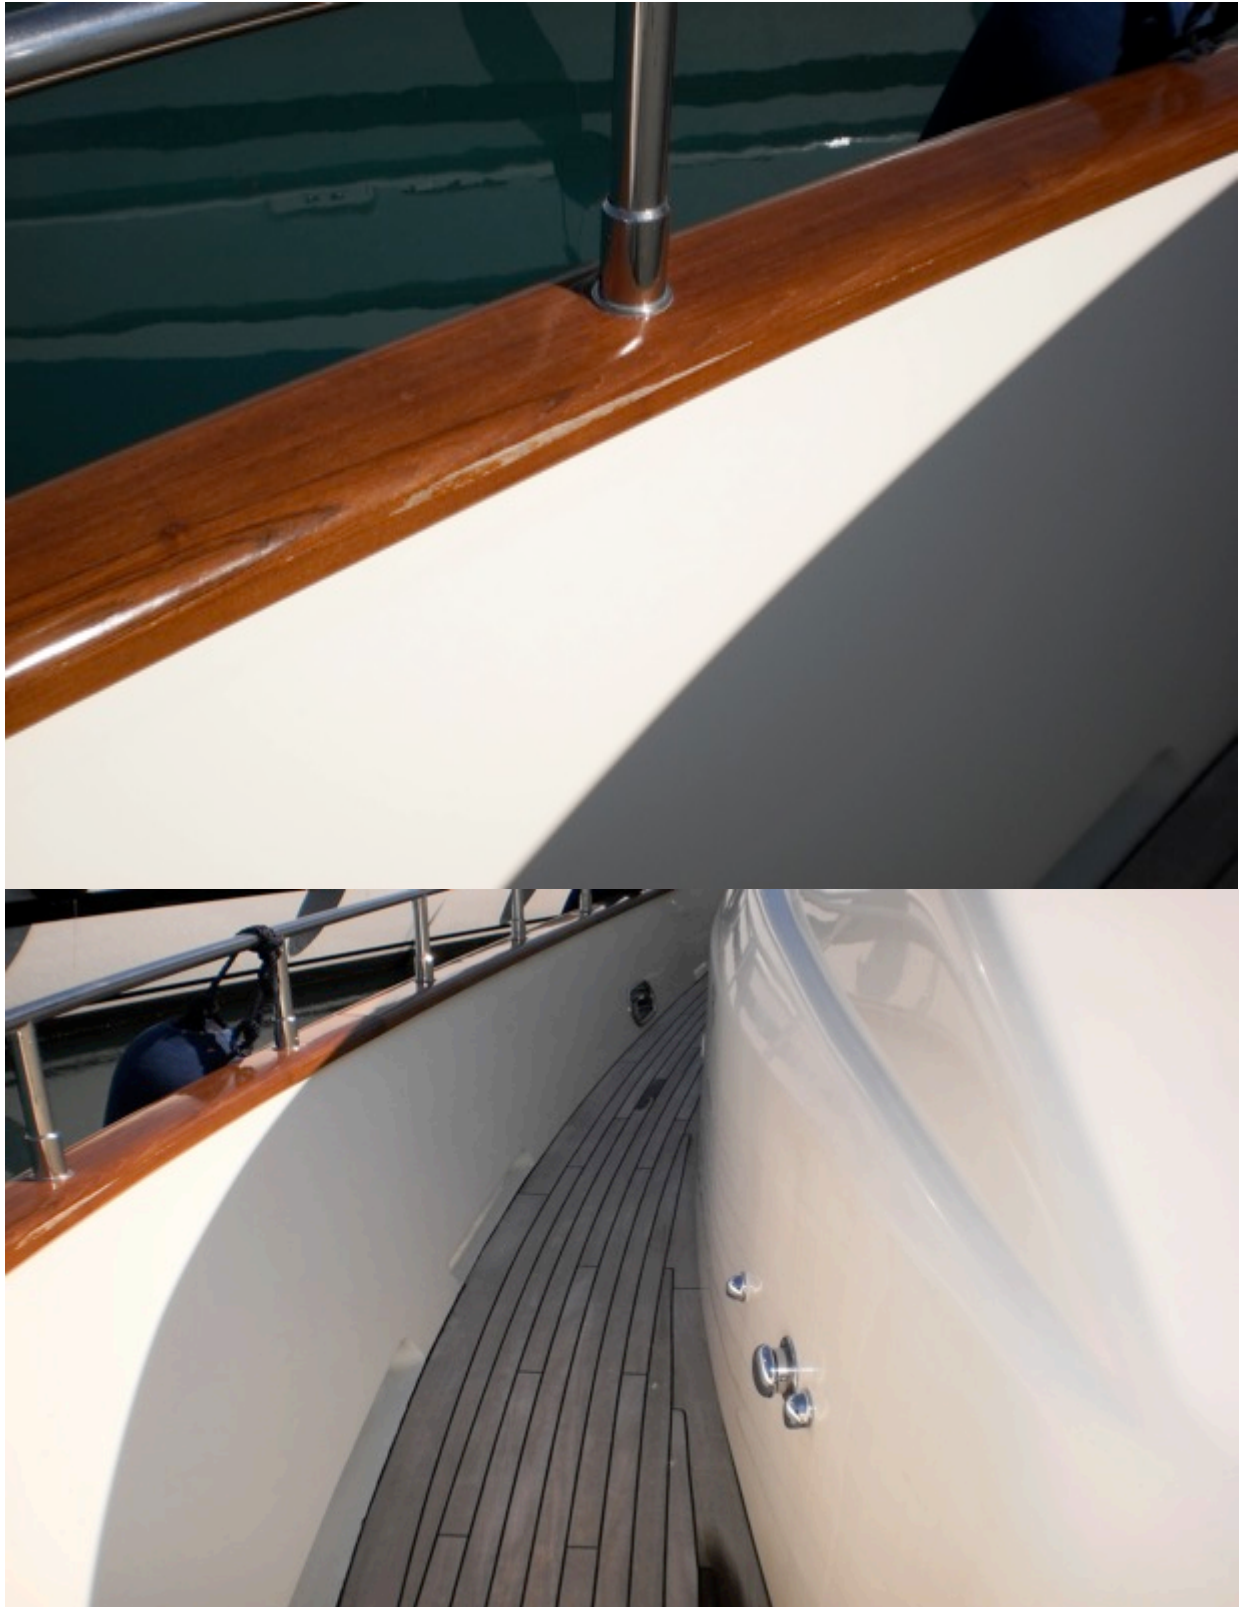
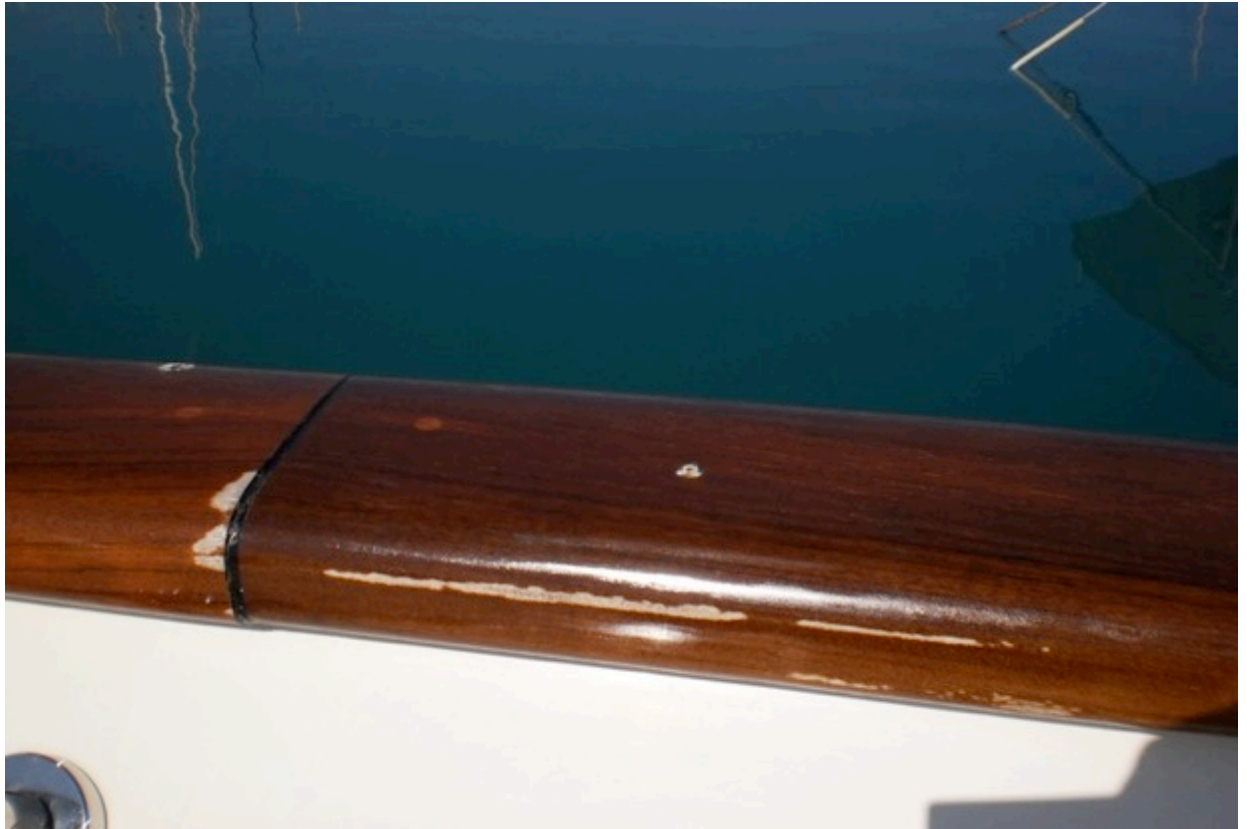
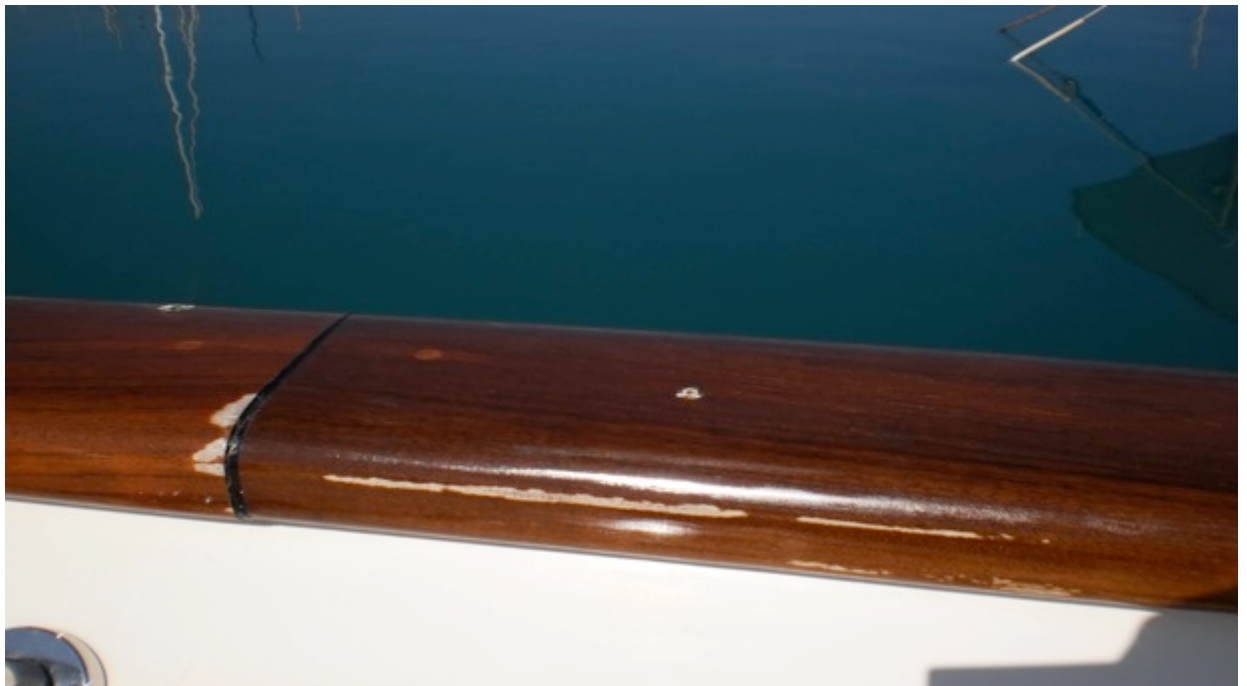
Photo 5

- TEAK HANDRAIL. Needs attention as necessary (see photo 5)
- TEAK MAIN DECK 16 MM THICK. D 6 DECK-BOLLARDS.
- 10 STAINLESS STEEL FAIRLEADS.
- 2 ELECTRIC ANCHOR-WINCHES 3000 WATT 380V WITH CONTROL FROM BOW, WHEELHOUSE AND FLYING BRIDGE.

- fuel tanks to be cleaned and treated for fuel bug.
- Handrail teak needs attention as necessary.
- Minor surface GRP cracks that need to be repaired as necessary
- Outer hull polishing is required

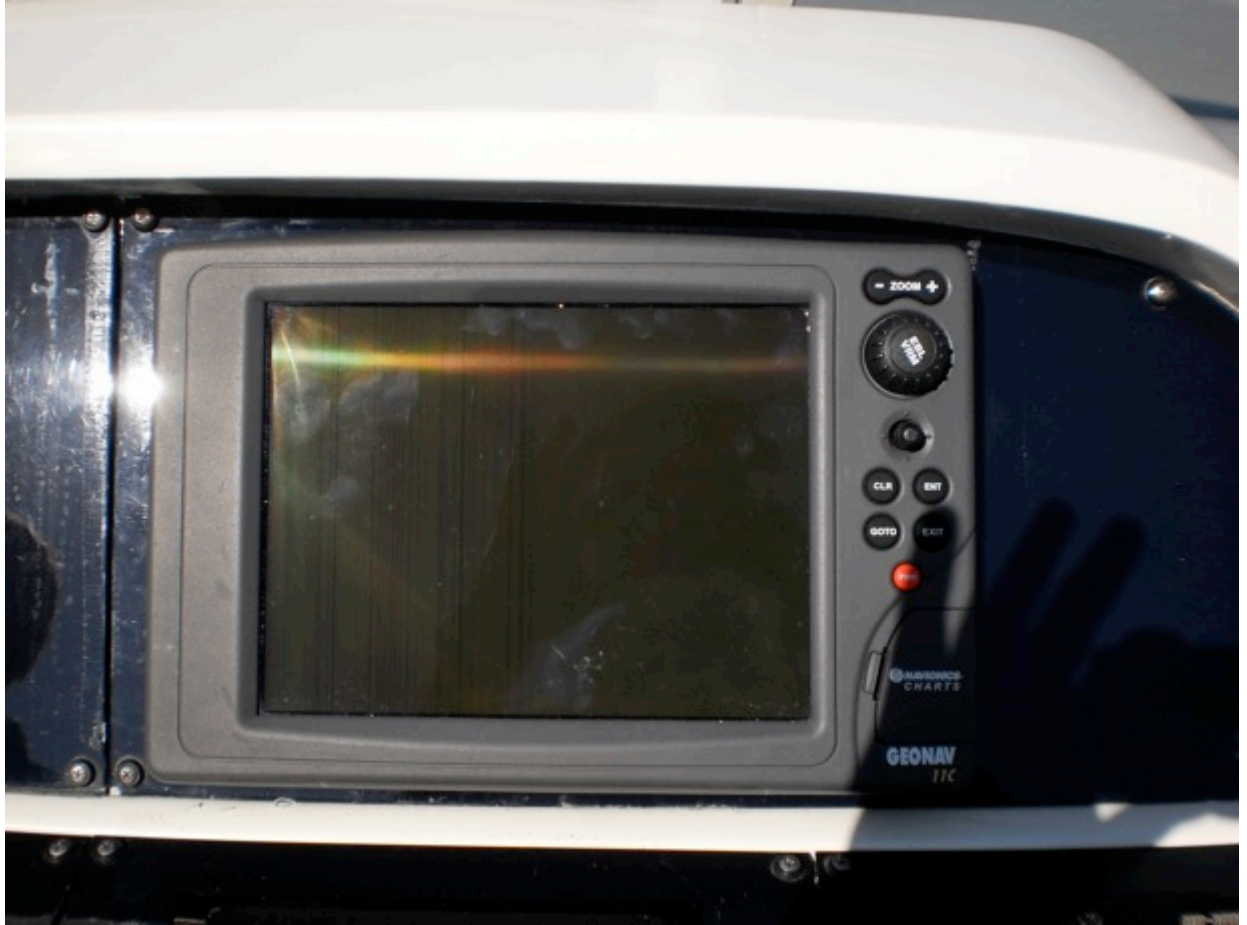
Photo 6

- ACCESS TO THE FLYING BRIDGE WITH INSIDE STAIRS AND FROM THE AFT DECK.
- WINDSCREENS IN TEMPERED GLASS WITH STAINLESS STEEL FRAME.
- DASHBOARD WITH STEERING WHEEL AND ENGINE CONTROLS. The FURUNO PLOTTER GEONAV 11C needs replacing. (see photo 6)

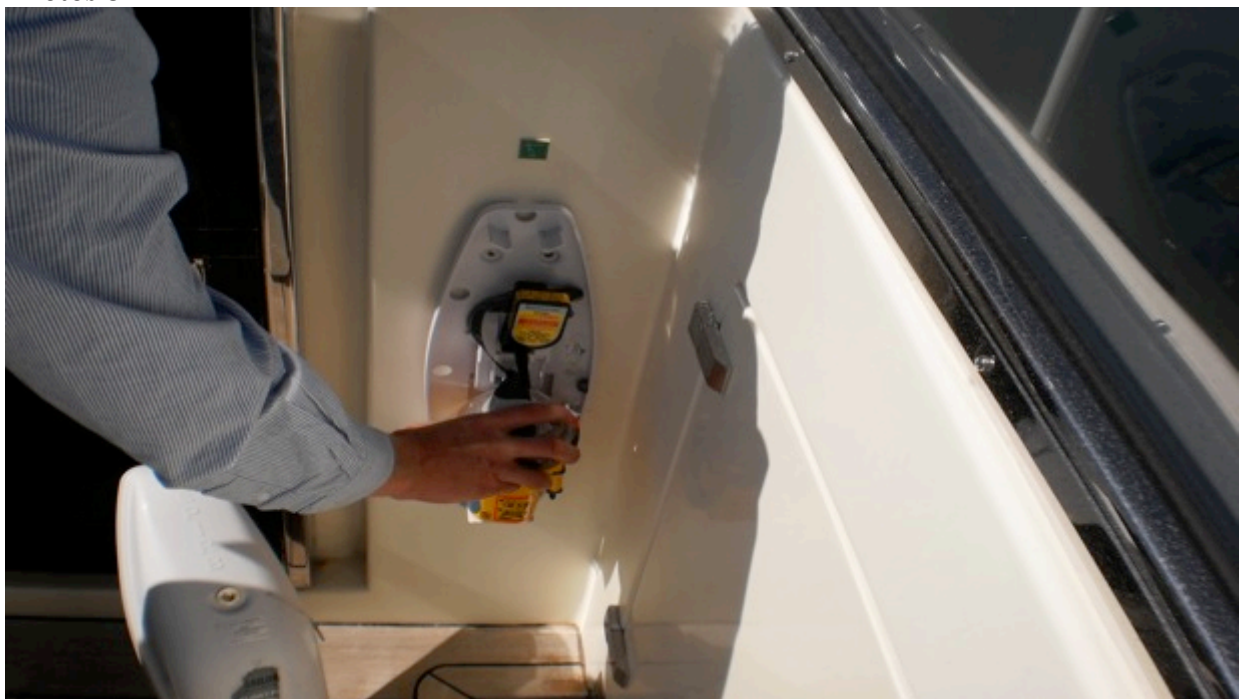
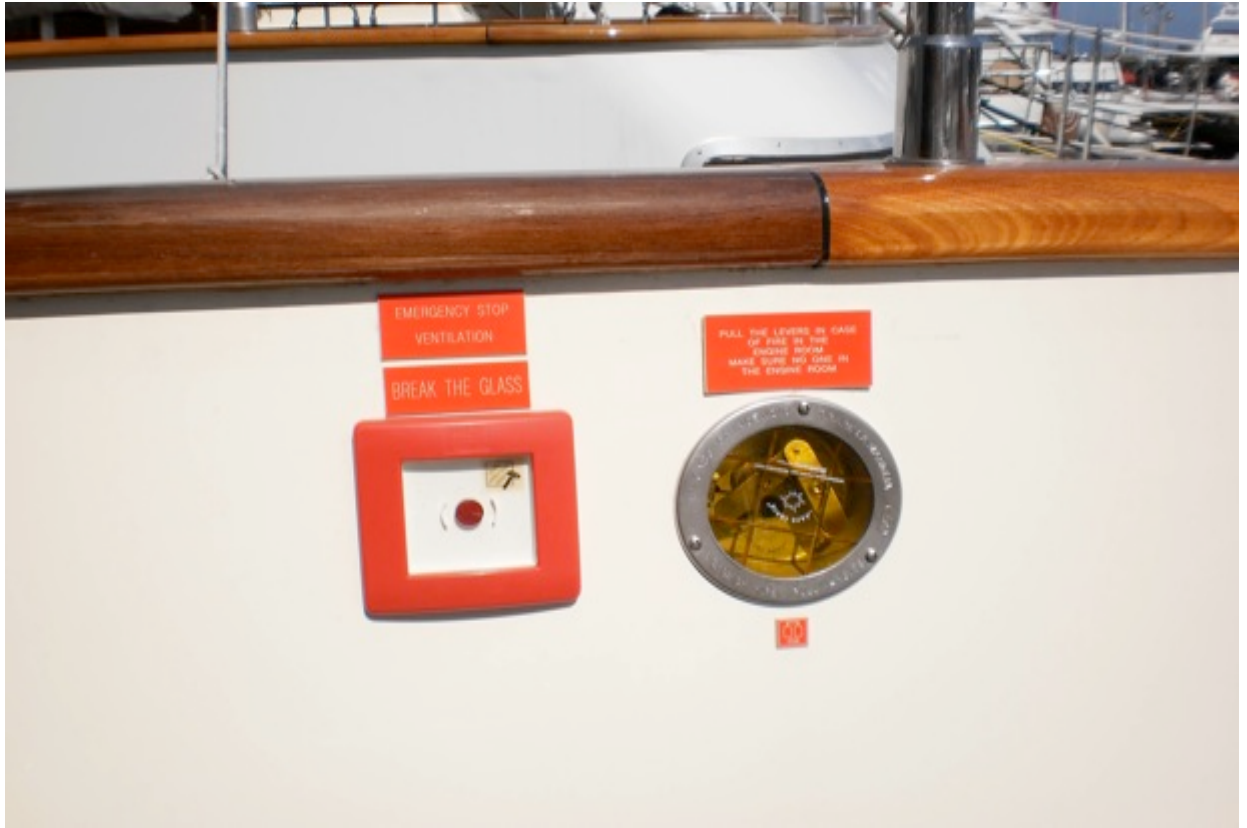
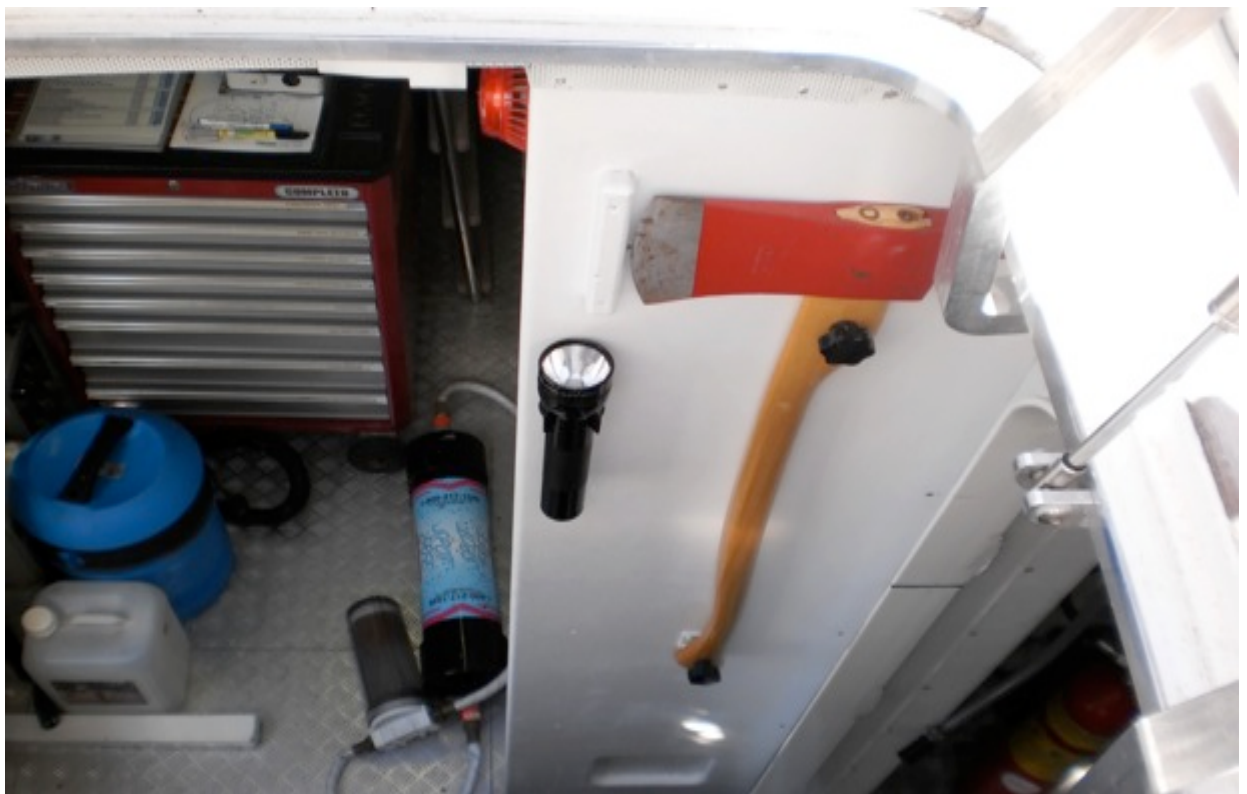
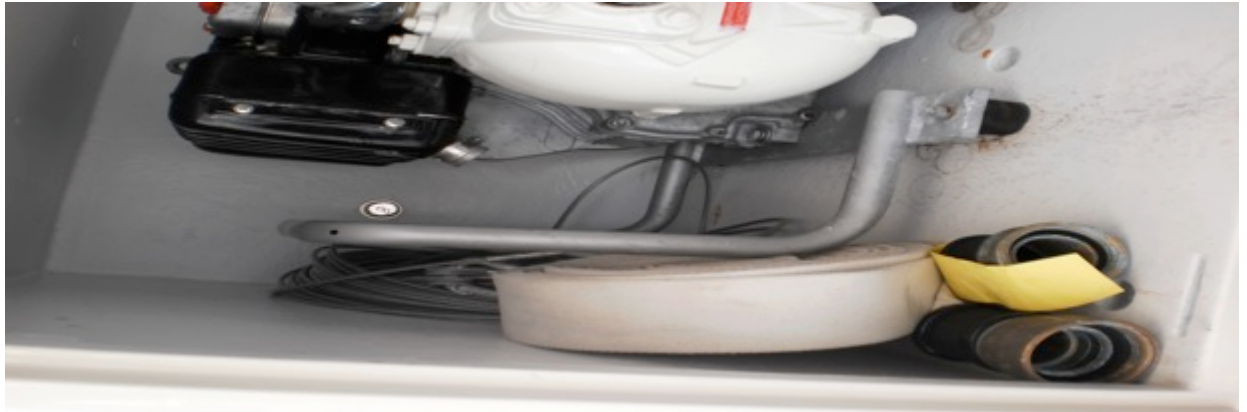
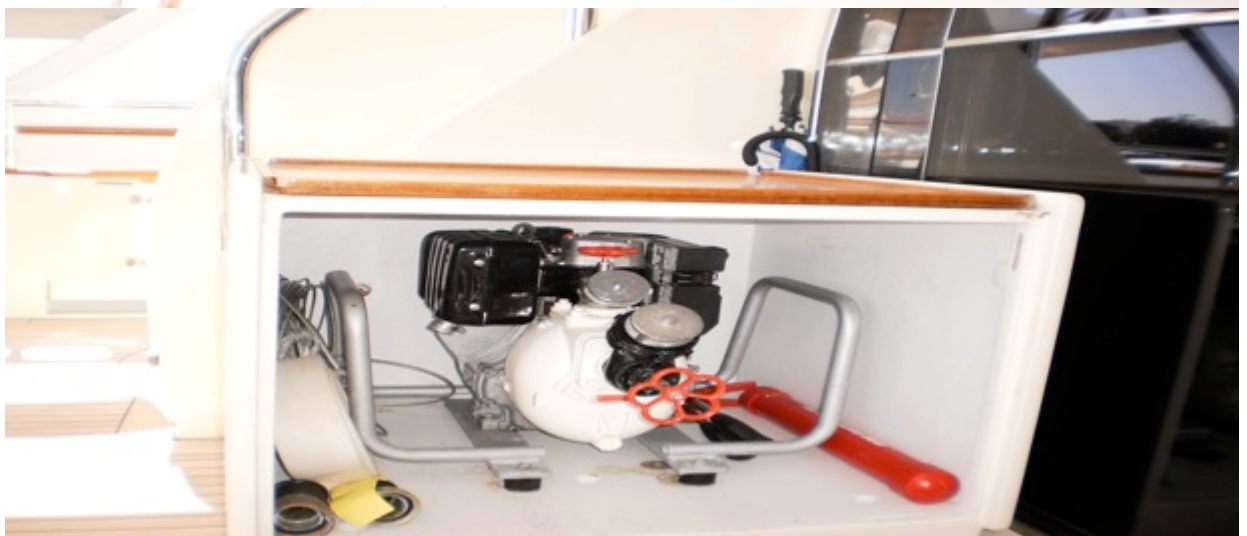
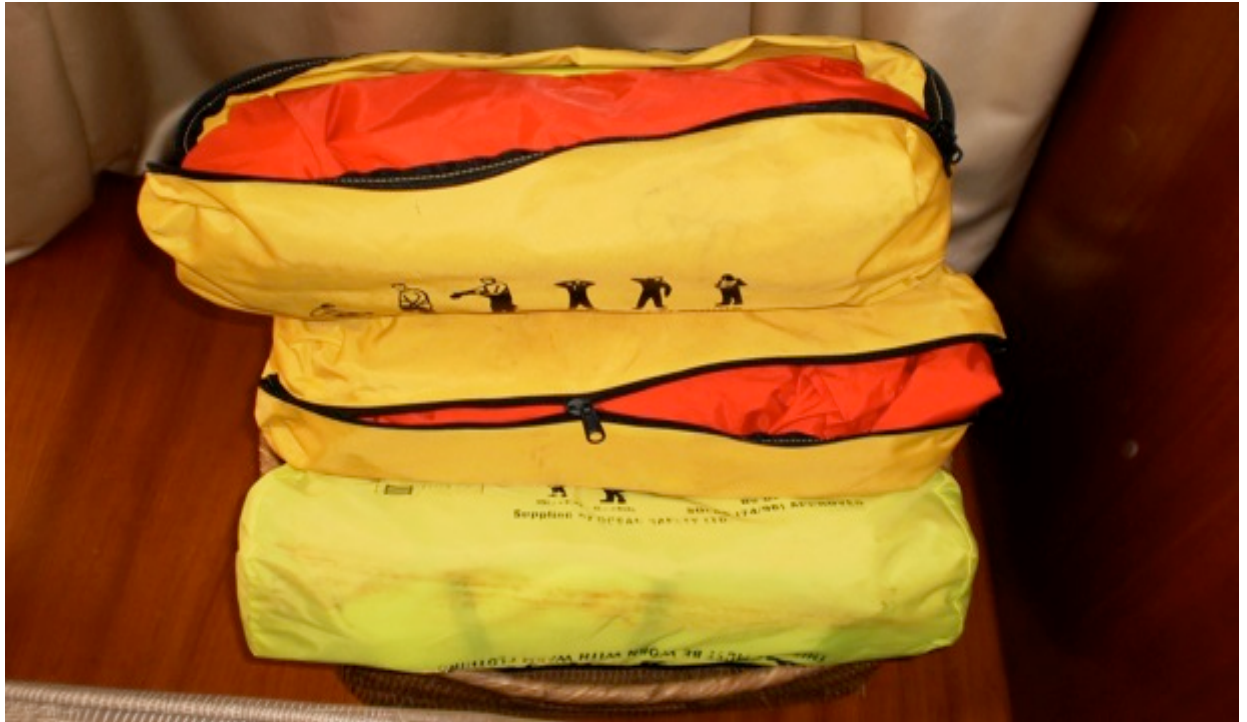
Photos 8

Life rafts (Zodiac x 4 10 persons) have been duly tested and all certificates and records found on board. Same is applicable with sailor EPIRB's & SART with hydrostatic releases, Immersion suits and man overboard, life jackets (SOLAS approved) and a up to date first aid kit that contains everything with detailed list of all medicines and their respective expiry dates. (See related photos 8)

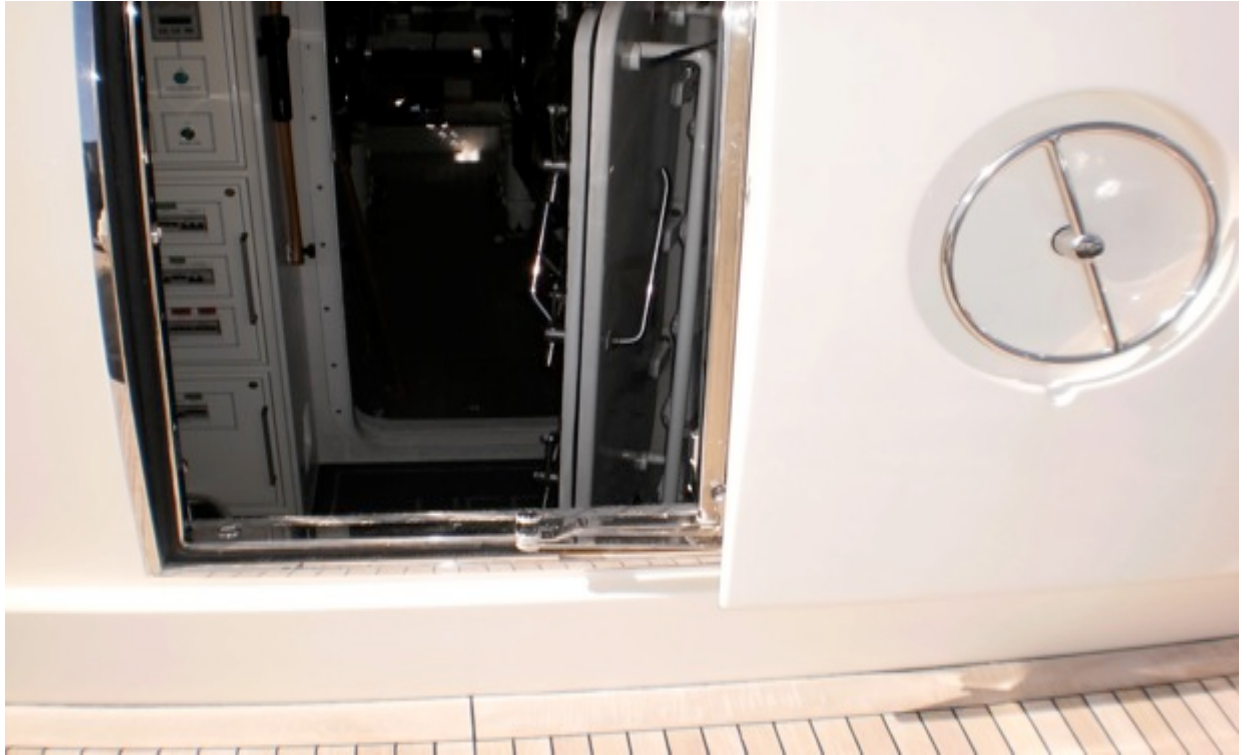
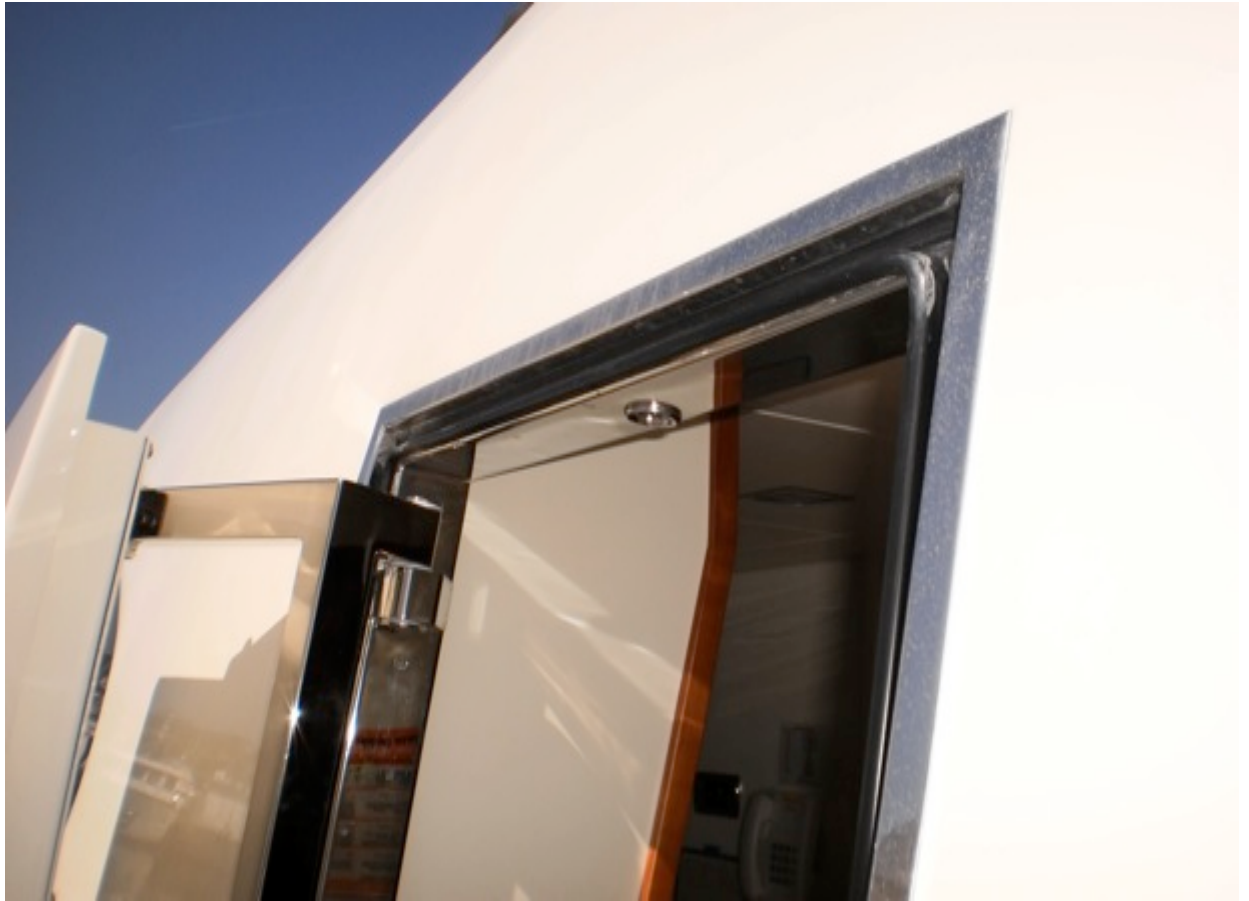
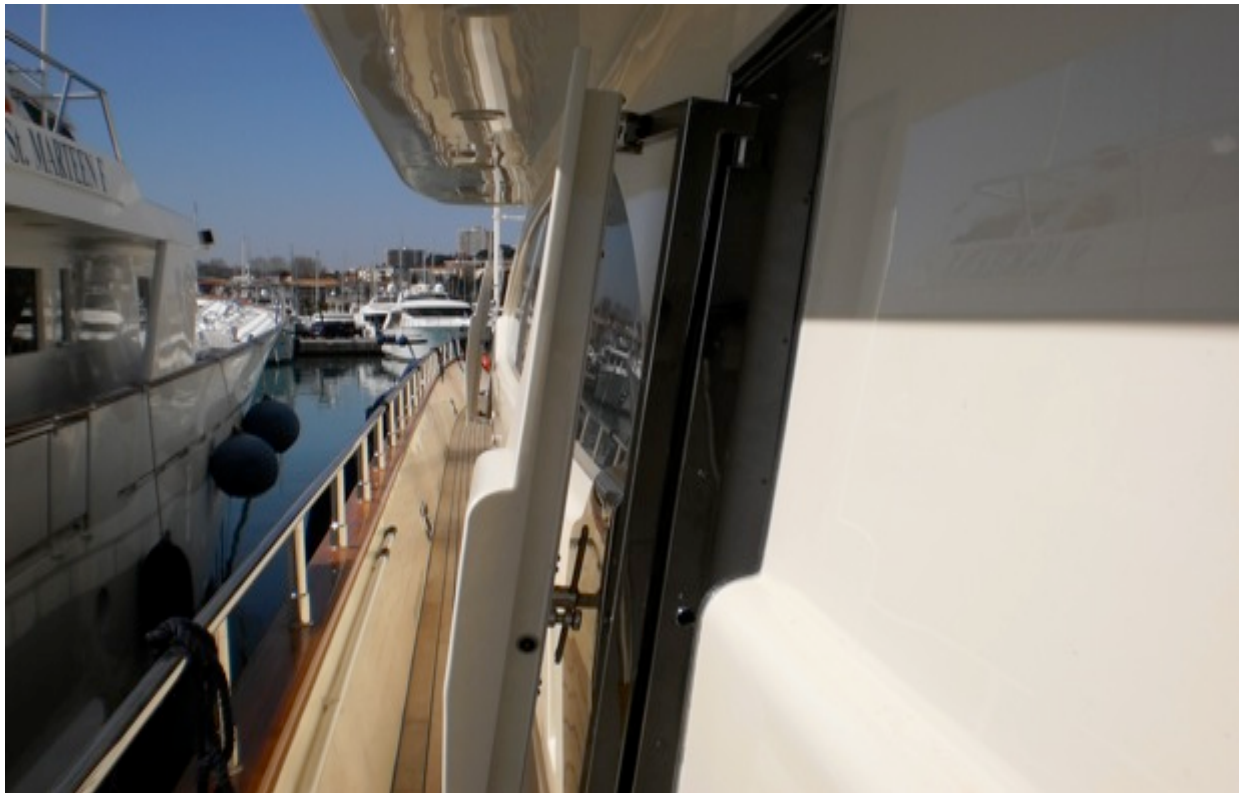
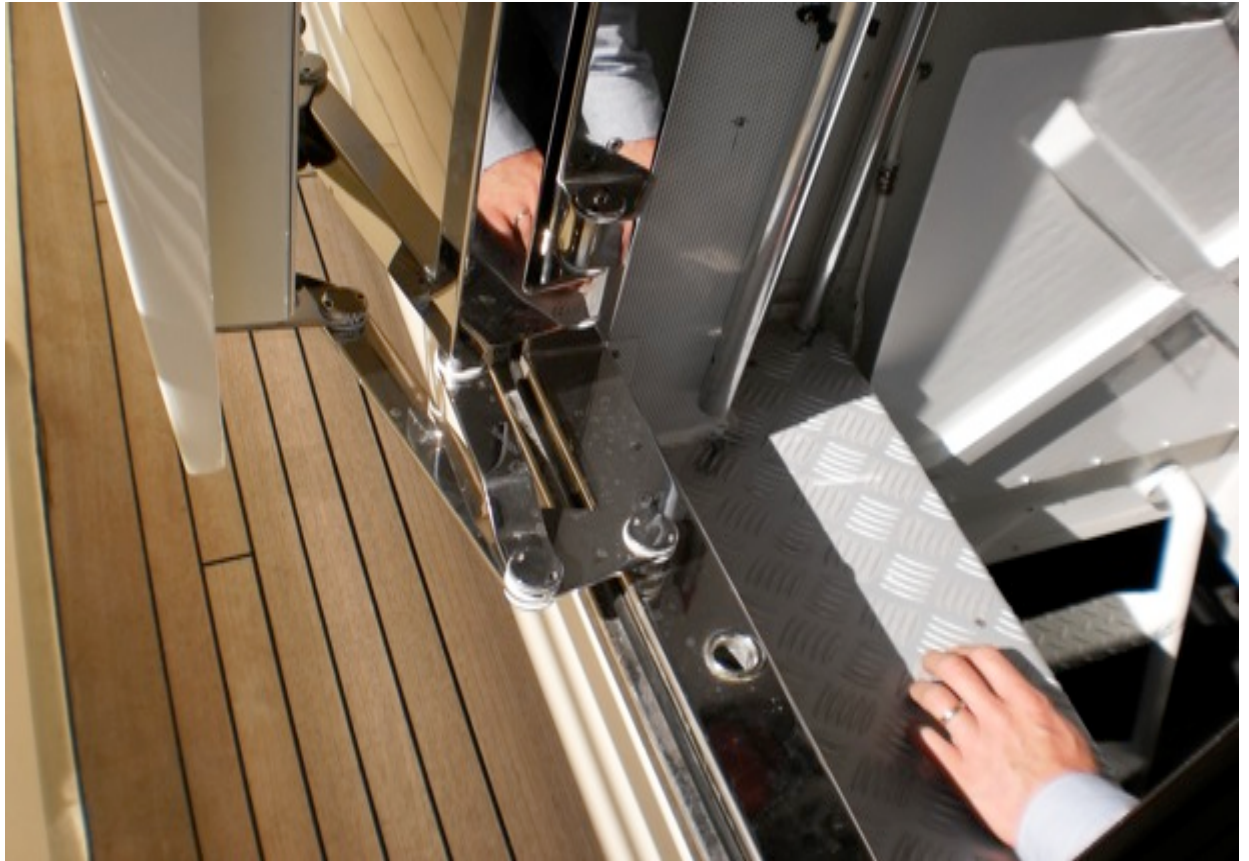
Photo 9

All watertight doors were examined and found that rubber seals are of no need of replacing. (see photo 9)

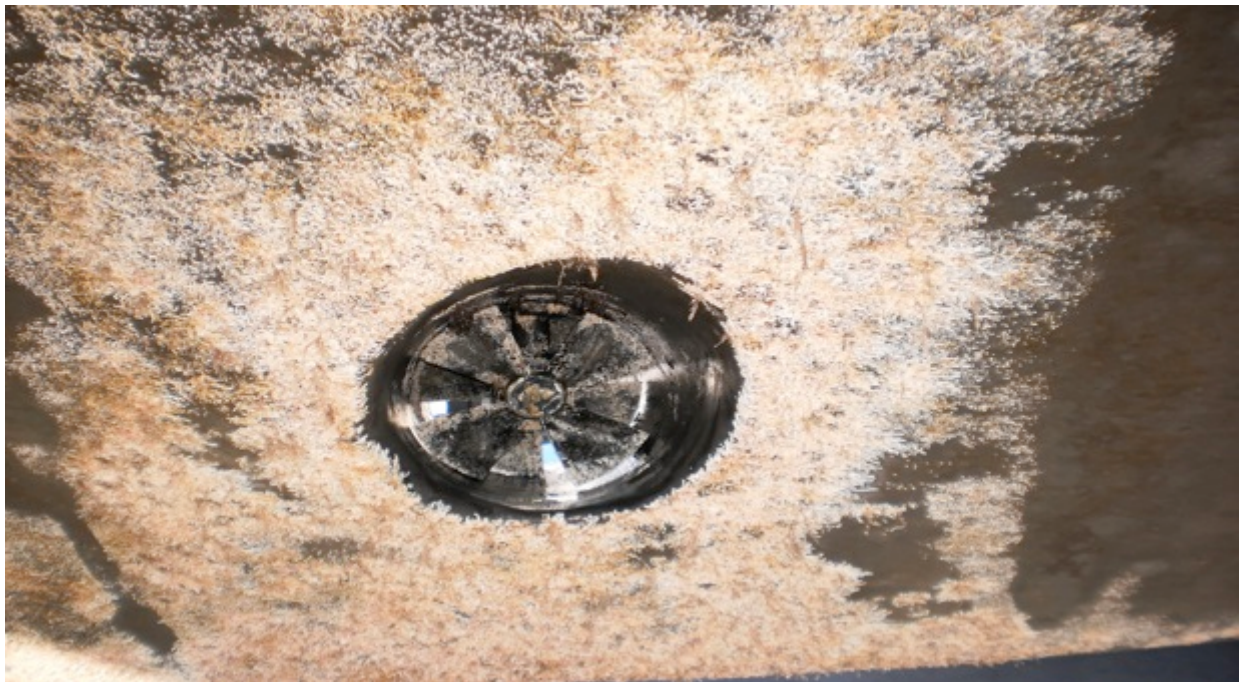
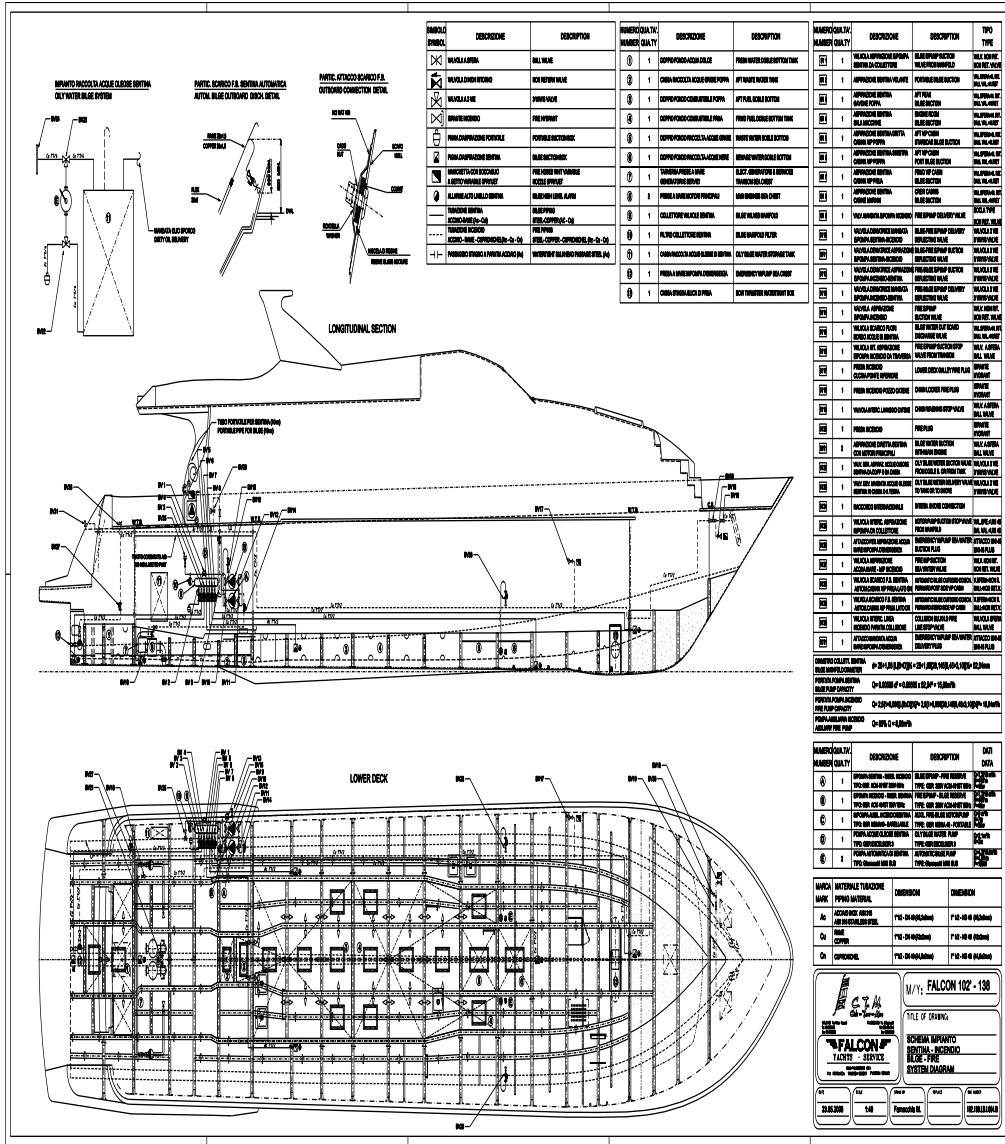
Photo 10

All were tested and found in good operational conditions together with the emergency systems and the fire emergency pump located in the aft deck area. A full diagram/layout of the on board bilge system can see at the end of the report as Photo 10.
