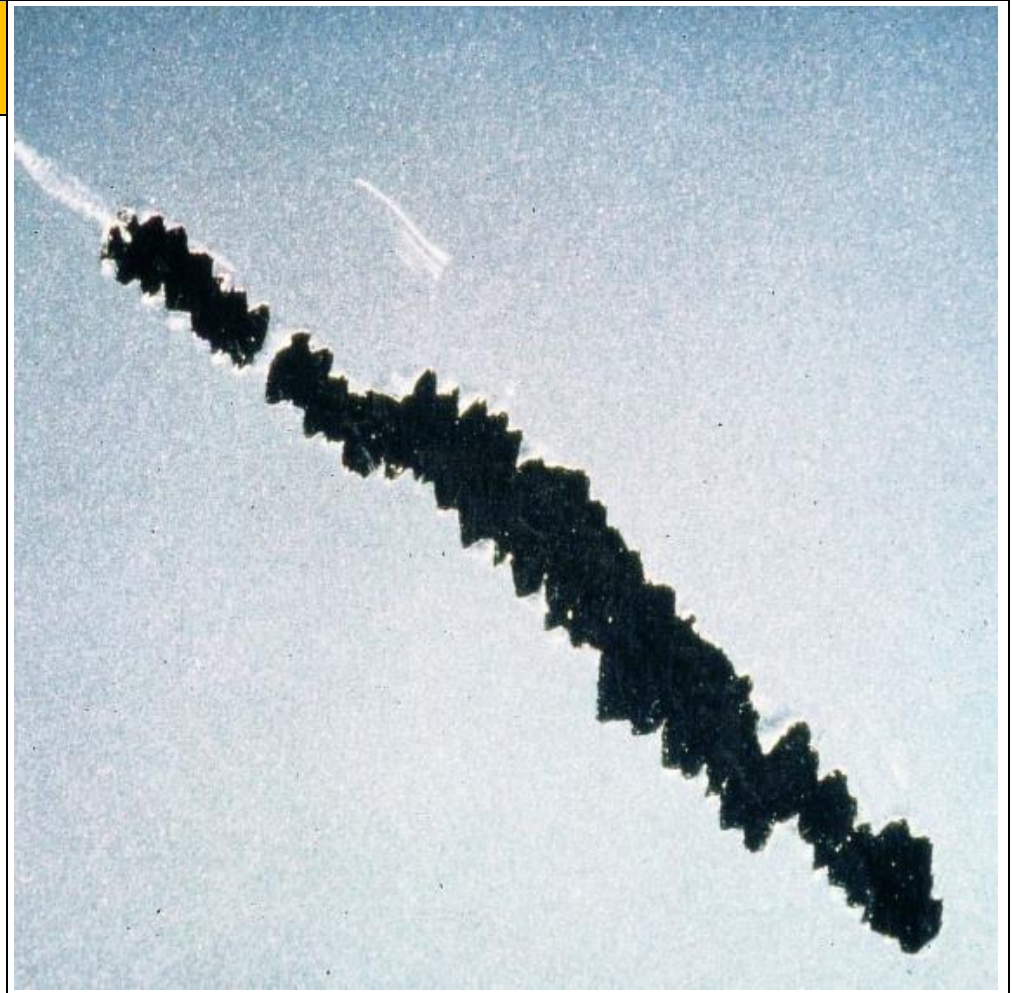
Poor adhesion may show immediately after application and drying or will be visual after some weeks or months.

Polyester body filler applied over Wash Primer.	Apply Polyester body filler <u>only</u> over bare metal or over Primer Surfacer EP.
	No recommended primer applied.	Apply recommended primer (for aluminum, plastic, galvanized steel) when needed.
	Wrong selection of the body filler, incompatible for the substrate.	Select the correct body filler related to the substrate.

Using wrong, not qualified degreasers, contamination not properly removed.	Use recommended degreasers only (compatible product for substrate).
	Using dirty cloths, contamination wiped on the surface.	Use two clean cloths, one to dissolve the contamination, one to remove.
	Incorrect degreasing technique.	Use two clean clothes, and degrease small parts at a time. Wipe off before the degreaser evaporates.
	No degreasing at all.	Wash with (preferably warm) water and soap and then degrease with recommended degreaser.

Insufficient or incorrect sanding grit and materials, too fine sanding grit selection enhances the risk of adhesion problems.	Sand the repair and feather edge with recommended sanding grit and with standardized sanding paper.

Using incompatible polyester for the substrate(system selection).	Use recommended products suitable for the substrate (system selection).
	Incorrect mixing. Not 100% mixing of the polyester with the peroxide hardener.	Mix according to recommendation. Do not stir when mixing, to avoid air inclusion in the mixture.

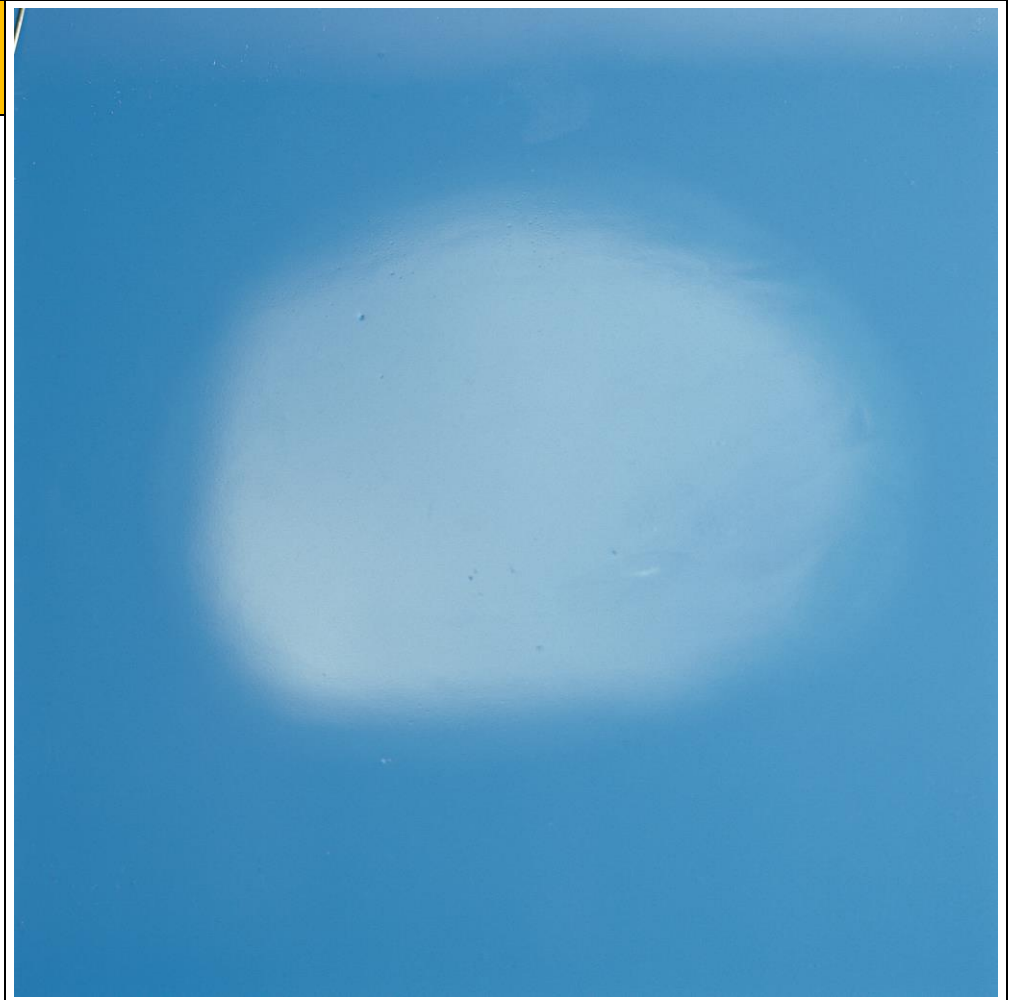
Although bleeding is predominantly an application defect, it can also occur on a time scale of weeks to months after application.

Clearly, the visual severity of bleeding is greatest, when lighter colors are applied.

Remove the paint system back to and including the bleeding layer and build up the system once more.
 Alternative solution: sand (visual) repair spot with P500 dry, apply a fine silver metallic till opacity is reached and Re-spray topcoat system.
 When the amount of peroxide is really overdone, even the Primer Surfacer EP will not block the peroxide in migrating to the surface.

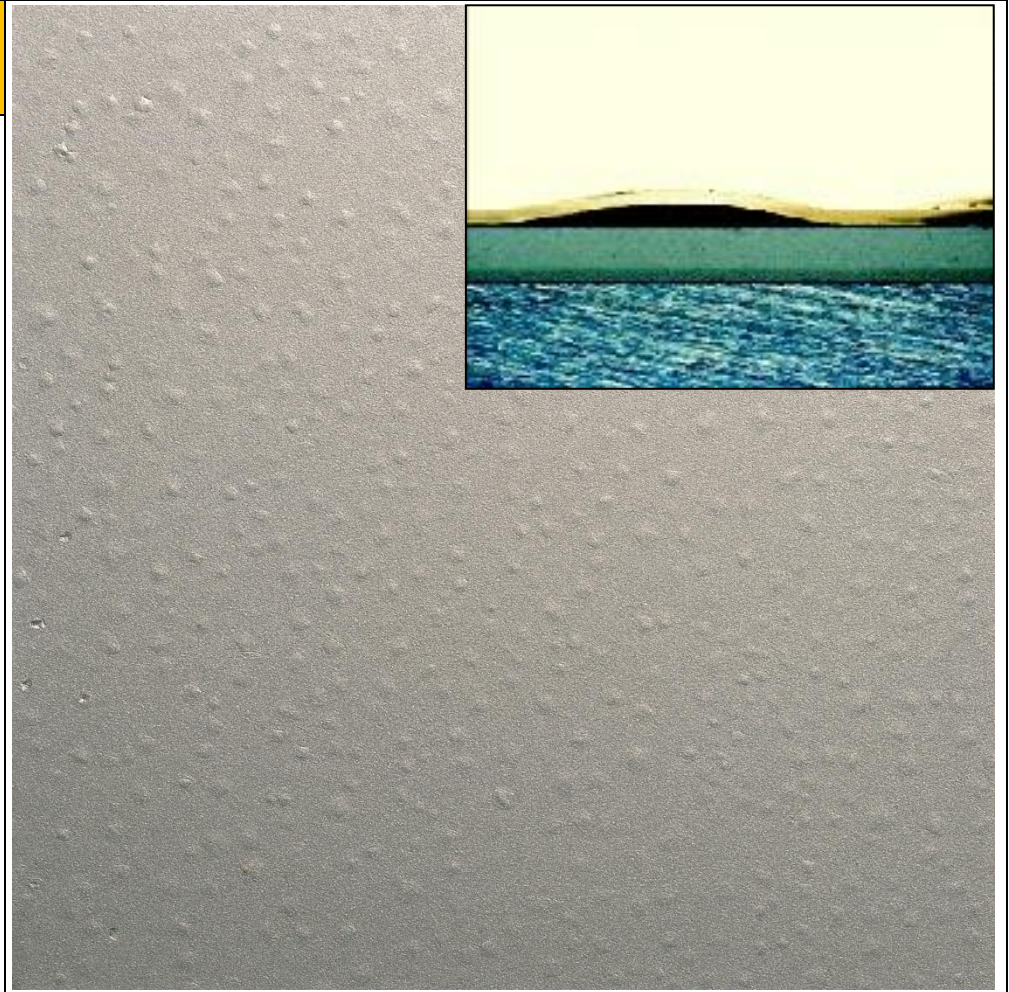
Blistering is caused by moisture or contamination under the paint which forces the paint system up.

This normally occurs after a longer time period.

<p>Contamination was left on the substrate.</p>	<p>Always degrease properly with every step in the process.</p>
	<p>Contamination caused by hands. One of the most underestimated risks during the repair process is finger or hand prints on the surface of the car. Because of perspiration, hands are covered with salt that will stick on the surface.</p>	<p>Do not touch ready to spray panels with bare hand; this kind of contamination can only be removed by cleaning with water and soap, or using water born degreaser.</p>

<p>Wet sanding of the polyester body filler. Absorption of the water into the polyester product.</p>	<p><u>Never</u> sand polyester body filler with water.</p>
	<p>Chalk and salt deposits from the “contaminated” sanding water remained on the substrate, absorbing moisture, which will be trapped in a new paint film.</p>	<p>Rinse thoroughly with clean water after sanding and dry the object completely.</p>

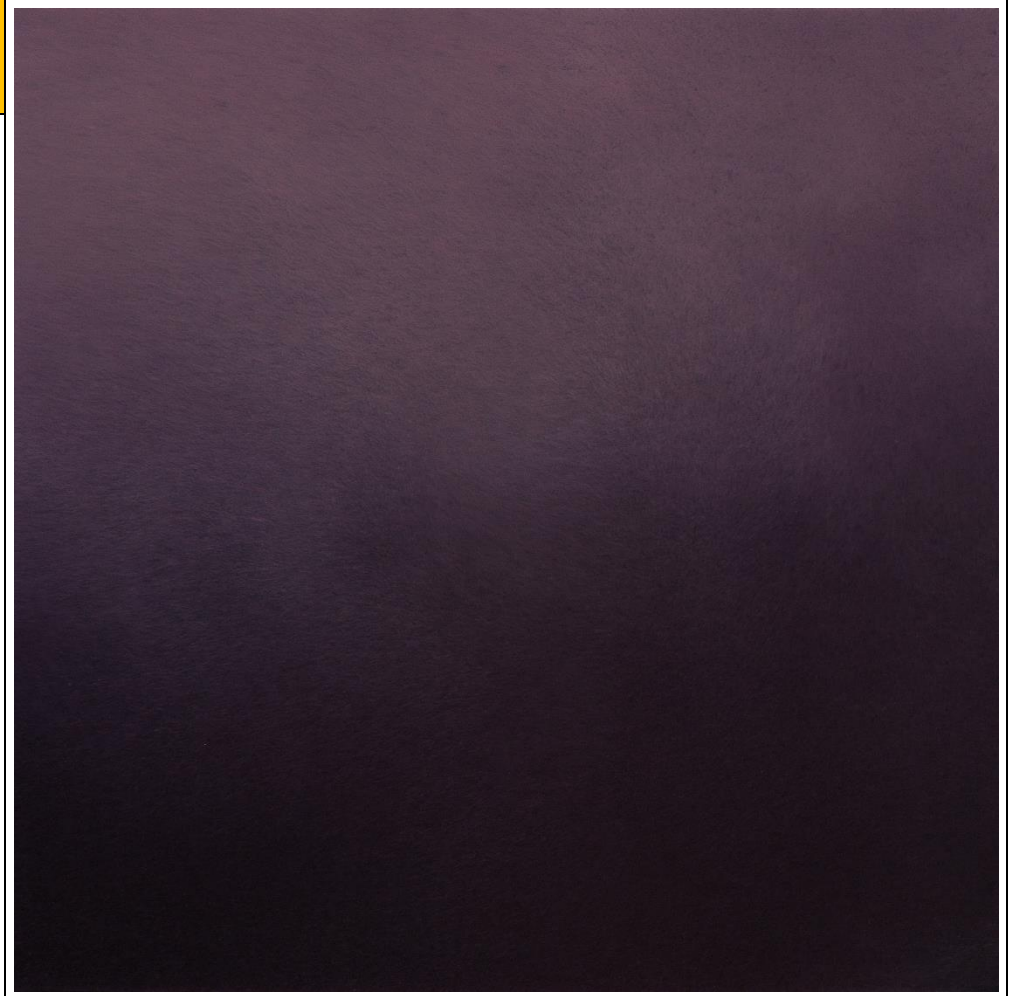
The freshly applied paint appears to be milky.

<p>The use of a too fast reducer will cool down the surface very quickly. In humid conditions the moisture from the air will be attracted and will condense on the surface of the wet paint film.</p>	<p>Select a Reducer related to temperature, job size and air flow.</p>

<p>Too cold storage temperature, temperature differences attracts humidity during application.</p>	<p>Let the paint acclimatize to ambient temperature.</p>

- If defect does not disappear, sand the topcoat and re-apply top coat system.
If defect re-appears, remove topcoat by sanding and re-apply the total paint system.

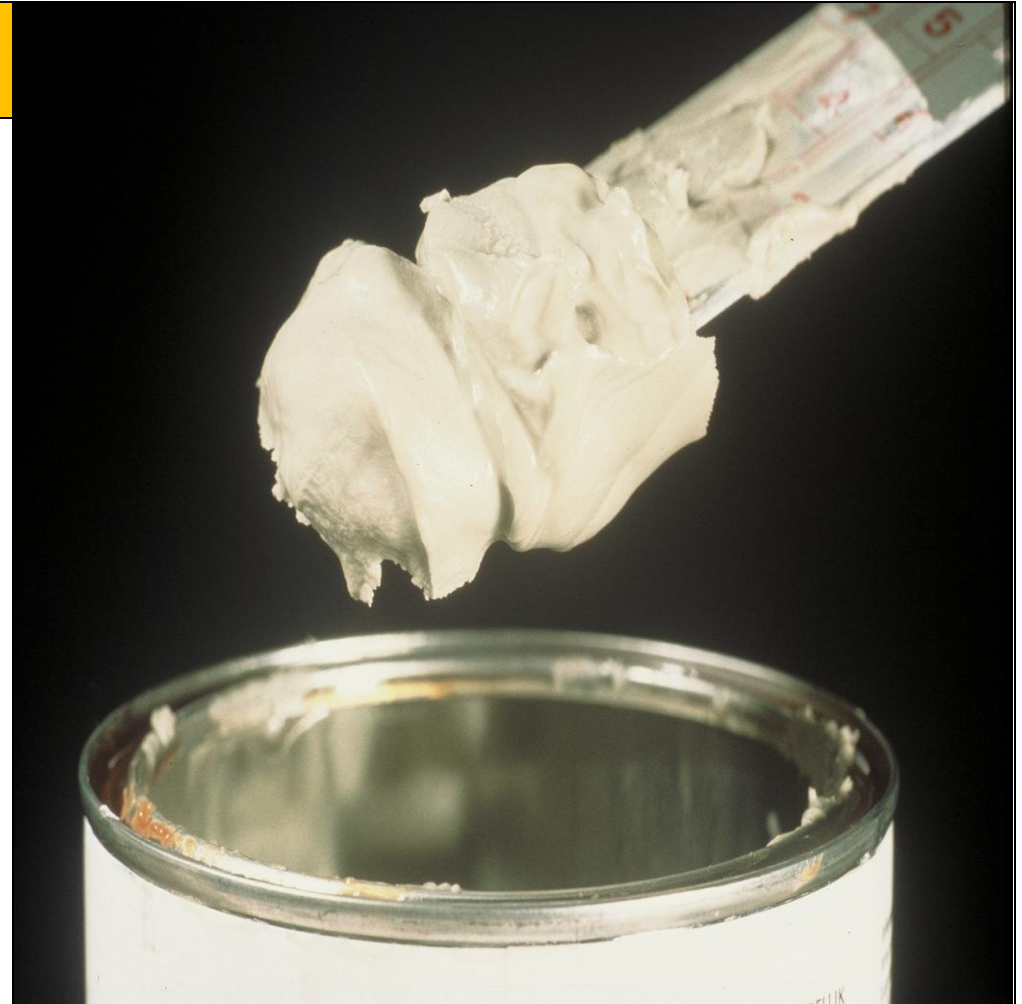
If paint bodies, gelatin or thickens, it is often the result of solvent evaporation.

1K products are particularly susceptible to this.

Bodied paint, primers and fillers are no longer suitable for usage and must be replaced with new ones.

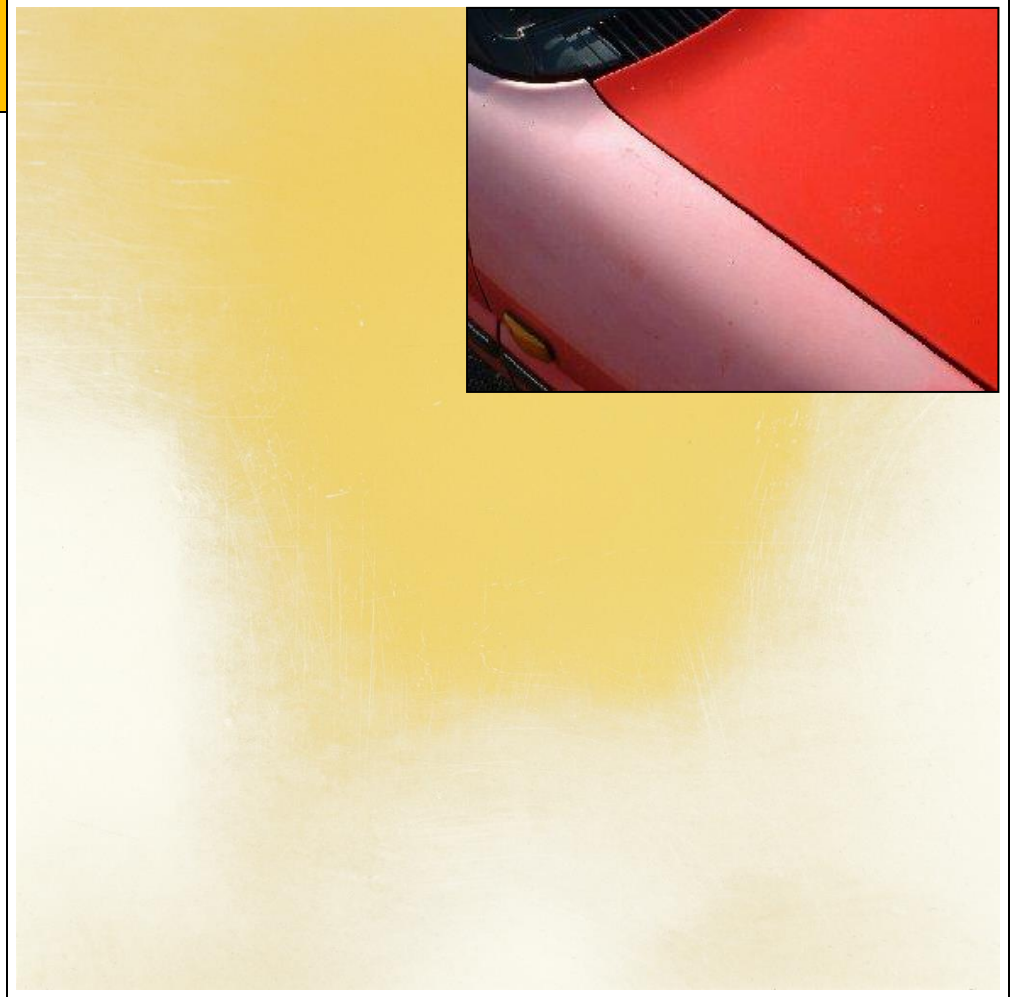
During exposure to UV radiation of sunlight, resins of the paint film get chalked. A powdery layer appears on the paint film resulting in (complete) discoloration.

Wrong quantity of Hardener, result in insufficient cross linking.	Mix according to the recommended mixing ratio, use the correct quantity of Hardener.
	Wrong type Hardener selected, result in no, or an insufficient cross-linking. The paint will be more sensitive to UV radiation.	Mix only with recommended Hardeners, as mentioned in the Technical Data Sheets.

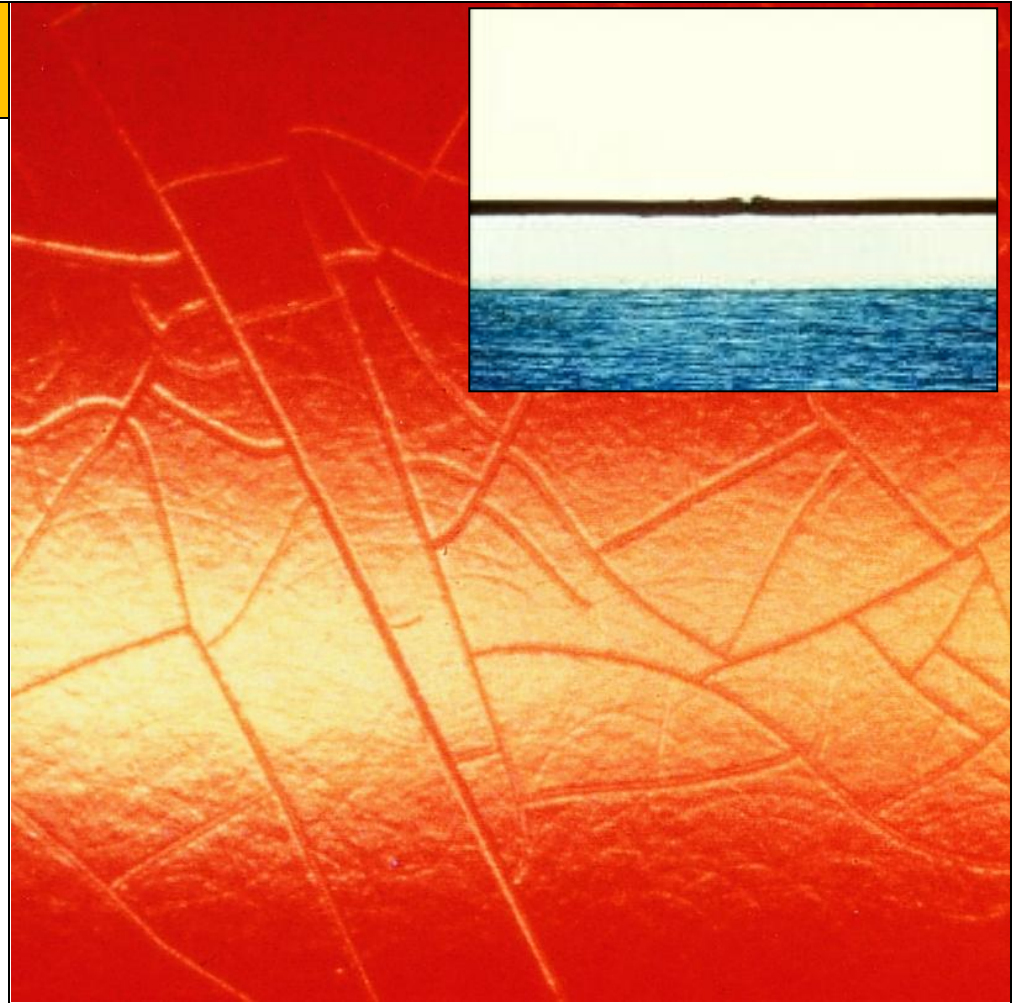
After some time a widespread pattern of fine hairline cracks appear in the paint surface.

Cracks can go straight through all paint layers.

Wrong mixing ratio. Too much Hardener in 2 - K product. Too much Reducer in 1 - K product.	Mixing ratio of the product according Technical Data Sheet. Use mixing stick.
	Wrong Hardener / Reducer selected. Incompatibility of the different products.	Select only recommended products, see Technical Data Sheet.

The only proper solution is to remove the cracked paint film completely to sound layer and re-paint.

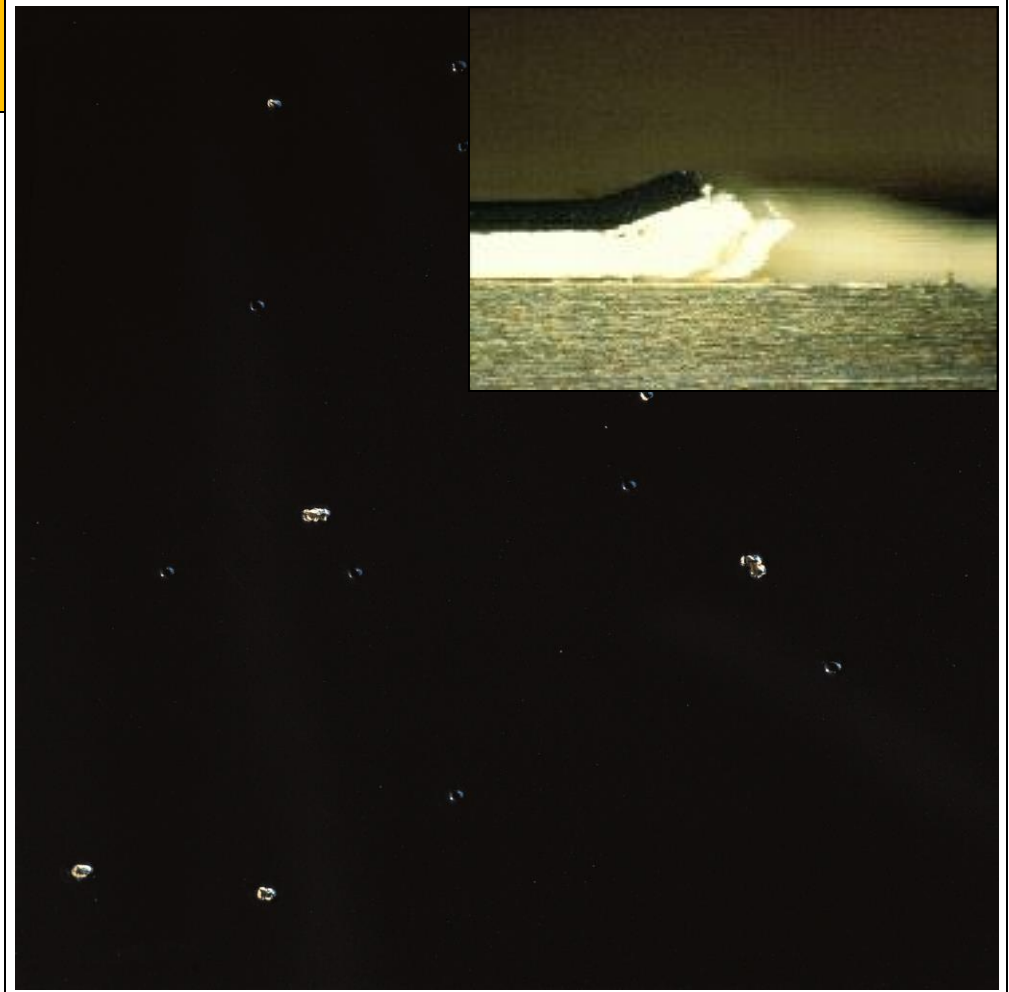
A small piece of the finish or even the total system seems to have broken away from the substrate.

Sometimes the underlying filler coat has broken as well.

This problem usually caused by stone chips.

Even small chips if neglected, can become a foothold for corrosion to start. Touching with a small brush and paint should be carried out as soon as possible after the damage occurs to avoid rust and minimize the risk of further paint coming loose. More extensive damage will require preparation and re-painting.

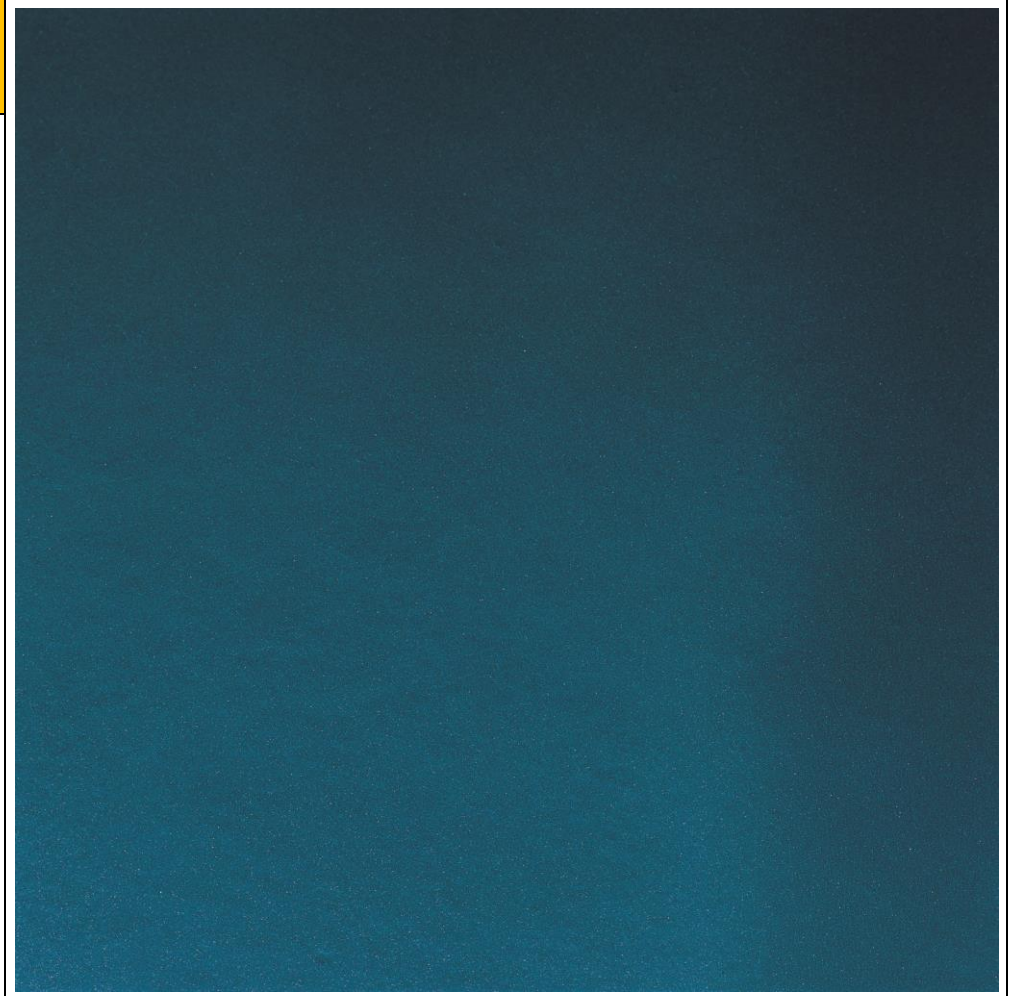
Cloudiness appears in metallic base-coats only.

The disorientation of aluminum pigments in the base-coat are causing a visible disturbance in the color appearance, known as cloudiness or mottling effect.

Too fast Reducer selected so too fast evaporation of the Reducer.	Select the correct Reducer related to temperature, size of the repair and air flow.
	Incompatible Reducer not qualified for the product selected.	Only select the recommended Reducers for the product, according to Technical Data Sheet.

Application of the base coat is too heavy and the metallic gets disorientated.	Apply according to recommended spraying technique.
	Wrong spray gun set up, incorrect air-pressure and / or spray gun distance.	Check spray gun set up and apply according to recommended spraying technique.

When re-applying the base coat, apply according to recommendation.

When clear coat was sprayed: sand after drying with P500 dry or P1000 wet and re-spray according to recommendation.

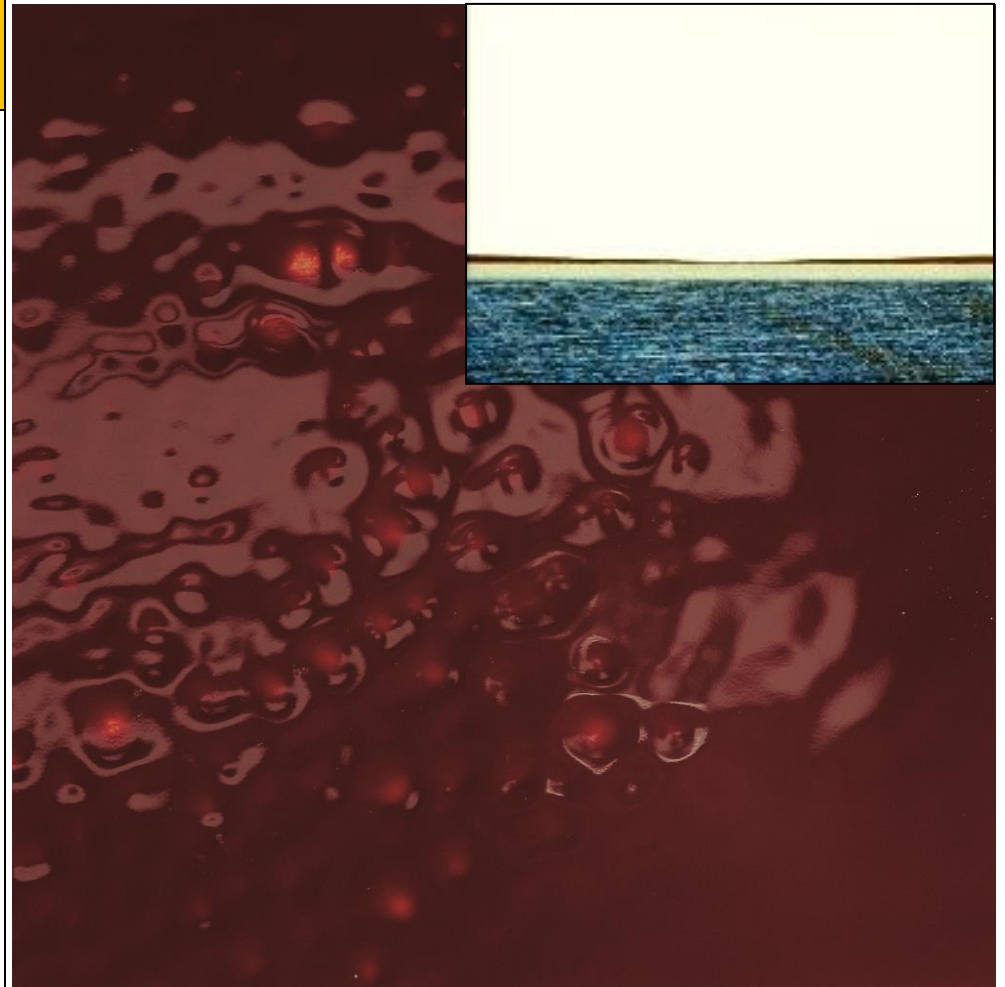
- Grease
- Wax
- Polishing agent
- Dirt etc.

Especially contamination from silicone compounds often causes problems

Using unqualified degreasers, contamination not properly removed.	Use recommended degreasers only.
	Using dirty cloths, contamination wiped on the surface.	Use two clean cloths, one to dissolve the contamination, one to remove.
	Incorrect degreasing technique.	Use two clean clothes, and degrease small parts at a time. Wipe off before evaporation.

Compressed air contaminated with oil and water, due to poor maintenance and check ups.	Check oil level weekly, yearly maintenance of air system by qualified maintenance company. Replace filters according maintenance schedule.
	Poor housekeeping, dirty contaminated working area.	Keep working area clean and free from contamination.
	Poor maintenance, soot from the oil heater.	Check heater and heating system regularly.

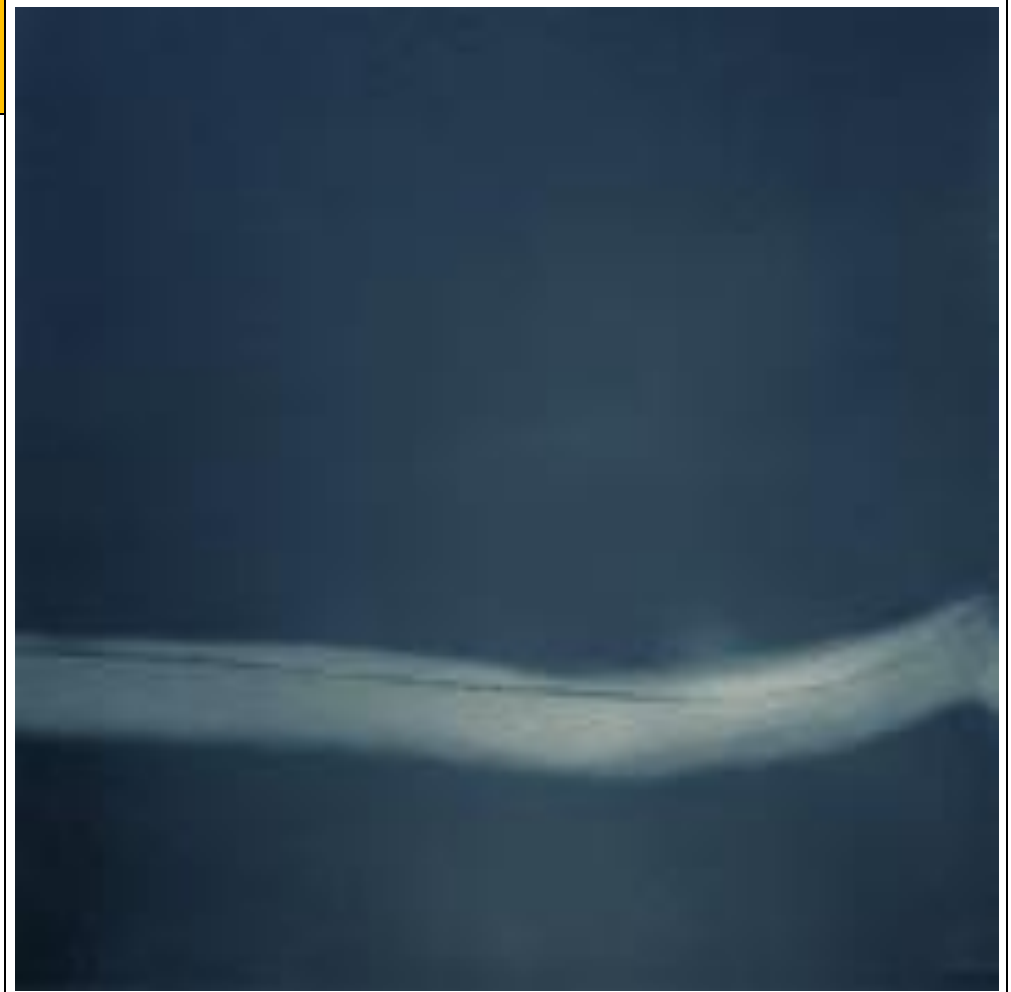
Either the edges of an underlying coat in the system can be seen in the top coat, or sanding marks around the original repair are visible.

<p>Application of products over Softer (TPA like) finishes.</p>	<p>By doing the thinner test, one can take precautions like;</p> <ul style="list-style-type: none"> • Removing the old finish totally <p>Isolating the old finish with a sealer, Wash filler 590 or Primer Surfacer EP.</p>
	<p>Degreasing The substrate was not degreased, or not degreased properly, this means the bodyfiller has not adhered. While sanding, the edges crumble away, leaving an irregular feathered edge to the area around the repair.</p>	<p>Always thoroughly degrease before sanding.</p>

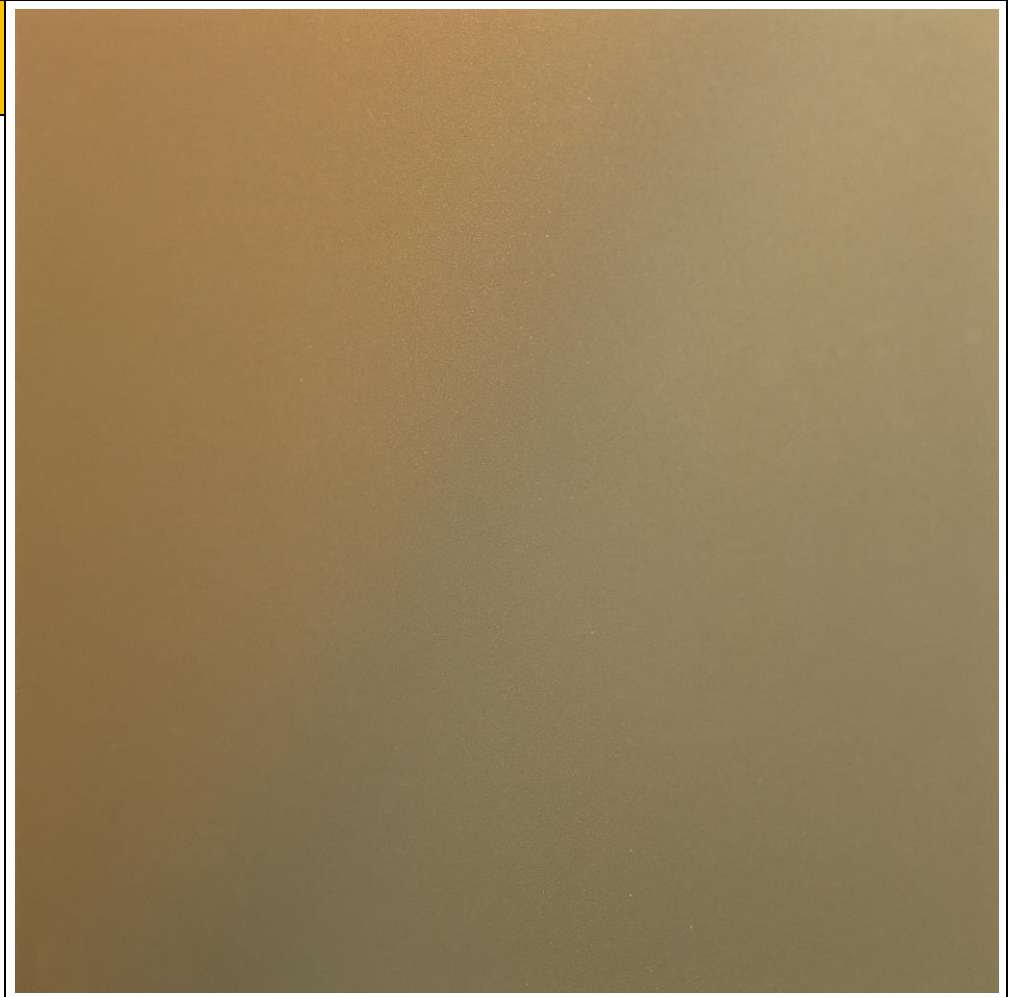
Color shade of the repaired area, does not match the original color of the car.

Wrong Hardener and or Reducer selection.	Select only recommended Hardeners and Reducers for the product according to Technical Data Sheet.
	Incorrect mixing ratio.	Mix the components as mentioned in the Technical Data Sheet. Changing this mixing ratio influences the color.

Wrong variant or color chosen when selecting the color code.	Select the right color or color variant. Correct stirring and sufficient tinting when necessary
	Color match is not checked using spray-out panel.	Check color using spray-out panel.
	Mixing of the formula was not closely followed.	Correct mixing of the color formula.
	Poor stirring of the mixed toners.	Stir and mix the toners properly.
	Tinting of the color is not sufficient.	Tint as close as possible and check by spray-out.
	Wrong application, inadequate covering because of wrong application technique.	Apply according to correct application technique.
	Excessive spraying of the mist coat.	Apply a mist coat according Technical Data Sheet.

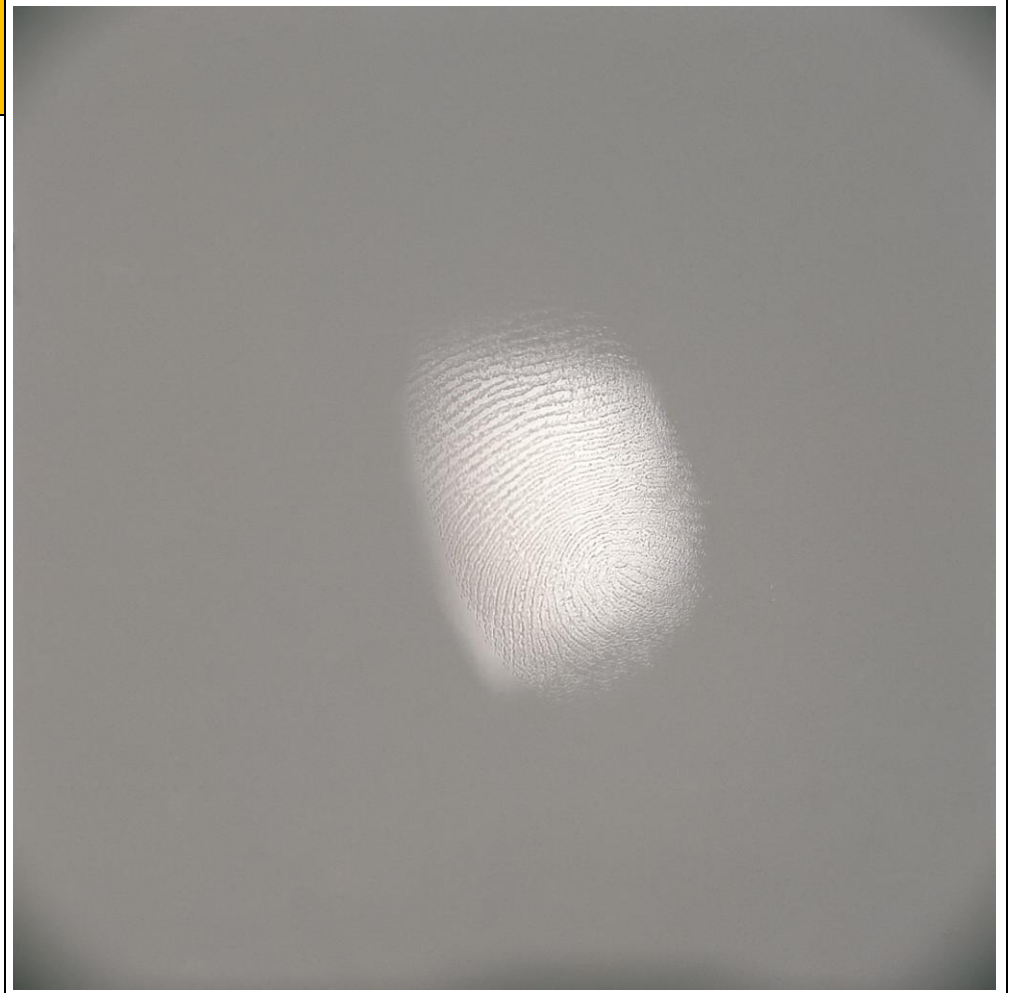
After a considerable length of time the body filler has still not hardened through.

In some cases it will never harden completely.

Not the correct mixing ratio Polyester body filler with Peroxide Hardener.	Mix with the correct mixing ratio.
	Hardener exceeded shelf life.	Notice shelf life of the hardener and keep track on expire date.
	Hardener was left open for a long time and reacted with moisture.	Keep hardener can or tube closed when not used.

Wrong Hardener selection.	Select recommended (sometimes dedicated) Hardener.
	Incorrect mixing ratio, too much or too little Hardener.	Mix according Technical Data Sheet.
	Lid of the Hardener can was not closed.	Always close the lids of Hardeners when not in use. Always close lids of all products.
	Hardener defective due to expiration date.	Pay attention to the expire-date of the products. Notice that the shelf life of Hardeners is usually shorter than the topcoat product.

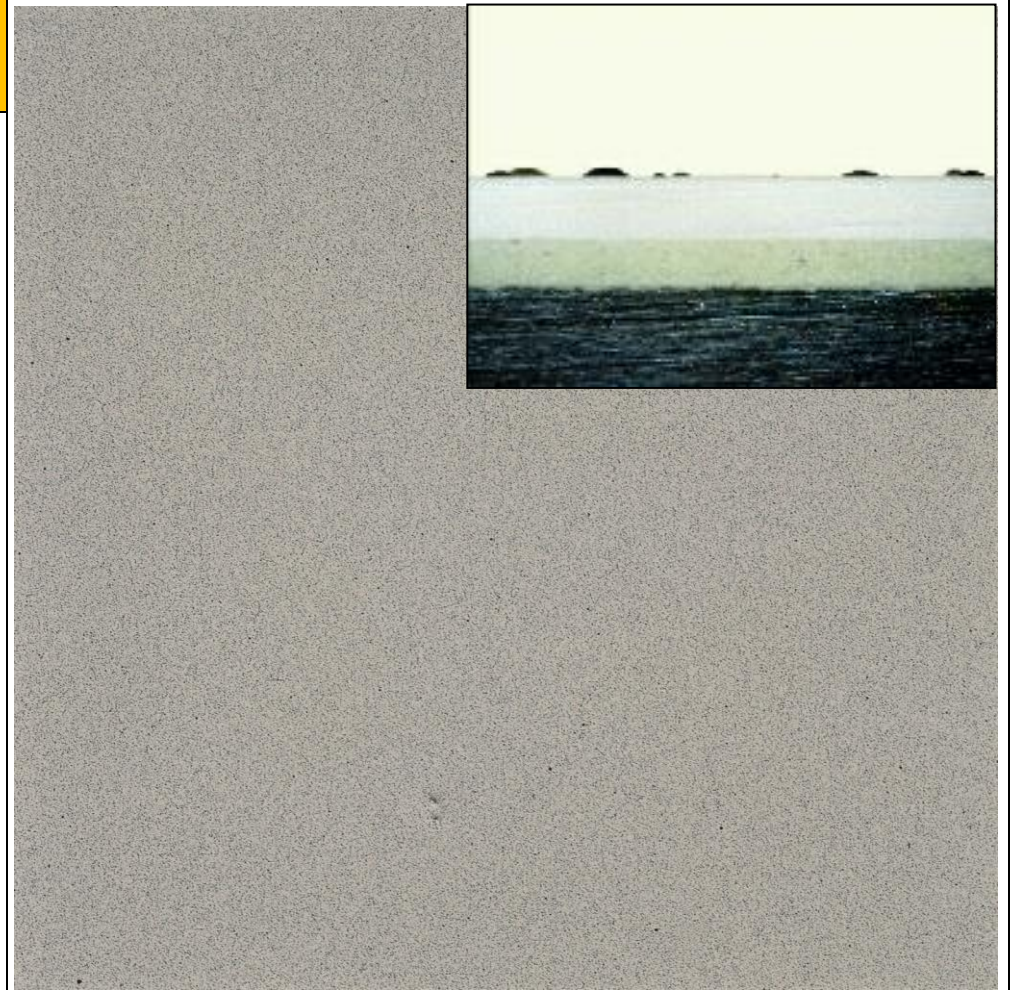
Over-spray falls on freshly sprayed paint and is no longer absorbed.

The surface of the fresh paint has a sandy appearance because of the dry paint particles sticking to it.

Wrong selection of Hardener / Reducer. Too fast Hardener, paint film is closing too fast. Too fast Reducer, paint film is closing too fast, too fast evaporation of the Reducer will result in too much atomization (spray-mist).	Select recommended Hardener and Reducer related to temperature, job size and air flow.

Spraying pressure is too high which causes too much atomization.	Spray according to Technical Data Sheet recommendation.
	Spraying distance is too far.	Adjust spraying technique and apply from recommended spraying distance.
	Wrong spray gun set up Check spray gun set up and adjust accordingly.	Use a correct spray gun set up in relation to the product to be sprayed.
	Poor maintenance, dirty spray gun.	Use a clean and proper spray gun.

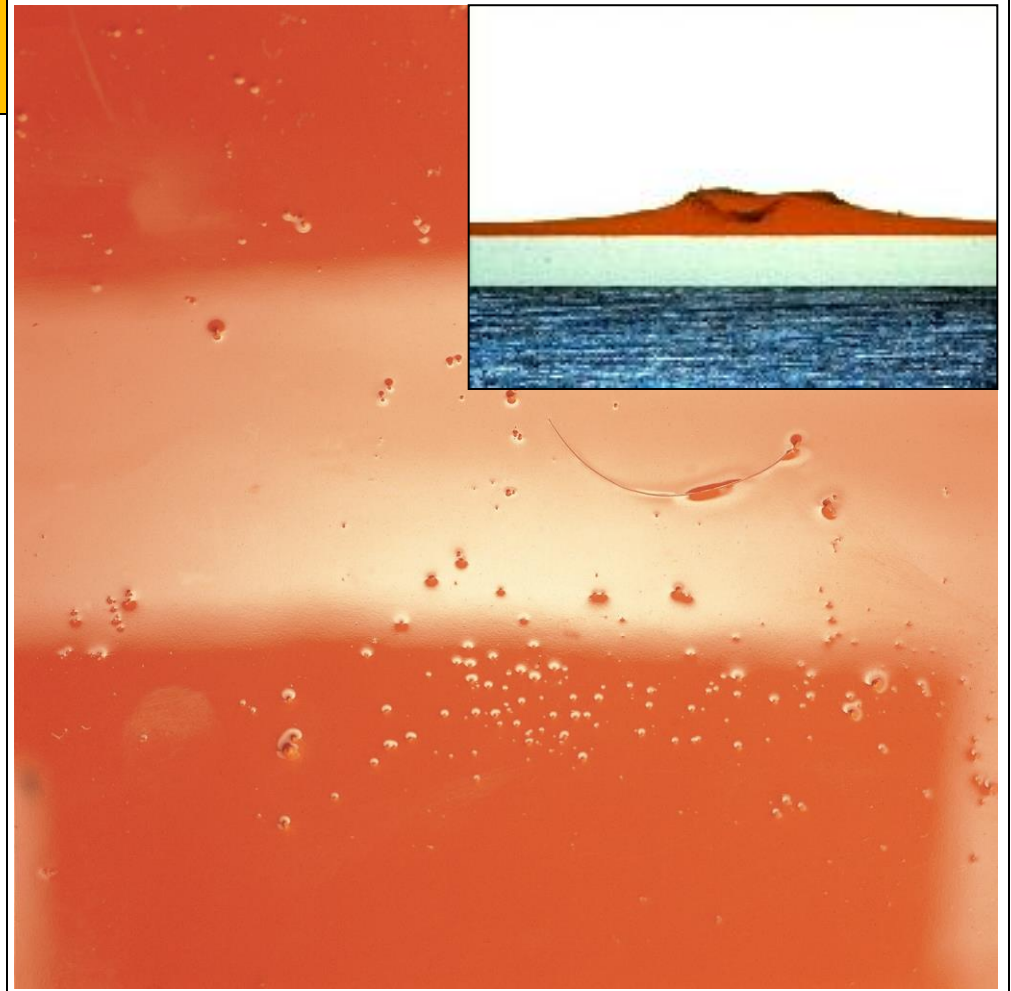
Dust particles have fallen onto the wet paint film and became trapped as the paint film dried.

<p>Tack rag was not used to remove dust particles before spraying or over-spray between the base coat layers.</p>	<p>Always use a tack rag for removing dust particles and over-spray.</p>
	<p>Paint strainer was not used. Contamination in the paint was not filtered out.</p>	<p>Always use a paint strainer to filter out the contamination particles.</p>
	<p>Painter did not wear a suitable spray overall. Poor housekeeping and no preparation taken too minimize dust.</p>	<p>Always wear a suitable spray overall. Work as a painter clean and proper. Tack and blow off dust from vehicle and air hose prior to spraying. Always wear a head cover.</p>
	<p>Cheap masking tape / paper were used. Sometimes newspapers are used for masking.</p>	<p>Use quality masking paper and plastic, to minimize dust contaminations.</p>
	<p>No Anti-Static degreaser used. Unnecessary build up of electrical charge.</p>	<p>Use Anti-Static degreasers for cleaning plastic parts. Use earth clamp to neutralize charge.</p>

Poor maintenance of the compressed air system. Poor maintenance of the spray booth.	Check oil level weekly, yearly maintenance of air system by qualified maintenance company. Replace filters according to maintenance schedule.
	Improper pressurization in the spray booth.	Check the spray booth pressure daily.
	Poor housekeeping.	Keep the surrounding area of the spray booth and mixing room clean.
	No dust prevention measures taken: <ul style="list-style-type: none"> • Tack rag overall, air hose, hair cap etc. • Earth clamp from car to floor. • 	A professional painter takes measures to minimize dust.

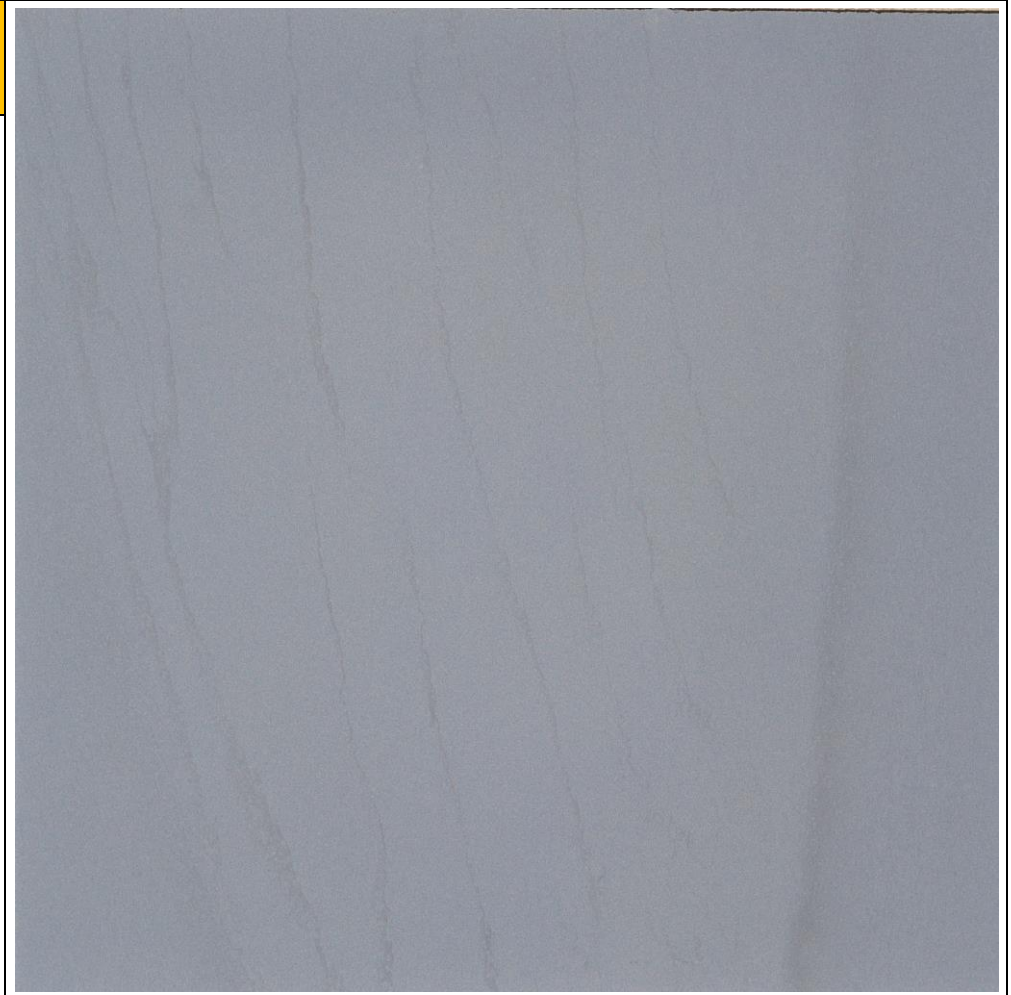
The lightest pigments will float to the top of the wet paint film.

This process can affect the final color.

Incorrect spraying distance, irregular and / or too close Application of the paint is too heavy, layers are too thick Overlaps are too small (much smaller than 50%).	Use proper spraying technique.
	Fluid nozzle too large.	Use correct spray gun set-up for the product.
	Spraying temperature too low.	Spray according to recommended temperature, between 20°C and 25°C.
	Object temperature is too cold.	Let object and paint acclimatize to ambient temperature.

Heavy floatation (almost up to runs), let the paint dry, sanding the topcoat, and re-spray with normal recommended coats.

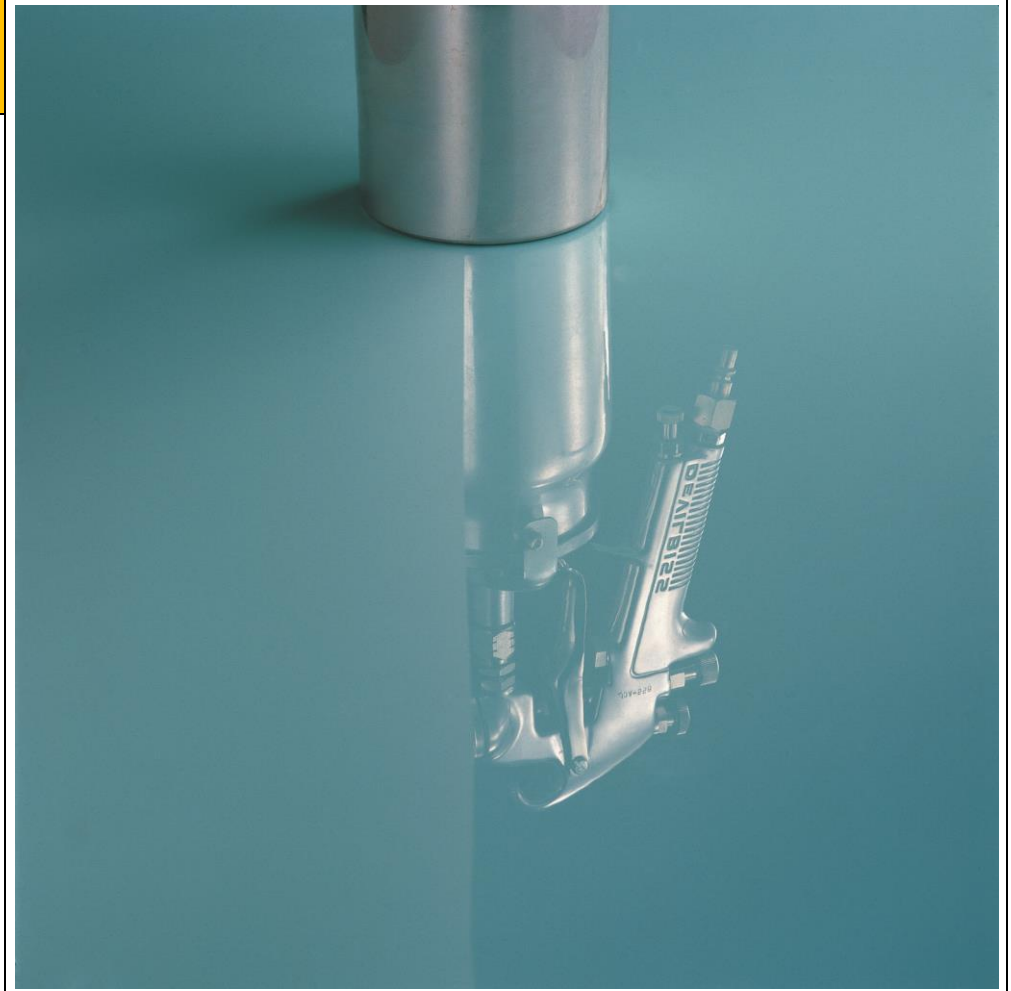
Freshly applied paint appears with a lower gloss level than wanted.

<p>Wax, polish or similar contamination has not been thoroughly removed and absorbed by the wet paint film.</p>	<p>Washing thoroughly with warm water and soap, followed by thoroughly degreasing (as recommended) before sanding and spraying.</p>

<p>Insufficient through hardening of the filler, sanding scratches will go too deep in the surface. Topcoat will sink in the sanding scratches, resulting in a lower gloss level.</p>	<p>Sufficient through hardening of the filler by heating or IR. When total through hardening is reached, sand with recommended sanding grit.</p>
	<p>Too coarse sanding grit will appear with the same effect. Mostly also related to very small visible sanding scratches.</p>	<p>Use only recommended sanding coarseness.</p>

<p>Insufficient through hardening, shrinking of filler or top coat after drying.</p>	<p>Follow the recommended drying times.</p>
	<p>Wrong product selection, too fast Reducer is used. Condensation can influence gloss level. Too coarse surface structure cause sinking of the clear coat.</p>	<p>Select the correct Reducer related too the repair size, temperature and airflow. Stick to the recommended flash off times.</p>

<p>Incompatible Hardener and Reducer used. Incomplete through hardening of the product.</p>	<p>Always mix with the recommended products according to Technical Data Sheet.</p>
	<p>Wrong product selection, too slow thinner is used. Flash off times ignored. Clear coat is applied over base coat even while Reducers or water were not completely vaporized out of the base coat.</p>	<p>Select the correct Reducer related too the repair size, temperature and air flow. Stick to the recommended flash off times.</p>

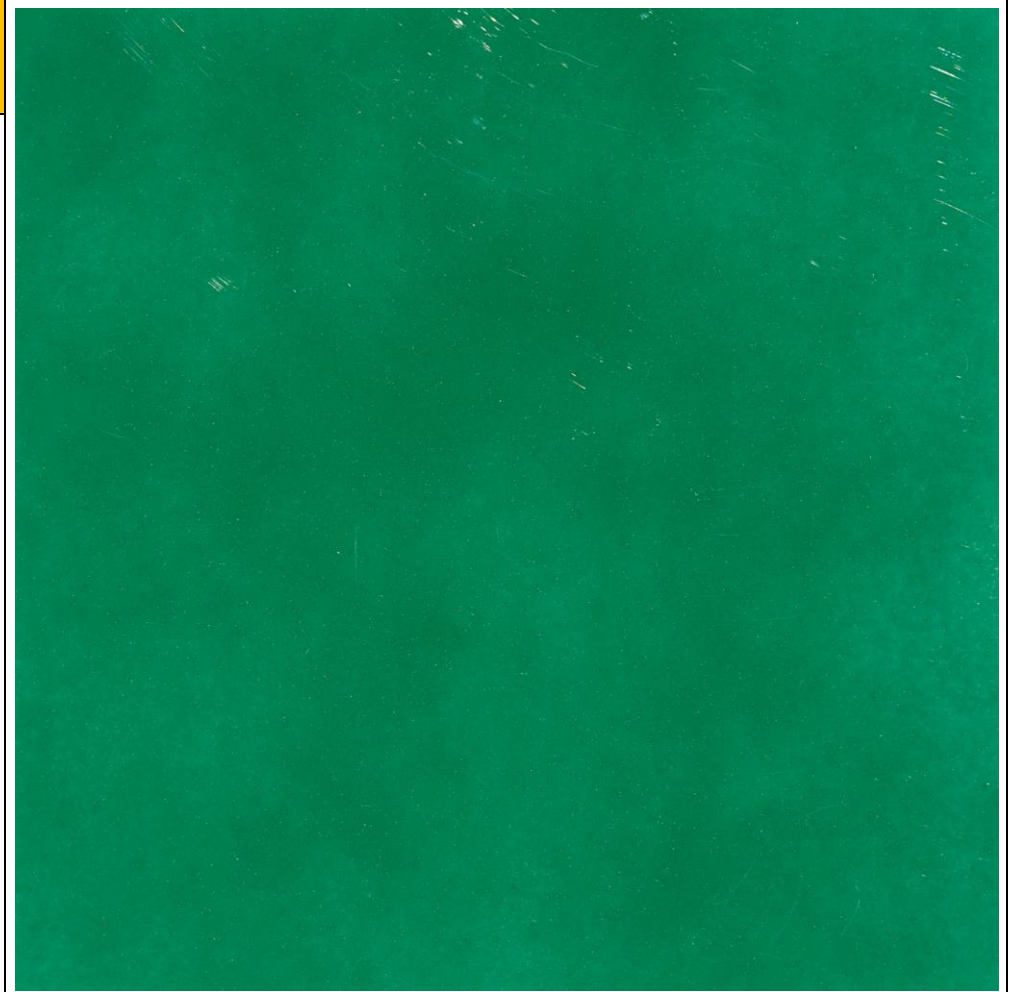
The substrate or the repair spot is visible through the top coat.

This often occurs on surfaces that are difficult to spray or on angles and edges.

<p>Poor overlapping of the coats. Irregular spraying distances. Ignoring flash-off times.</p>	<p>Apply according to recommended spraying technique. Look at the paint flow and check visually if the repair spot is covered. Work under sufficient lightning. Check color covering power before application.</p>

<p>Lightning inside the spray booth is insufficient. Wrong color strength or old lightning that needs to be replaced.</p>	<p>Use recommended color strength for the spray booth. Use the right amount of lightning and under the correct angle. Replace the tubes after indicated numbers of hours in use.</p>
