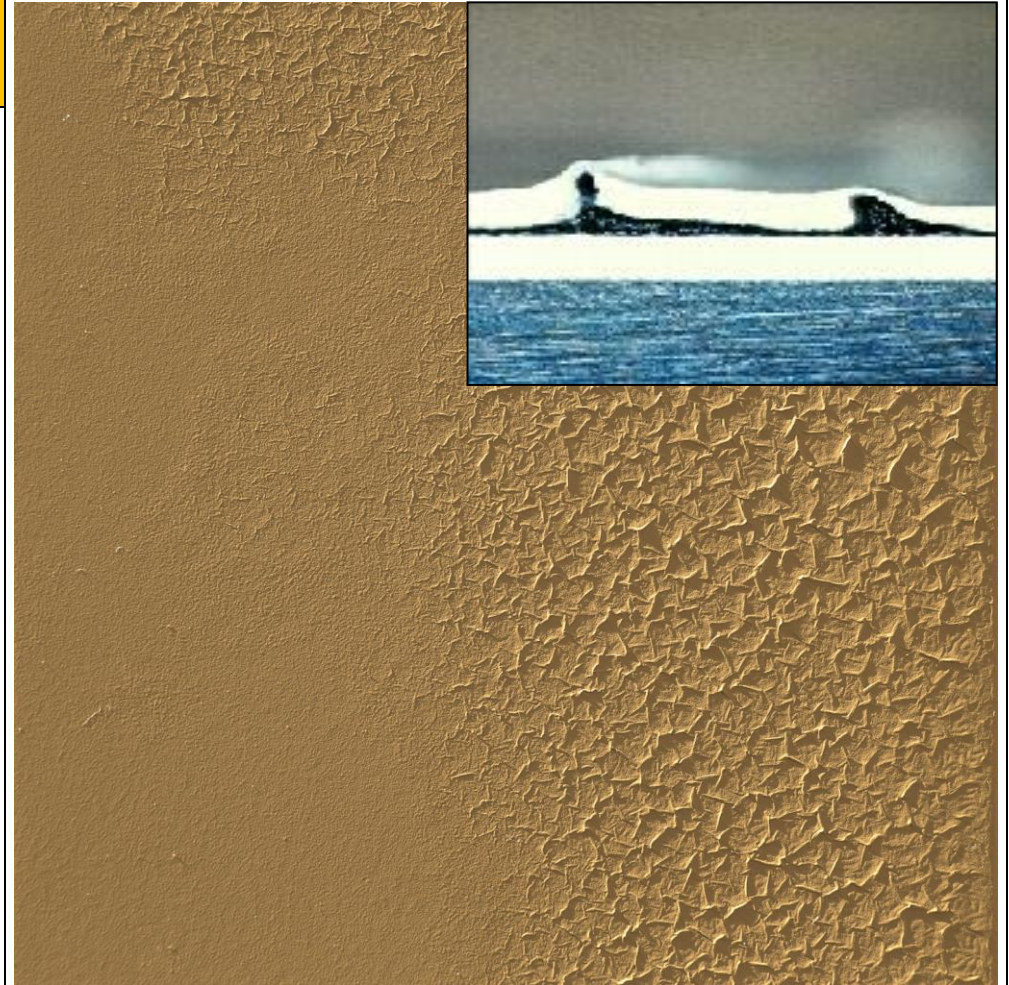
During application of a product, the paint film partially dissolves

<p>Selection of incompatible products with the substrate. Soft, TPA like paint system repainted with a solvent borne base coat.</p>	<p>Do the thinner test, seal or remove existing substrate when needed.</p>
	<p>Insufficient adhesion to substrate of previous applied product.</p>	<p>Select recommended products (primers / fillers) related to substrate.</p>

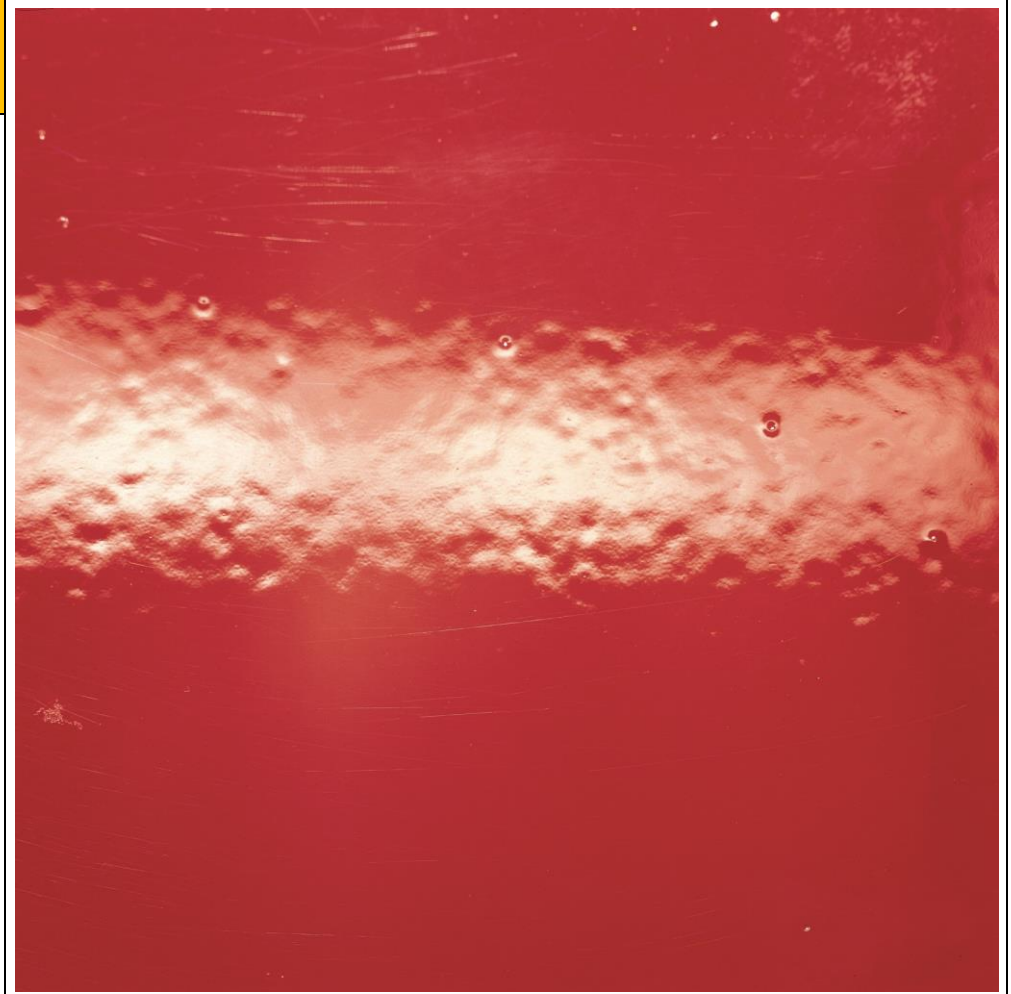
The freshly applied paint exhibits poor flow and resembles orange peel.

Wrong mixing ratio, too high spray viscosity, the paint is too thick and flows poorly.	Mix according to Technical Data Sheet.
	Wrong Hardener selection.	Select the recommended Hardener.
	Wrong Reducer selection related too temperature, job size and air flow.	Select the correct Reducer related too temperature, job size and air flow.

<ul style="list-style-type: none"> • Incorrect spraying distance, irregular or distance too far • Too heavy application of the paint, layers are too thick • Too large and / or irregular overlaps • 	Apply according to the recommended spraying technique.
	Spray gun set-up too large or too small.	Use correct spray gun set-up for the product as per Technical Data Sheet.
	Spraying temperature is too low.	Spray according to recommended temperature, between 20°C and 25°C.
	Object temperature is too cold.	Let object and paint acclimatize to ambient temperature before spraying.

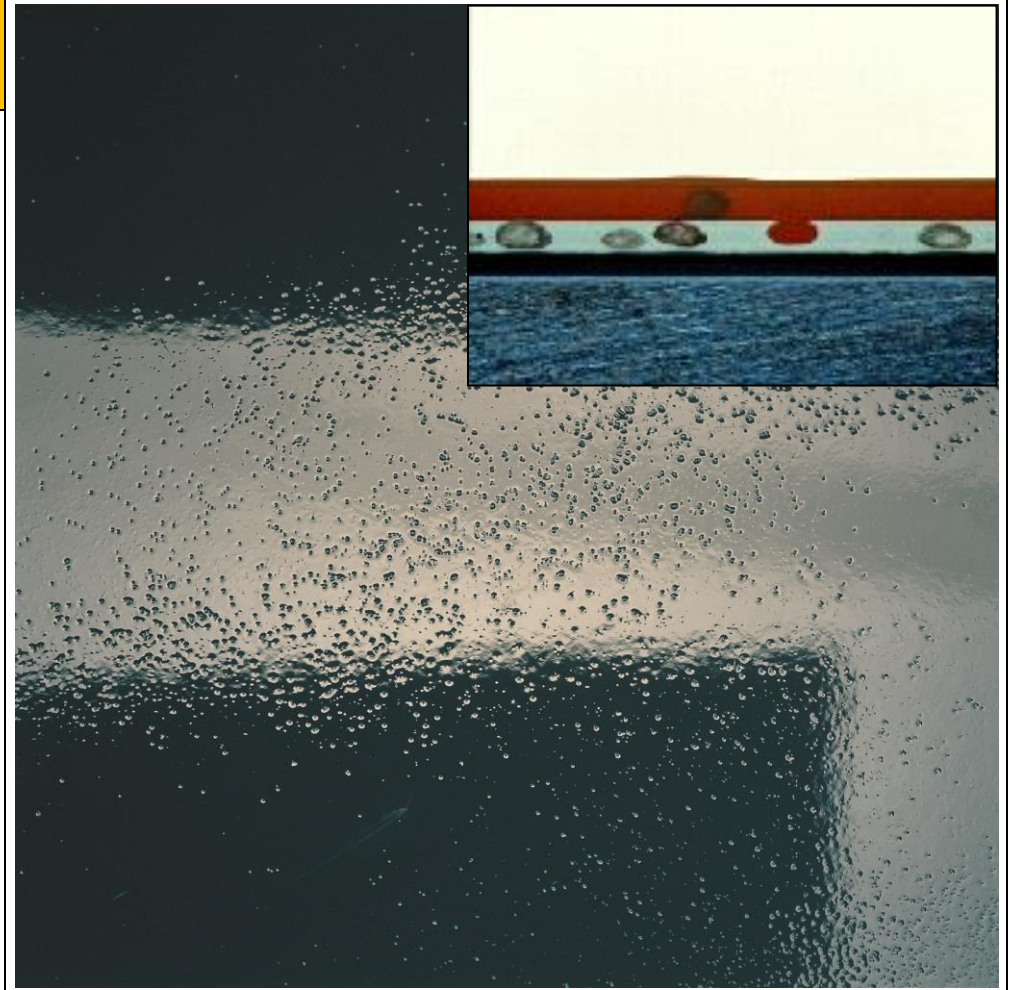
Body filling: air becomes trapped in the body filler during filling. Sanding will open the surface, causing small holes.

Primer / Filler: Too heavy application of (2K) filler, not respected flash off time, blow drying between coats can result in solvent pops. During sanding the filler, the solvent pops become little pinholes.

Wrong mixing technique; do not stir to avoid air inclusion.	Mix according to recommendation.
	Wrong application technique, incorrect knife angle during application.	Apply the products with recommended tools, at the right angle.
	Extension of the pot-life of the body filler.	Apply the polyester body filler before pot life is exceeded.
	Drying out of the body filler.	Close can after use. After opening a new can, mix the binder thoroughly with the bodyfiller.

Application of the paint too heavy Too much layer thickness. Too short flash-off times between application and drying. Too much airflow (formation of a viscous surface skin).	Apply the products according to recommendation and Technical Data Sheet.
	Exceeding the potlife of the paint.	Use the product within the pot life, according Technical Data Sheet. Do not attempt to extend the pot life by adding extra Reducer.

Sand the paint or filler to remove pinholes as much as possible, if needed, apply filler (according to recommendations). Dry and sand the filler, and apply topcoat system again.

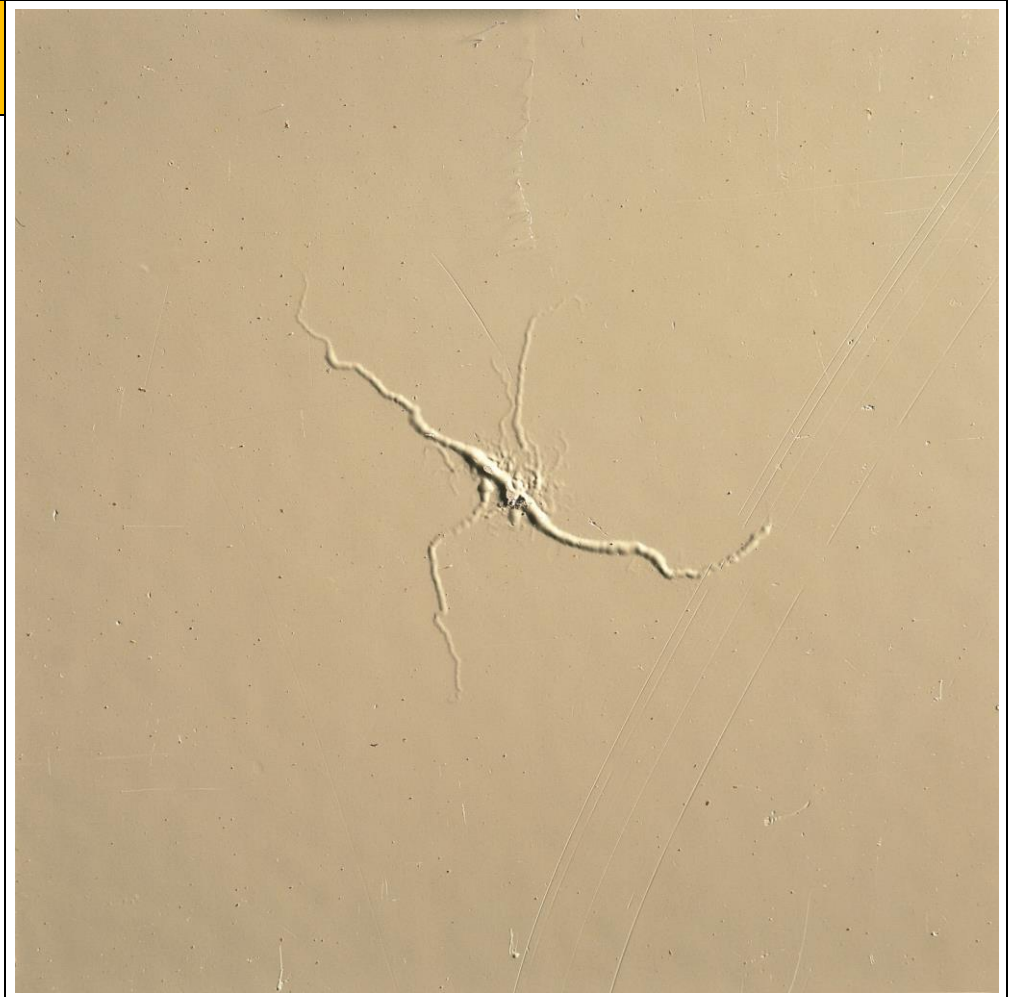
Paint system has been forced up over small areas, in strange patterns or as blisters.

When punctured we discover rust and moisture on the metal surface.

Previous rust was not properly removed.	Remove existing rust thoroughly, particularly pitted corrosion.
	Application of the topcoat directly over bare metal.	Always apply recommended primer followed with filler for optimal warranty.
	Substrate was insufficiently degreased, primer could not adhere well.	Always degrease sufficiently before application of the primer, degrease according recommendations (two clean cloths, one wet one dry).
	Substrate was insufficiently degreased, contamination stays at surface, will cause blisters and results in rust formation.	Always degrease sufficiently before application of the primer, degrease according recommendations (two clean cloths, one wet one dry).
	Wrong mixing ratio. Influences the cross linking so, no optimal adhesion and rust protection.	Mix according Technical Data Sheet.
	Insufficient layer thickness was applied.	Apply according to Technical Data Sheet recommendation.

Premature application of products after degreasing. Condensation forming at substrate.	In humid conditions, let panel acclimatize before applying primer / filler / top coat .

Remove entire system, remove thoroughly all rust (preferably by sand- blasting), degrease and apply total new system

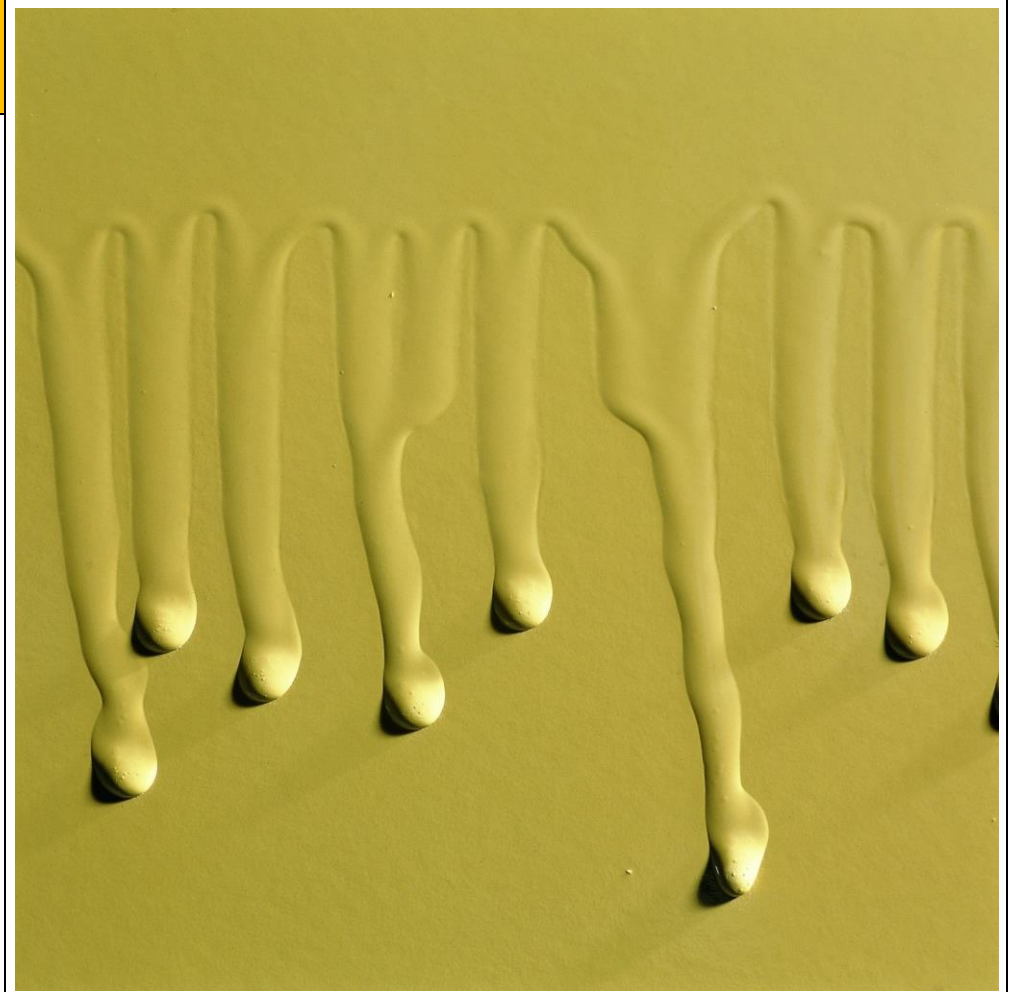
Through uneven thickness of the coat in some places, runs can be seen, mainly on vertical surfaces.

The accumulation of paint in the area is so great that the paint coat starts to run while still wet.

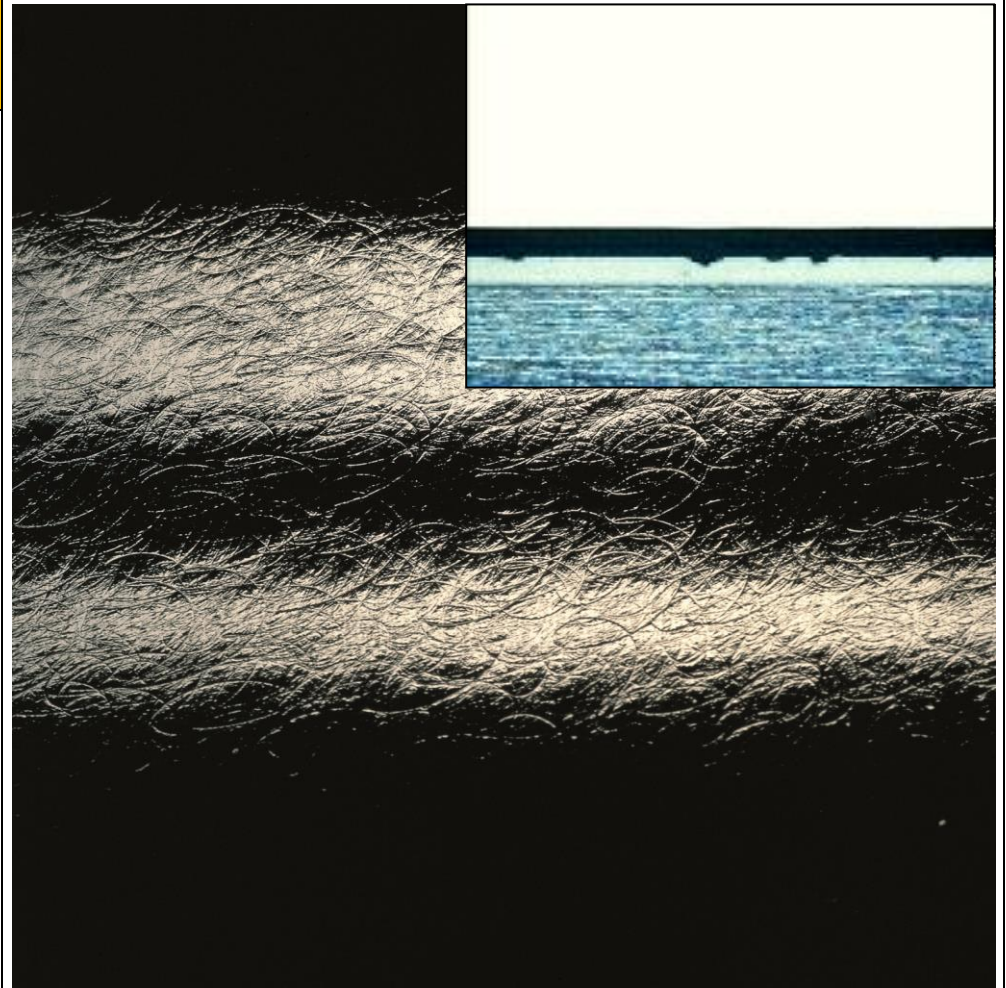
**Fine scratches become visible in the finish.
Problem can reveal immediately or after a period of time.**

Often sanding patterns of sanding machine or block is visible.

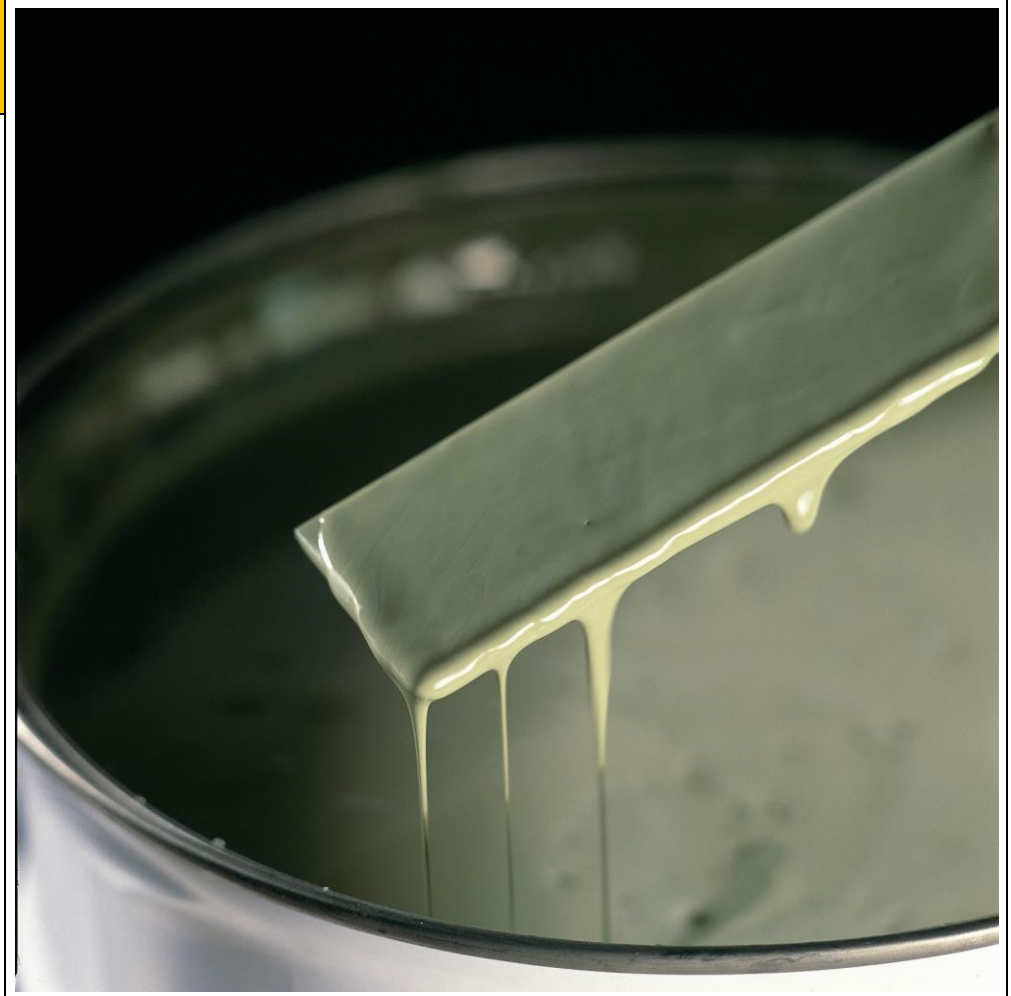
Extreme settlement is also called hard-caking.

A little settlement is also called soft-caking.

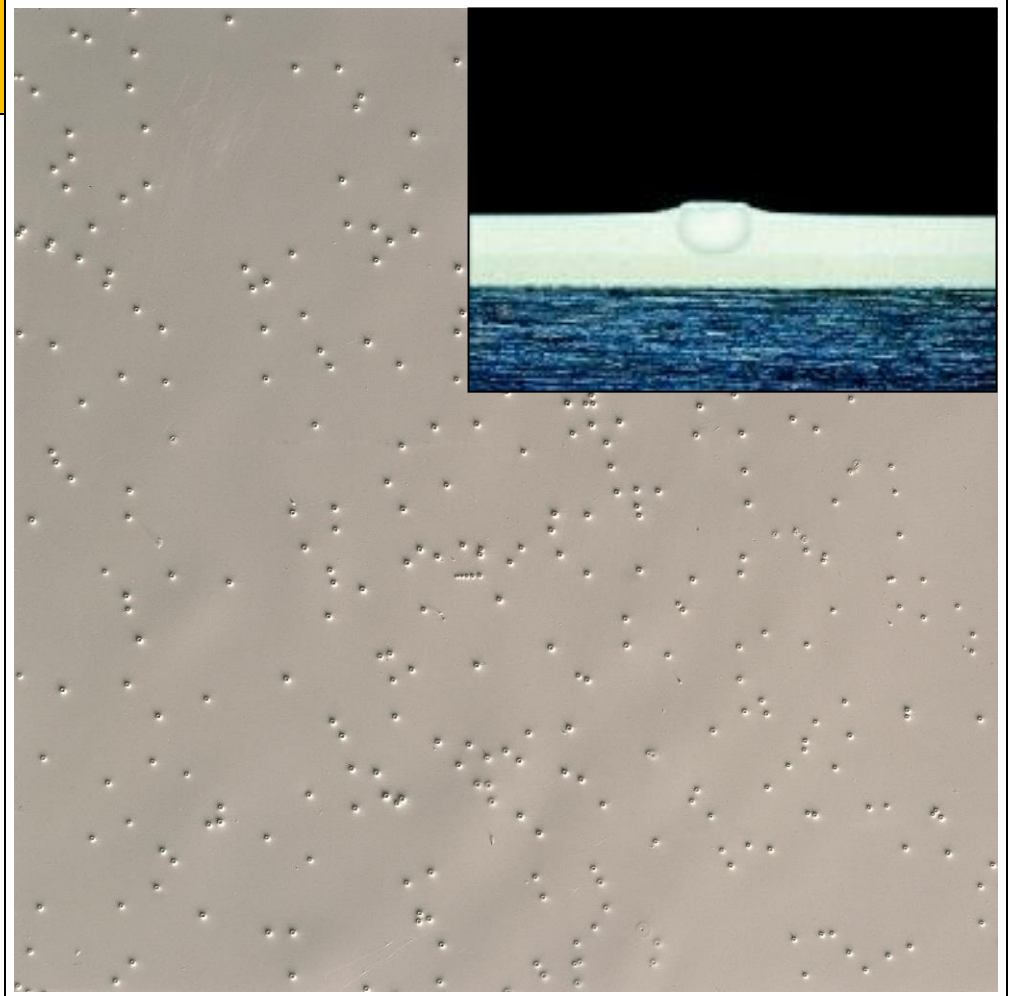
Small pops (open on top) can be seen on the freshly dried surface.

Solvents becoming trapped inside the paint film and will “pop” open during or after drying of the topcoat.

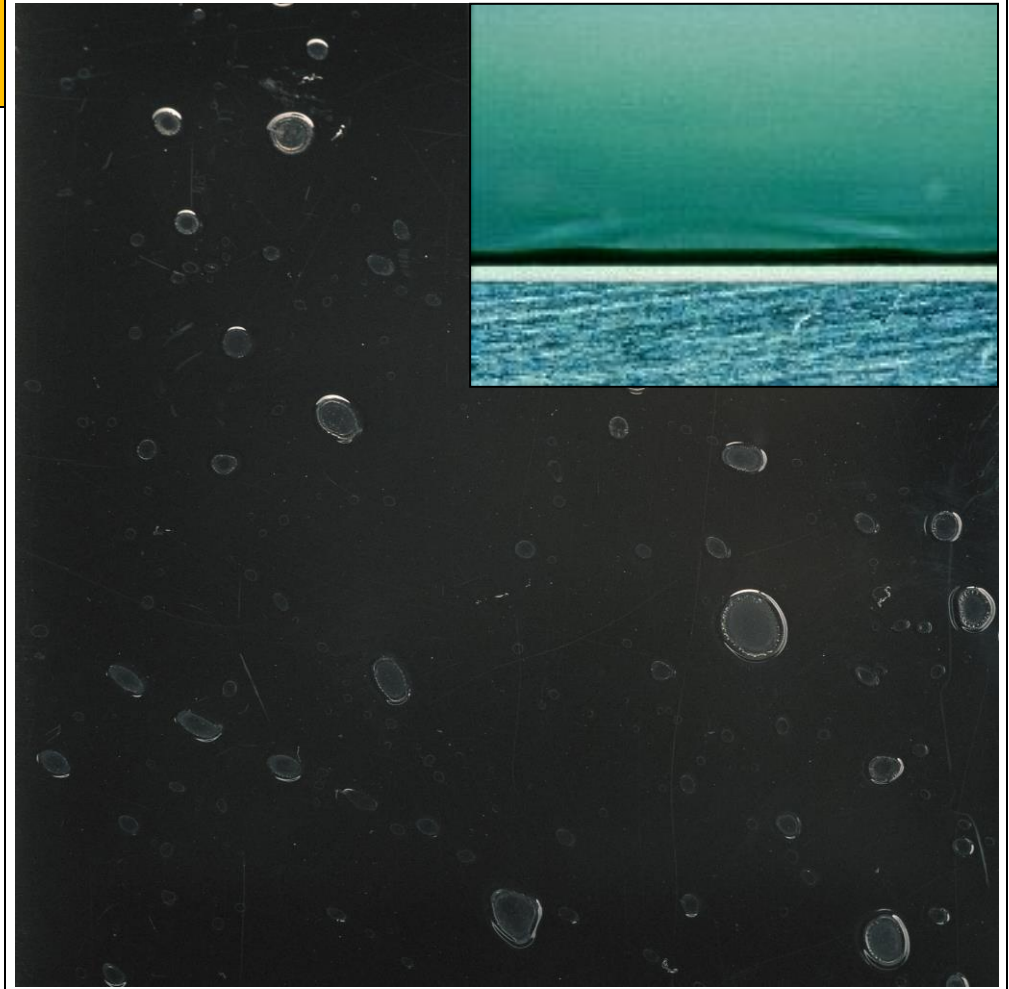
The edges of evaporated water droplets can be seen on the paint.

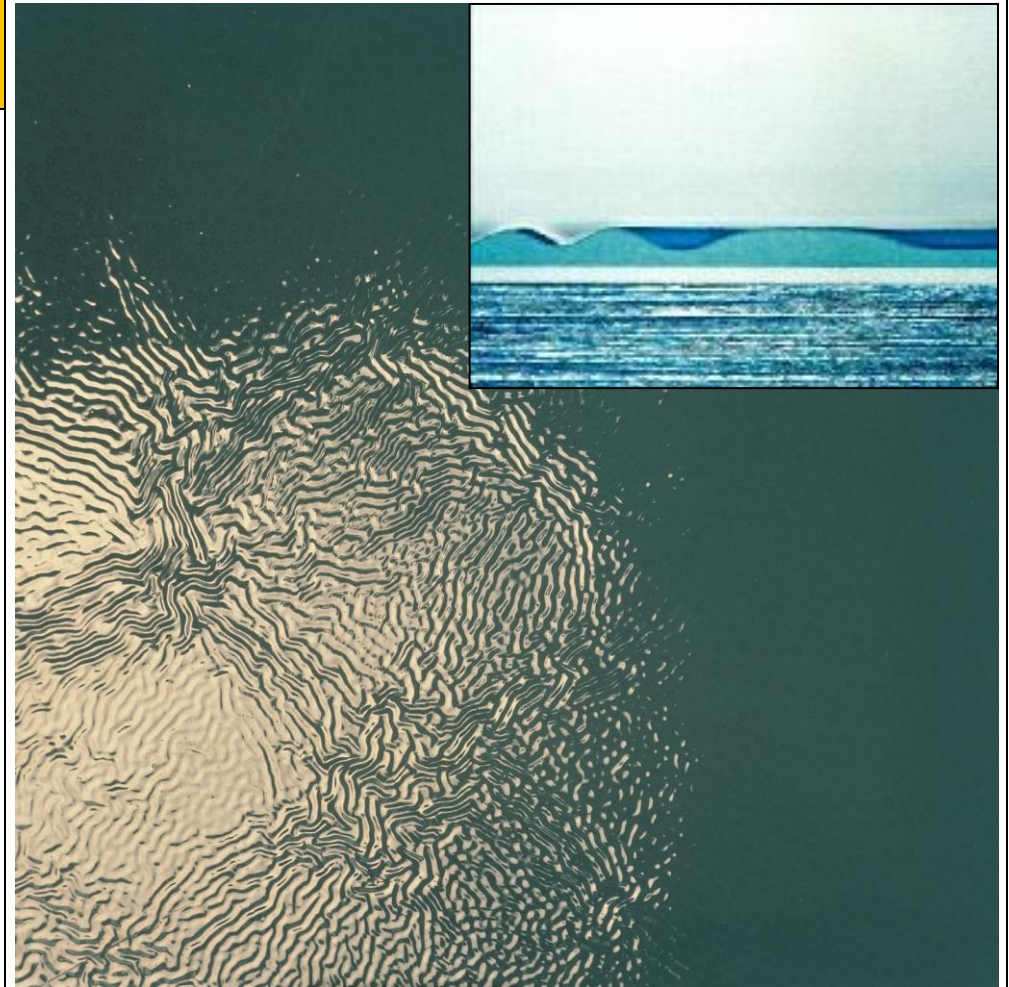
The paint surface acquires a finely waved appearance.

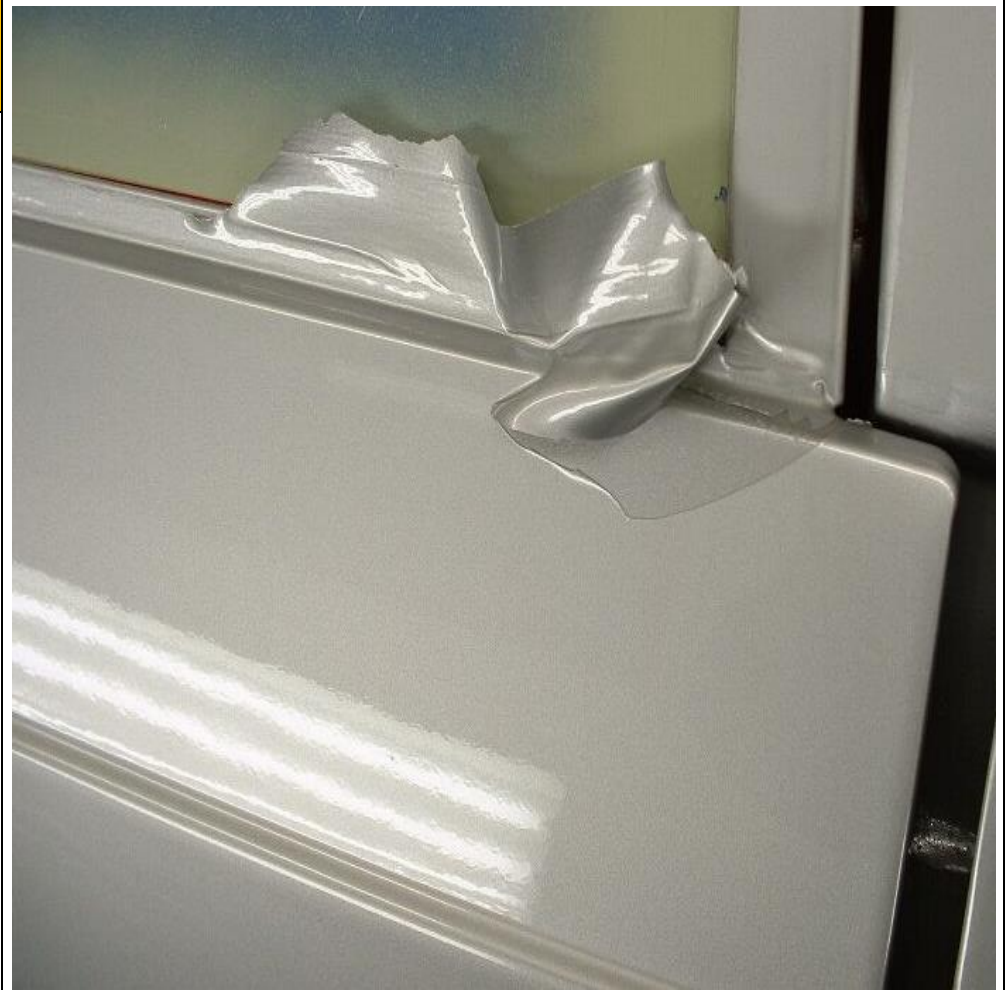
Poor adhesion of the clearcoat may show immediately after application and drying of the paint, but it may also develop after some weeks or months.
