Address of Site: Convent Field, Ham Lane, Lewes. TQ41710956

Date: 4th September 2017

A GPR survey on Convent Field, Lewes

by David Staveley

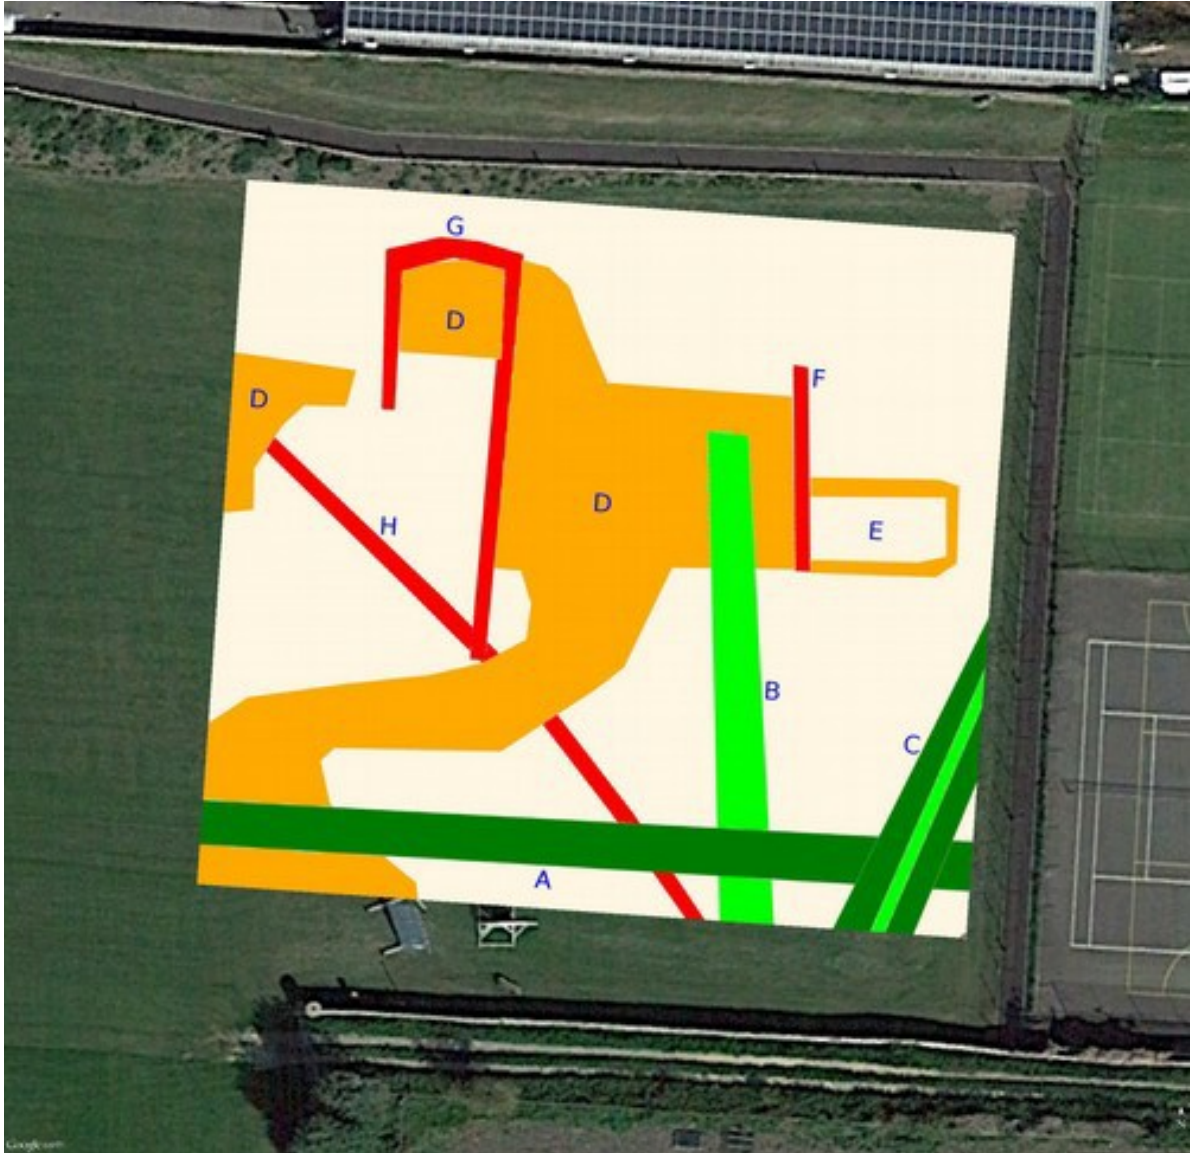
Negative cut features are shown in red.

More solid features are shown in light green.

Less solid features are shown in dark green.

The area of possible hard standing is shown in orange.

A) This feature is a very broad ditch. It appears quite close to the surface at 2ns (~10cm) and is visible in the western part to a depth of around 25ns (~100cm) where it seems to have a roughly V shaped profile. It seems to be below, and earlier than, feature D, and the material from that feature fills feature A. making it more visible at depth in the area of feature D. The relationship with feature H is uncertain, but H is probably later and cuts this feature. This feature cuts feature B and is later than it. Feature C is later than feature A and cuts it. This feature is mostly likely a continuation of the large field drain shown on the lidar just to the east of the survey area, which has since been backfilled.

B) This feature seems to be a metallised trackway. It starts to make an appearance at 8ns (~30cm) to the southern end and disappears around 20ns (~80cm). It is earlier than both features A and D. Feature A cuts it, feature D is just at a higher level.

C) This feature seems to be a utility, with a wide excavation trench associated with it. It is visible from the surface, and hence is most likely modern, and continues at least to the recorded depth of 30ns (~120cm). The cut for this feature may be wider than is shown, but the clearest cut is shown on the interpretation image. This feature cuts feature A.

D) This is a very complex multi-part feature, which the interpretation image does not do full justice. It is a layer of semi-solid material of varying thickness and depth. It appears from around 3ns (~10cm), mainly to the south-west and continues to a maximum depth of around 18ns (~70cm). The place where it appears the deepest is centred on the letter H on the interpretation image, where it appears to sink in a bowl shape not otherwise shown on the image. This may be due to subsidence, but is more likely more flat than it appears, but appears to sink in this area due to the wave velocity changing due to water leaking from feature H. The eastern part has a fairly rectangular form, but the western part is more amorphous. This feature is later than features A and B, and probably related in some way to feature E. As for interpretation, this feature may be a large area of hard standing, but another possibility is a dump of rubbish. Speaking to a groundman while the survey was taking place, it is known that there was a rubbish dump to the south-west. It may be that dump extends into this area also.

E) Seemingly related to the more regular eastern part of feature D, this slight rectangular feature appears from around 5ns (~20cm) to a depth of 10ns (~40cm). It has the horizontal appearance of a foundation, but its vertical profile is too weak and insubstantial to be a building. It is most likely an oddly formed extension to feature D.

F) This negative cut feature may extend further north and south, but is only visible in this area due to the presence of the features either side. It is most likely related to those features, being on the same alignment.

G) Another negative cut, similar in form to feature F

H) This is probably a small utility cut. It's relationship to the other features is uncertain, due to a lack of clarity on the results, but is most likely later than them. It may be a water pipe that is leaking around the point marked H.

Suitability for a bonfire site is variable across the site. The south-east corner should be avoided. If feature D is a rubbish dump, that may be ignited by extreme heat, but if feature H is leaking water, that would mitigate the situation. There doesn't appear to be any archaeological features important enough to be affected by a bonfire site.*

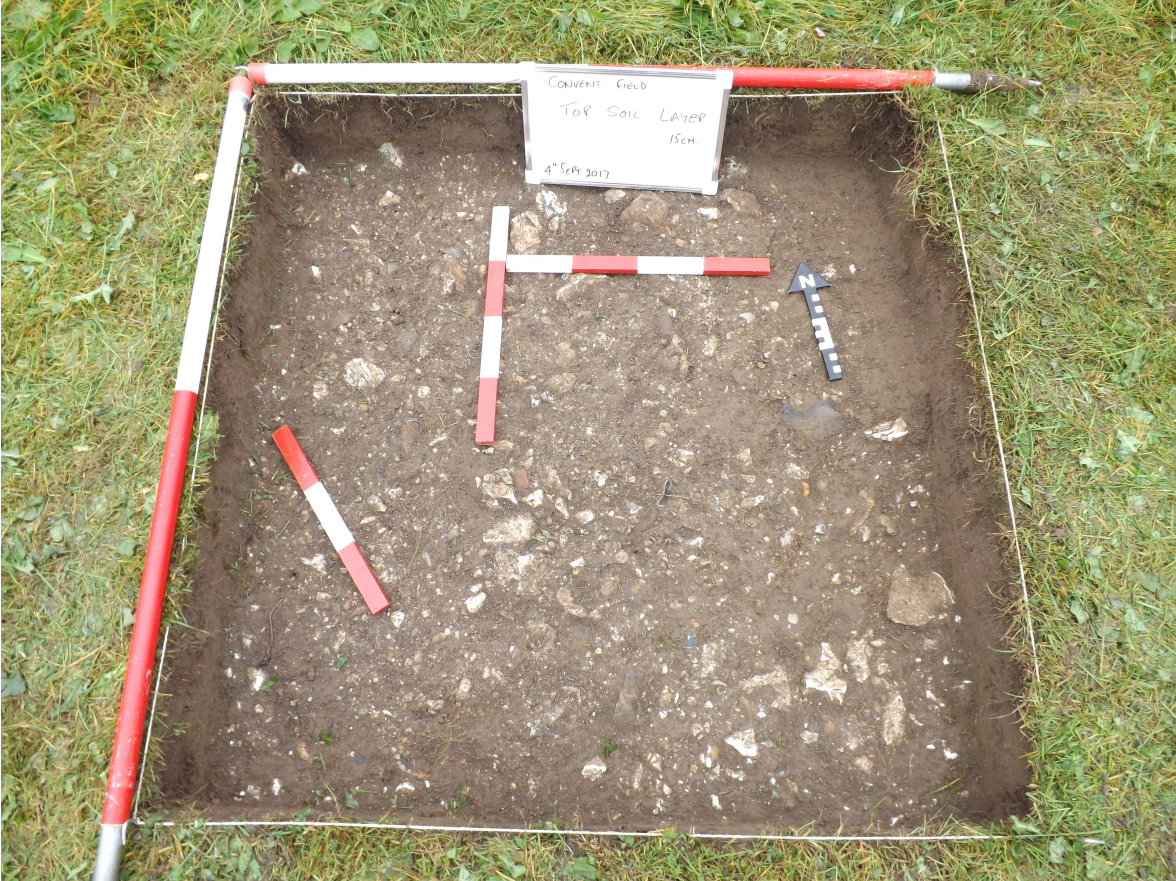
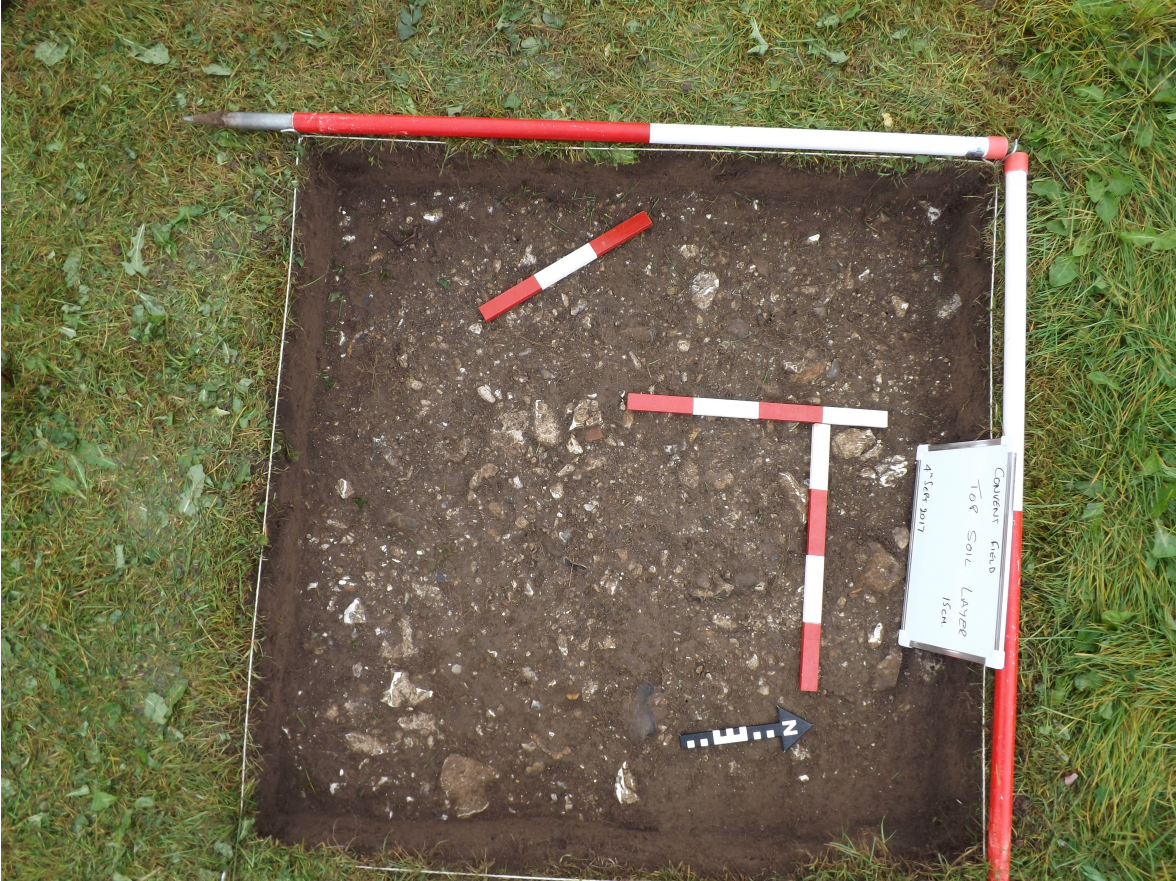
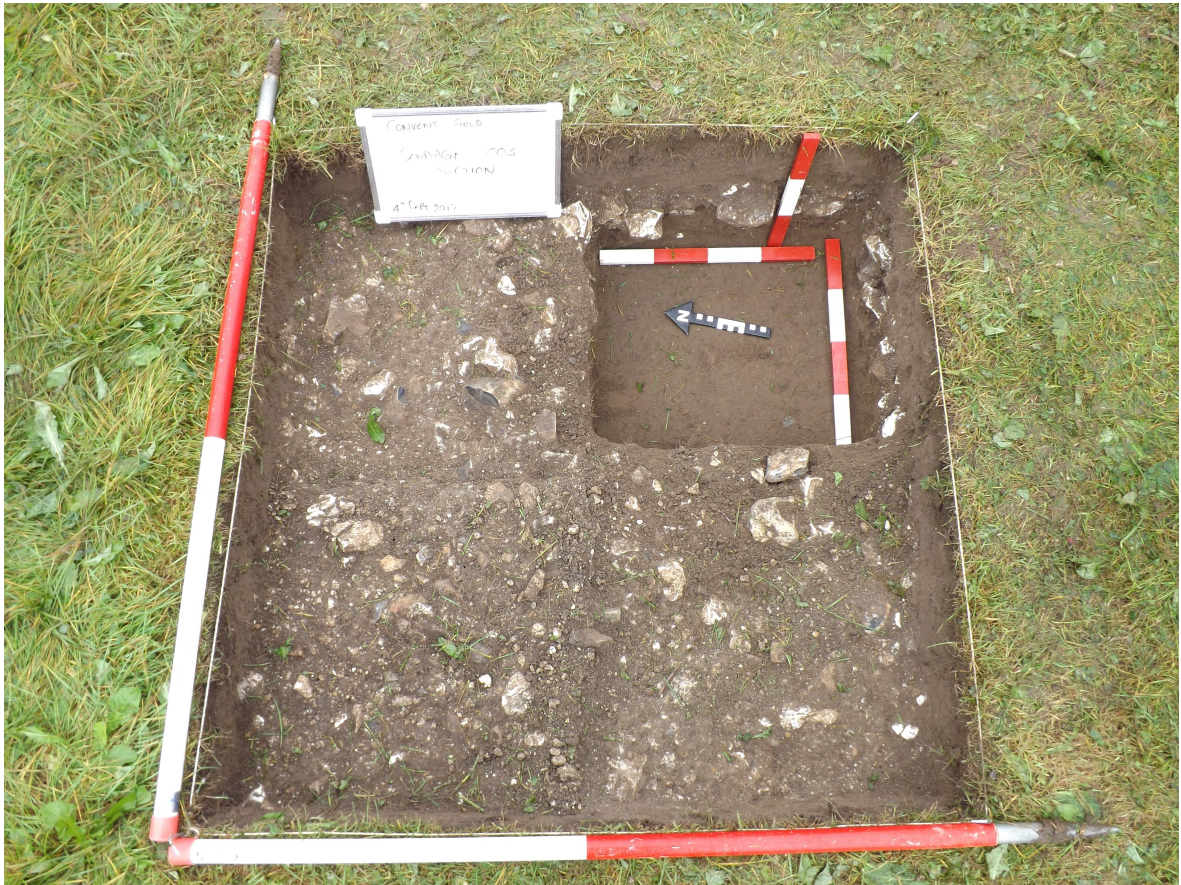
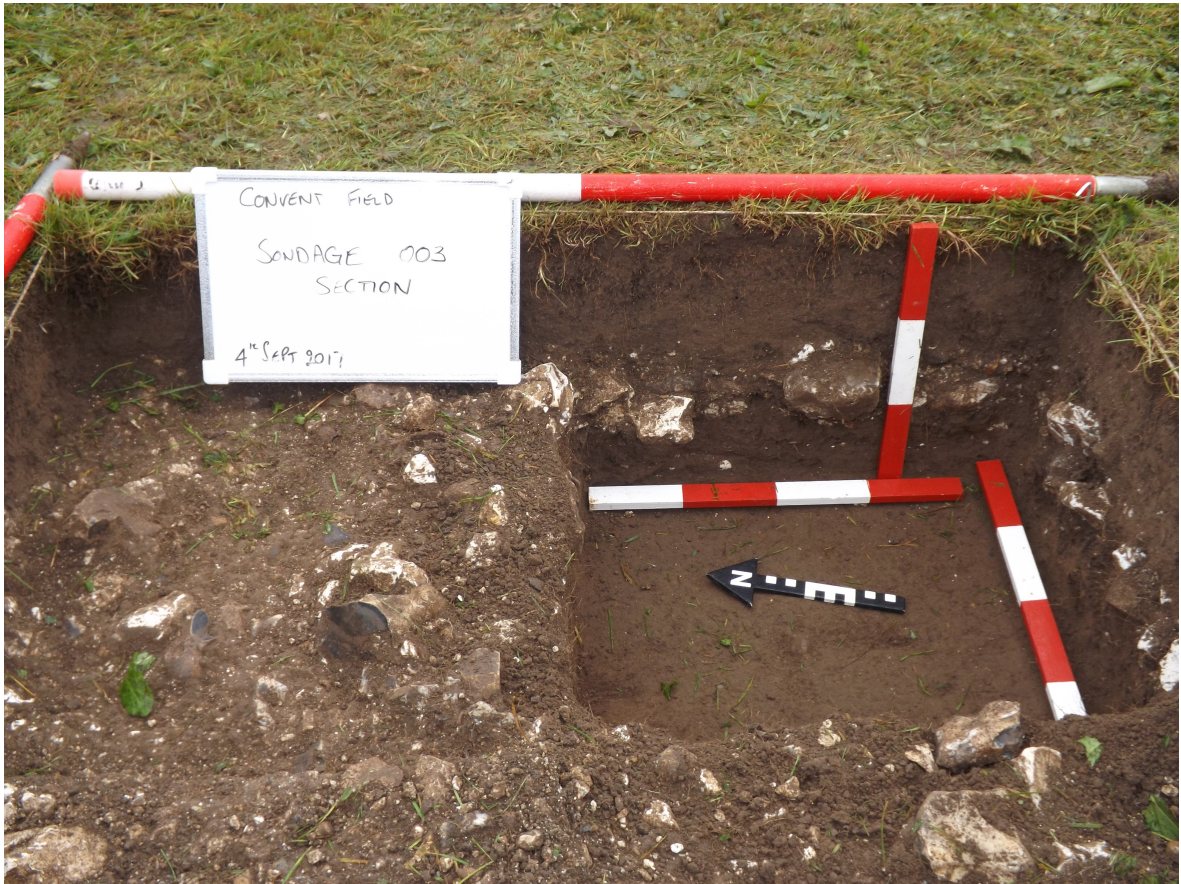
Excavation Photos

The next 5cm consisted of more coarse components, 3 – 5 % flint and chalk. This increased after 5cm to 75% flint, chalk and mortar. This was a solid surface and may have been a compacted floor or yard surface.

A 50cm x 50cm sondage was dug to a depth of 30cm in the south east corner of the test pit and showed that the floor surface had an average depth of 7cm. Below this the soil was dark and firm and contained no coarse components or finds.

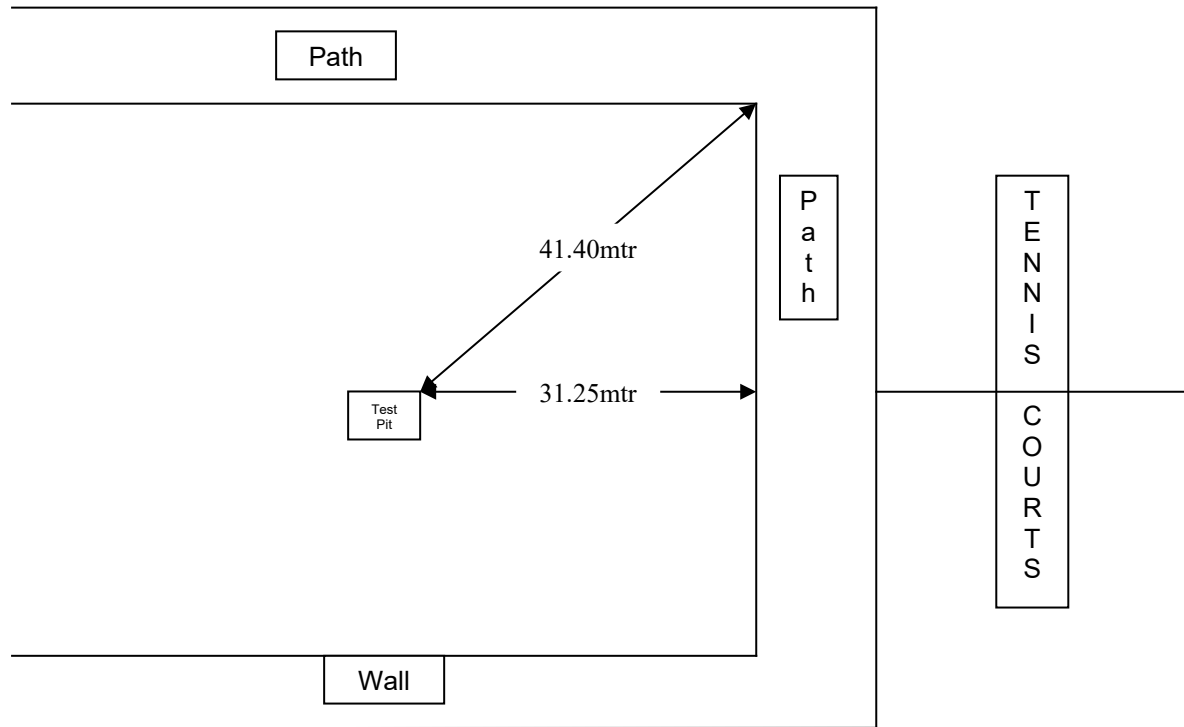
Convent Field Test Pit Location.

41.40mtrs from the corner gate.

31.25mtrs from the fence and between the two tennis courts.
