# CV joint spacers

This is for all of us who lift the van, whether you have a Syncro or not.

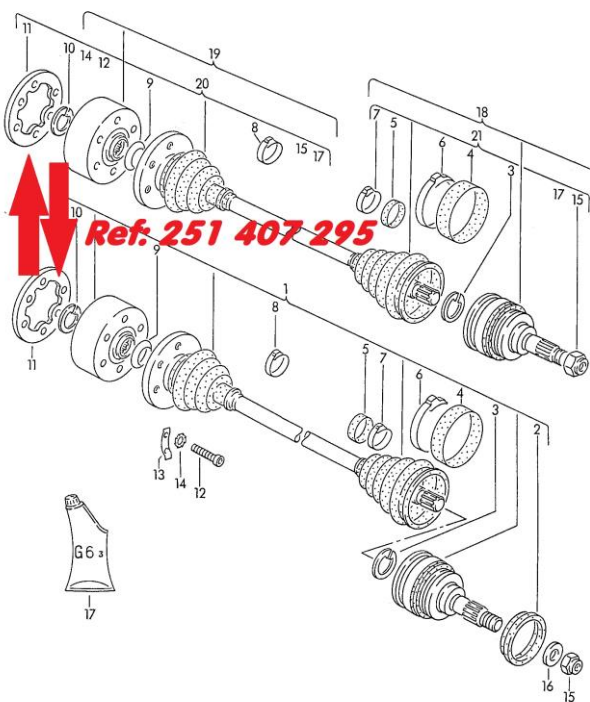
-The second reason is that when lifting, we lengthen the bearings. If you have ever had a CV joint near you, you will have seen that the splined area moves in and out. This is to absorb the up and down movements of the wheel. What is going on?? If we raise the van, we eliminate part of the possible movement, and when the wheel goes down, it stops immediately... This has a solution: The Syncros, which are already higher as standard, have spacers between the CV joint and the gearbox, once again shortening the travel of the driveshaft and leaving it as it should be. I'll give you a diagram with the reference.

So if we get into the van again we can place another one on the wheel side, or if we get into a van that is not a Syncro, that is the so-called Prerunner, because depending on the climb, one or two supplements can be placed, and this way we ensure that we will have a homokinetic much longer...

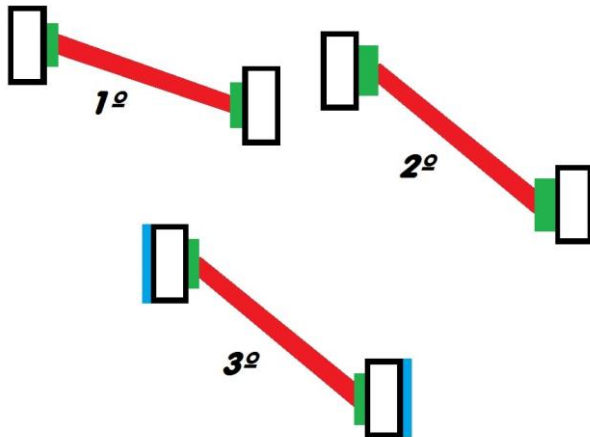
-In the 1st, the van would go in the original position, the white rectangles are the CV joints and the green ones are the CV joint cage, where the balls go, which moves axially in and out, absorbing the length differences that occur. occur when the suspensions are operating.

-In 2nd position, we increased the height of the van, so we “forced” the cages to go more outwards as a starting point. They have less useful travel, so they will be able to stop easily in suspension extensions.

-In 3rd position we placed separators between the CV joints and the box, and between the CV joints and the wheels, correcting the previous difference.

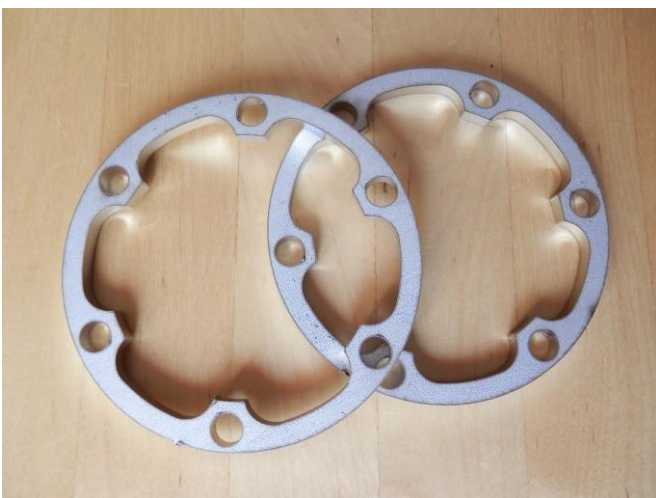
Here are the supplements:

And so they remain. They have longer screws. We went from M8x48 to M8x55, and respecting the original hardness, which is 12.9.

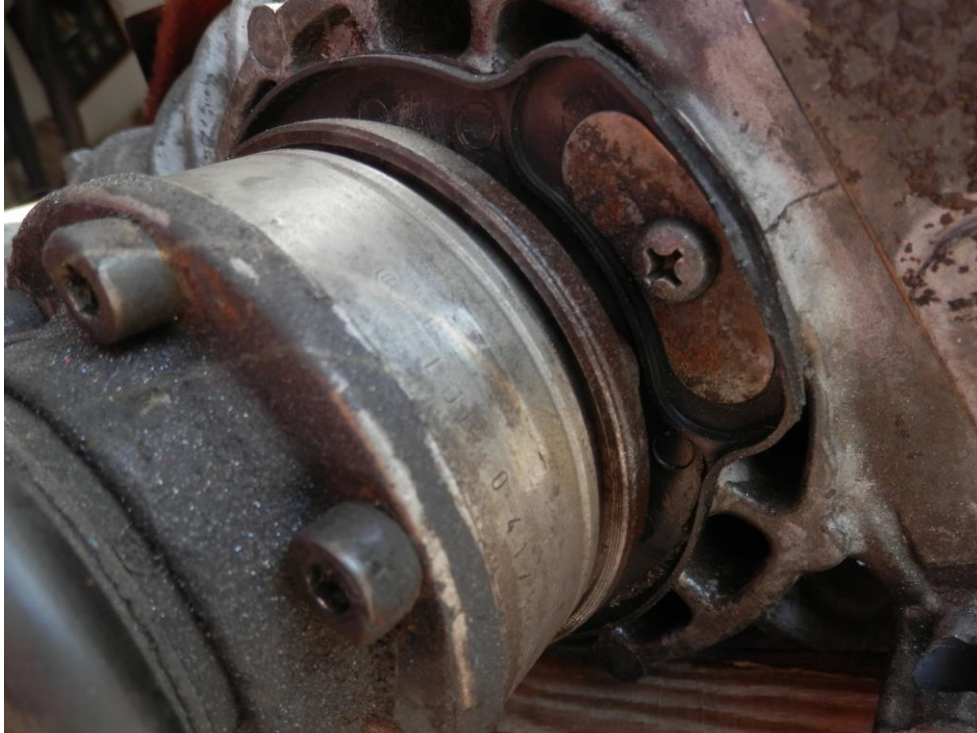
The problem is that over time one of two things usually happens: the grease dries out, forming deposits in certain areas, or water enters and liquefies. Either way, you end up losing properties.

If we want to protect the CV joints and at the same time our wallet, one afternoon when we are bored, we dismantle a transmission shaft and even without dismantling the CV joints or dismantling the balls or anything, we remove the dust cover towards the rear and this way we can clean it well with a brush and diesel, then blow out all the remains and re-lubricate with lithium grease (about 80 or 100 g per CV joint)
