## Assessors Guide to Reviewing Photographic Evidence

# Assessors Guide to Reviewing Photographic Evidence

## Overview

- Provide guidance on what OCDEAs should review in photographic evidence supplied for Appendix B of Approved Document L 2021.

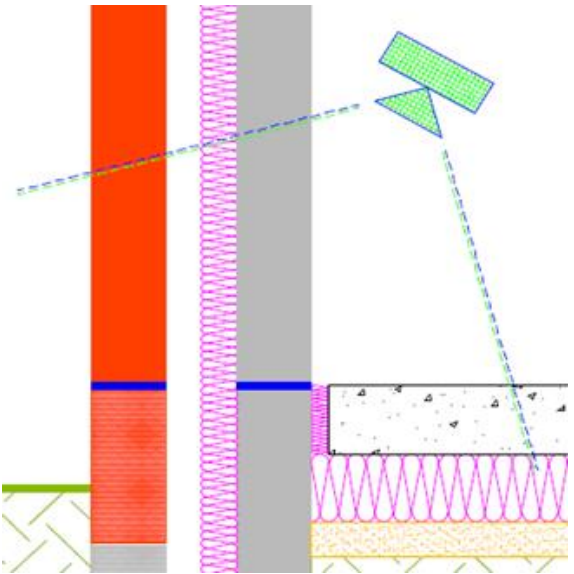
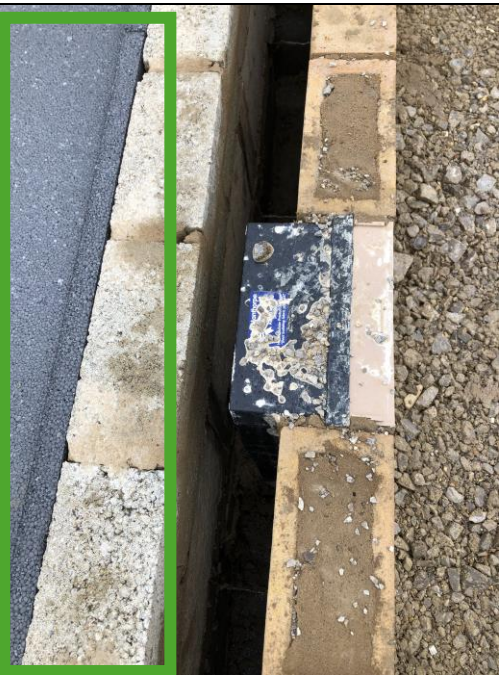
AD L Photo Reference	Example direction of Photograph	Example Photographs	What should the OCDEA check from the photographs?	What if the photograph shows a difference to the assessment?
<p>1A – GF perimeter insulation</p> <p>(SAP junction reference E5)</p>

<p>✓ Photographs should show a strip of insulation in contact with the external walls around the perimeter of the ground floor prior to floor screed.</p>	<p>✗ If the perimeter insulation is not visible/present or photographs are missing inform the builder.</p> <p>It is likely that the psi value for the E5 junction would be based on perimeter strip insulation being present so therefore this would need to be changed to either a psi value model that doesn't contain perimeter strip insulation or the SAP default psi value.</p>
<p>1B – Door threshold</p> <p>(SAP junction reference E3)</p>

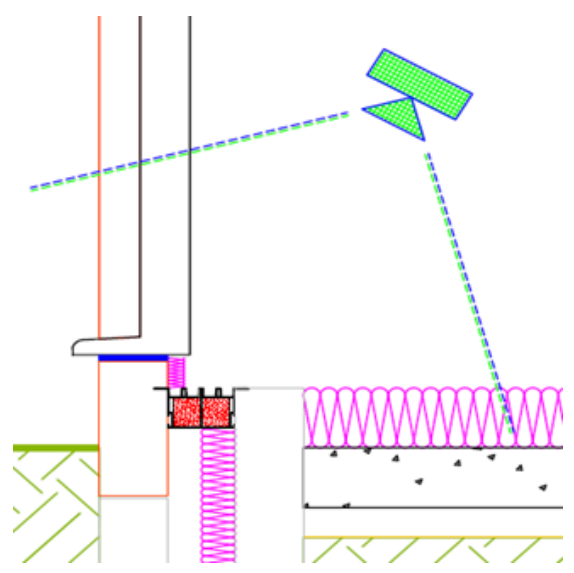
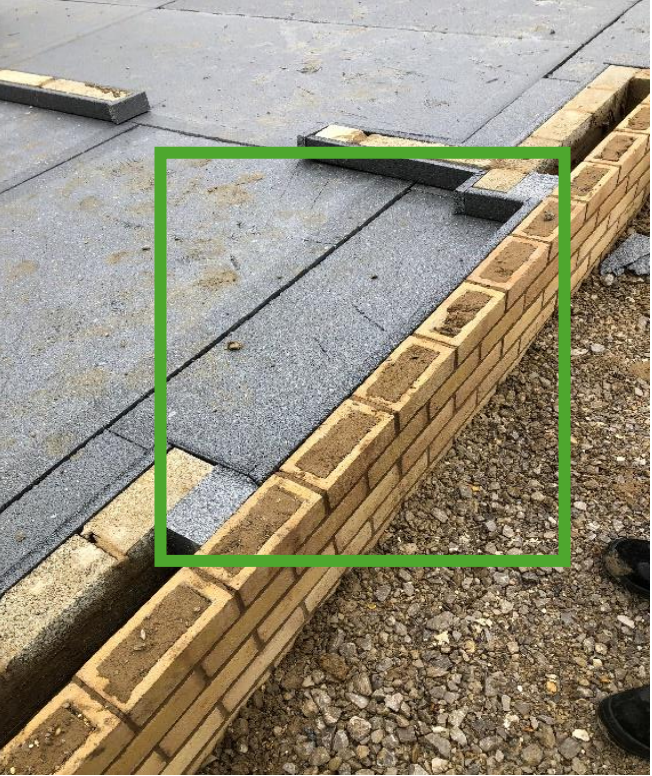
<p>✓ Photographs should show perimeter insulation or insulated cavity closers in the threshold zone for each door type.</p>	<p>✗ If the perimeter insulation/cavity closer is not visible/present or photograph is missing inform the builder.</p> <p>It is likely that the psi value for the E3 junction underneath external doors would be based on strip insulation so therefore this would need to be changed to the SAP default psi value.</p>

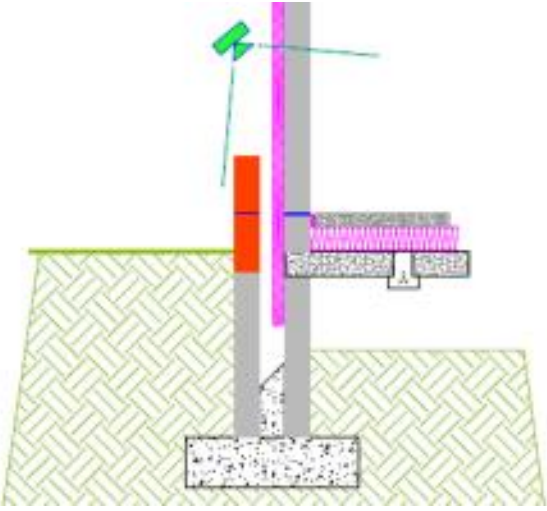
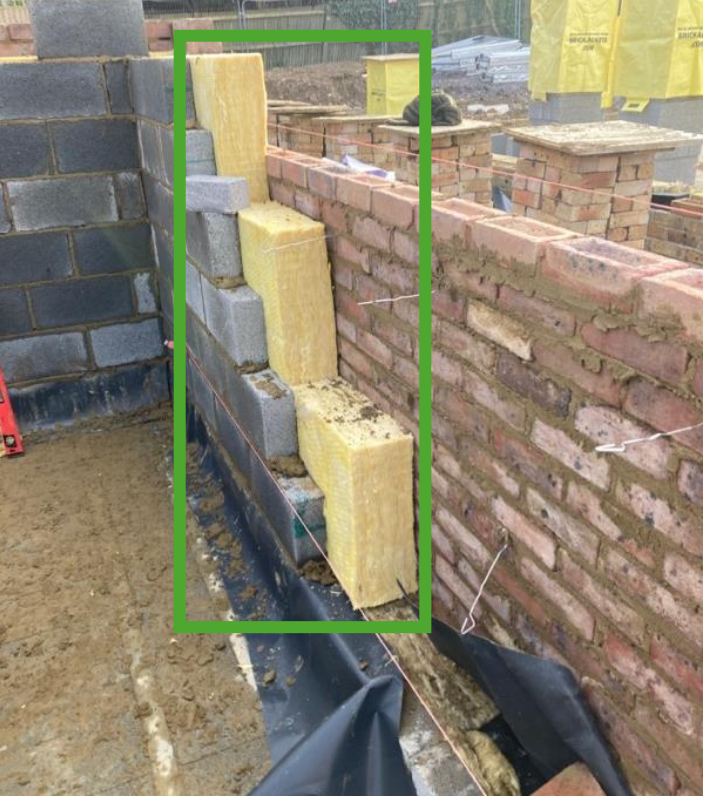
AD L Photo Reference	Example direction of Photograph	Example Photographs	What should the OCDEA check from the photographs?	What if the photograph shows a difference to the assessment?
<p>2A - Ground floor to wall junction.</p> <p>(SAP junction reference E5)</p>

<p>✓ Photographs should show insulation running above the DPC up the external wall.*</p> <p>✓ The generic insulation type* (e.g. PIR, mineral wool slab) should match what has been used in u-value calculations and psi value models.</p> <p><i>*Where blown insulation is used there will be no insulation visible in these photographs.</i></p>	<p>✗ If the generic insulation type* differs from the u-value calculations and/or psi value models or photograph is missing inform the builder to determine what specific type of insulation was used.</p> <p>The u-value calculations for the external walls should be changed to reflect the specific insulation type used.</p> <p>It is likely that the psi values for any external wall junctions (E1-E25) would need to be changed to either a psi value model based on the type of insulation used or the SAP default psi value.</p> <p><i>*Where blown insulation is used there will be no insulation visible in these photographs.</i></p>

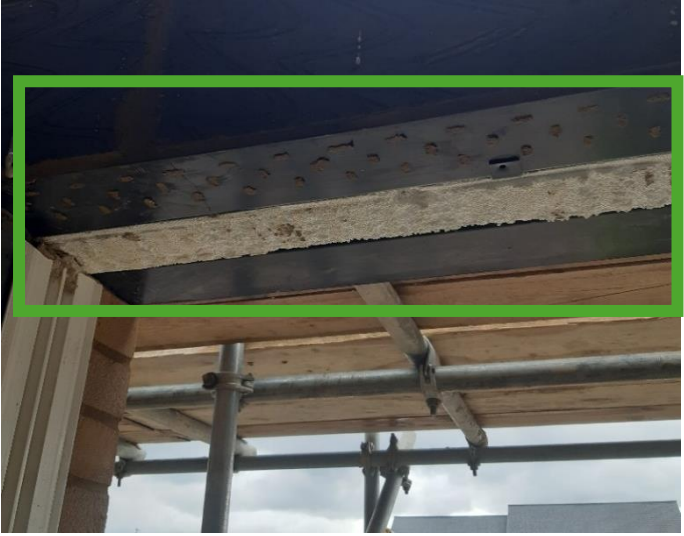
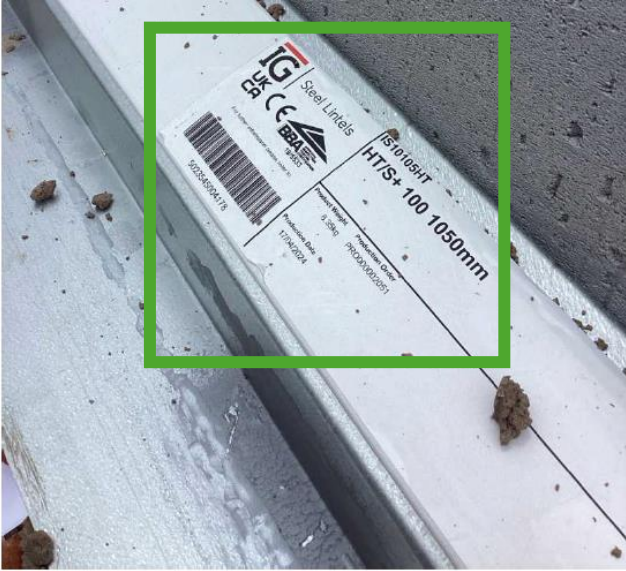
<p>2B - Structural penetrating elements</p> <p>(SAP junction reference E1, E2, E23)</p>

<p>✓ Photographs should show structural elements that penetrate wall insulation. Typically this includes lintels or balconies with penetrating supports.</p> <p>One photograph per element type, e.g. lintel type, is sufficient. The photograph should be used to demonstrate the type of lintel, this could be achieved by taking a photograph of the sticker stating the manufacturer and model of lintel.</p> <p>For example, where different lintels are used a photograph would be required for each type including openings in dormers.</p>	<p>✗ If the lintel is different to the one used in the SAP assessment or photograph is missing inform the builder.</p> <p>The psi value for the E1/2 junctions should to be changed to the psi value for the relevant type of lintel used or the SAP default psi value in this scenario.</p>

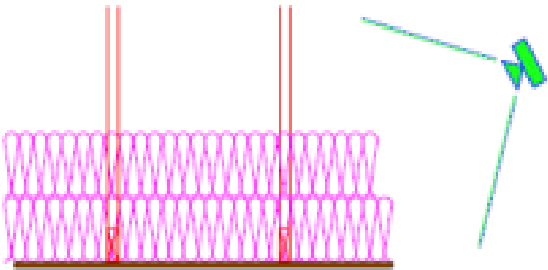
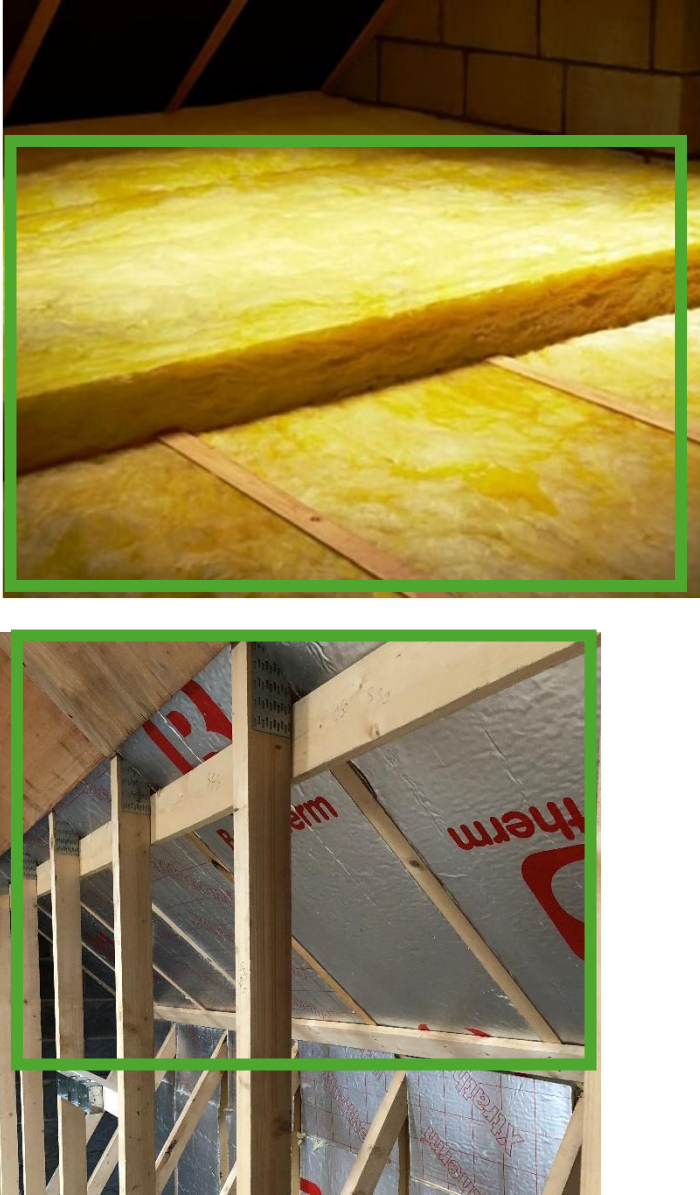
AD L Photo Reference	Example direction of Photograph	Example Photographs	What should the OCDEA check from the photographs?	What if the photograph shows a difference to the assessment?
3A - Joist/rafter level

<p>✔ Photographs should show the generic type (e.g. mineral wool, PIR) of insulation installed.</p>	<p>✘ If the generic insulation type shown differs from the type in the u-value calculations used in the SAP assessment or photograph is missing inform the builder and determine what specific type of insulation was used.</p> <p>The u-value calculations should be updated to reflect the insulation that has been installed.</p>

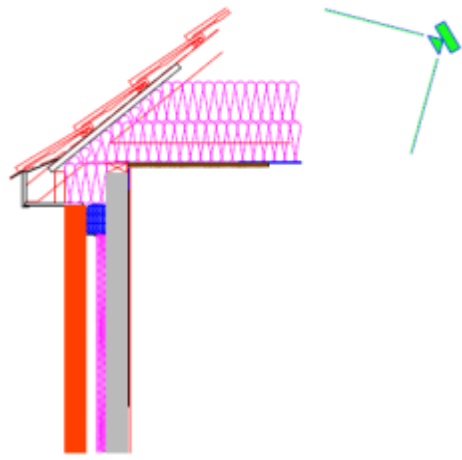
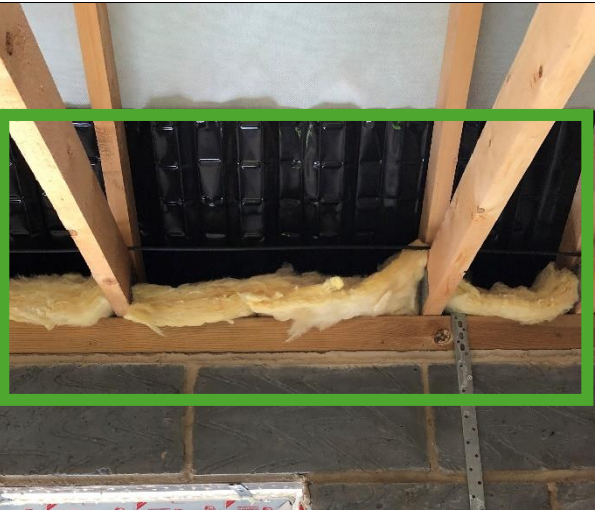
<p>3B - Eaves edges</p> <p>(SAP junction reference E10, E11)</p>

<p>✓ Photographs should show insulation is present in the eaves to minimize cold bridging.</p>	<p>✗ If the insulation is not present in the eaves or photographs are missing inform the builder.</p> <p>It is likely that the psi value for the E10/E11 junction would be based on roof insulation being present in the eaves so therefore these junctions would either a psi value model based on insulation not being present in the eaves, or need to be changed to the SAP default psi value in this scenario.</p>
<p>3B - Gable edges</p> <p>(SAP junction reference E12, E13)</p>

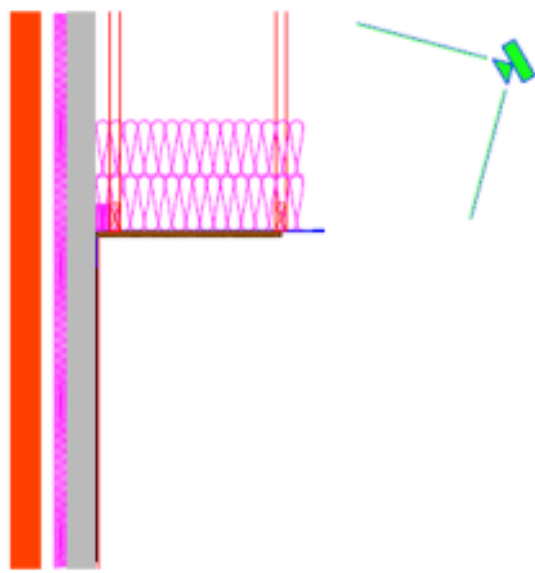
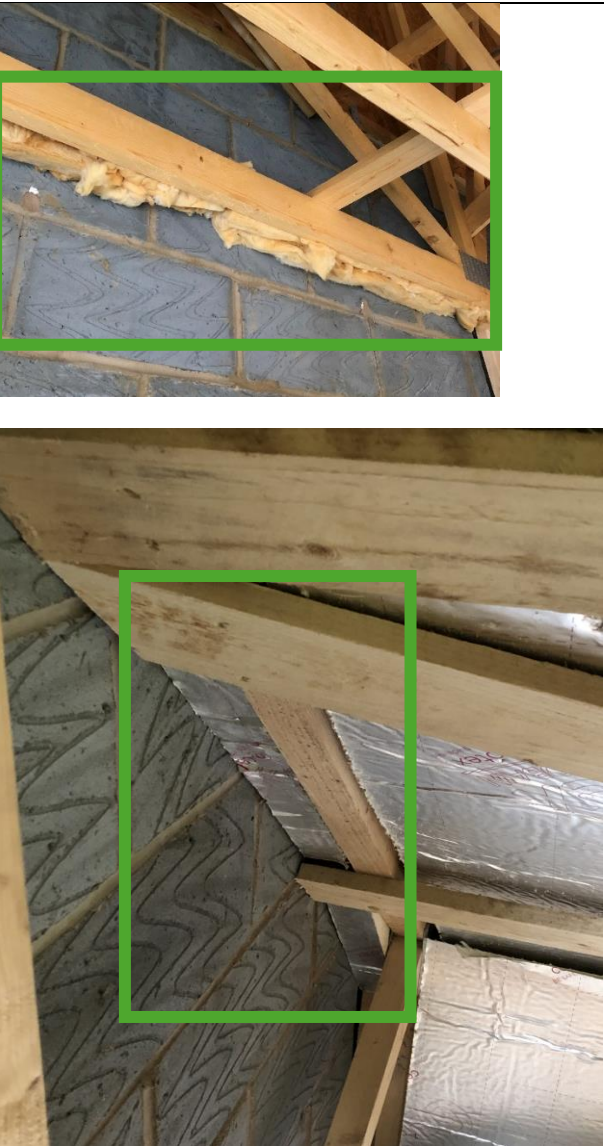
<p>✓ Photographs should show insulation between the final joist/rafter and gable walls to minimize cold bridging.</p>	<p>✗ If the insulation is not present between the final joist/rafter and gable walls or photographs are missing inform the builder.</p> <p>It is likely that the psi value for the E12/E13 junctions would be based on insulation abutting gable walls therefore these junctions would need to be changed to either a psi value model based on insulation not abutting gable walls or the SAP default psi value in this scenario.</p>

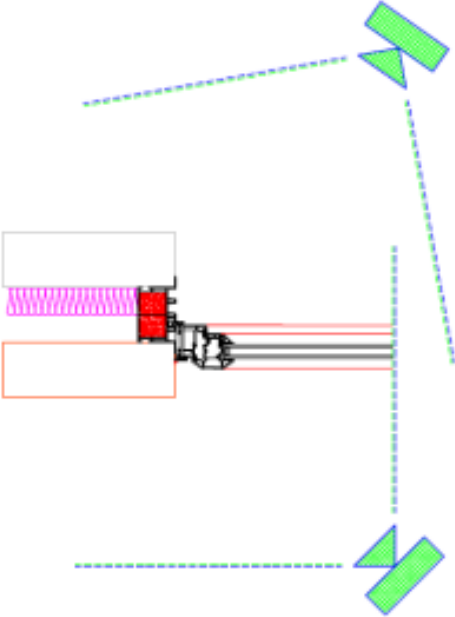
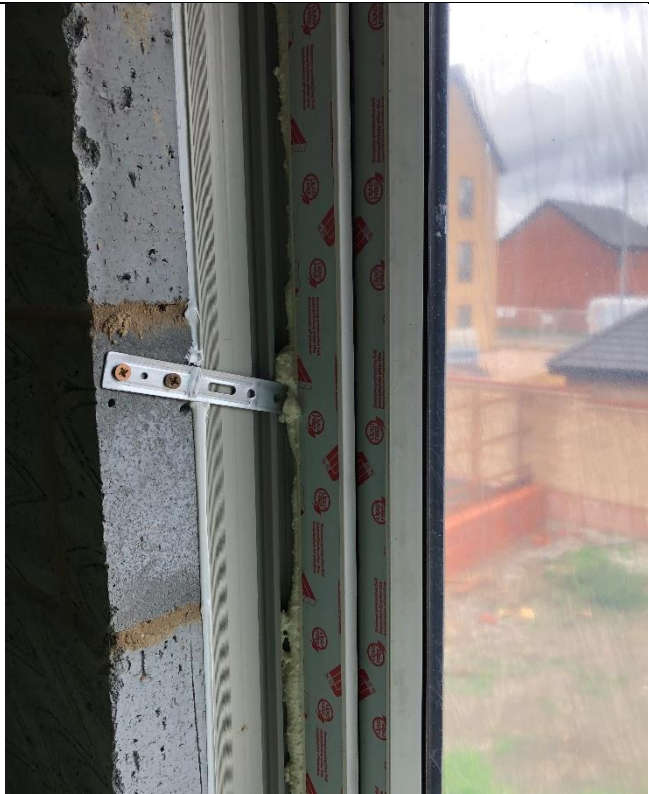
AD L Photo Reference	Example direction of Photograph	Example Photographs	What should the OCDEA check from the photographs?	What if the photograph shows a difference to the assessment?
4A/B – Window/Door positioning in relation to cavity closer or insulation line  (SAP junction reference E4)

<p>✔ Photographs should show the window/door closer is in line with the cavity closer/insulation.</p> <p>One photograph per window/door type is required.</p> <p><b>However OCDEAs do not need to comment on or review these photographs unless there is something that directly influences an area of the SAP assessment.</b></p>	N/A

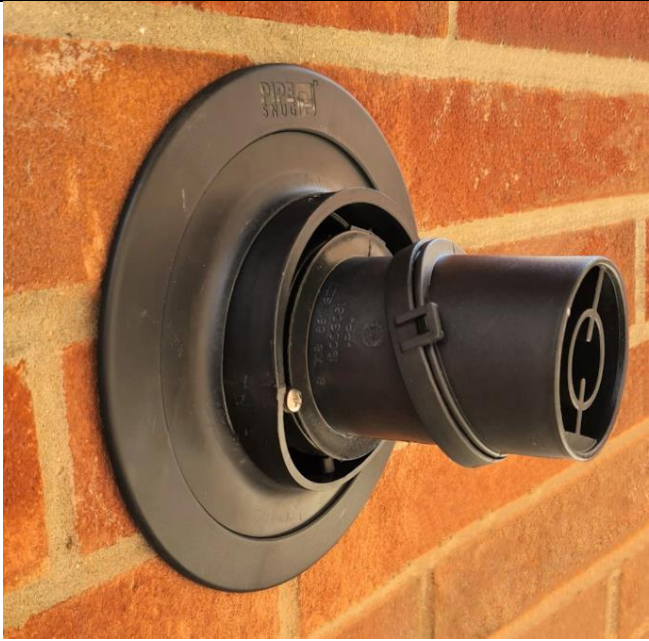
AD L Photo Reference	Example Photographs	What should the OCDEA check from the photographs?
5 - Airtightness

<p>✔ Photographs should show any area where detailing has been completed for airtightness purposes e.g. Grommets or flexible collars sealed around incoming services.</p> <p><b>However, OCDEAs do not need to comment on or review these photographs unless there is something that directly influences an area of the SAP assessment.</b></p> <p>OCDEAs will obtain the airtightness test certificate and feed the score into the SAP assessment to account for the airtightness of the home.</p> <p>Elmhurst does not believe a photograph of the airtightness test certificate, or the airtightness test being undertaken is required for this section.</p>

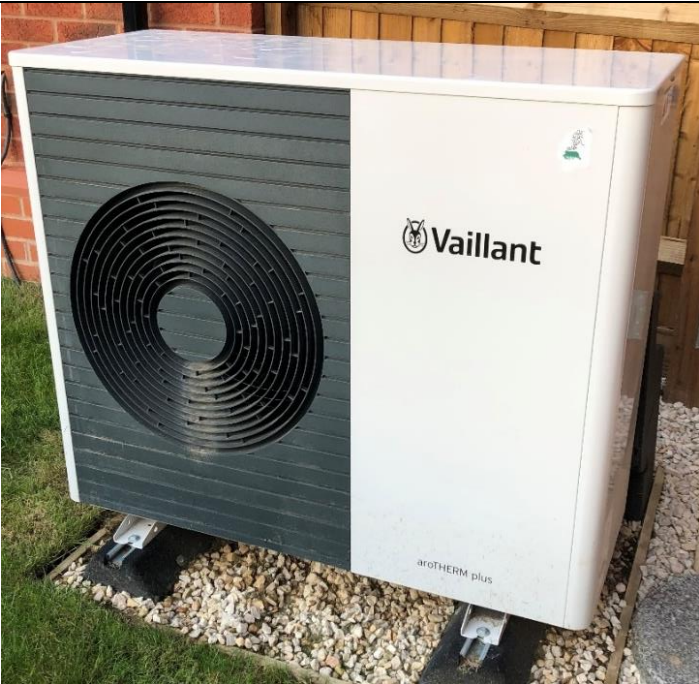
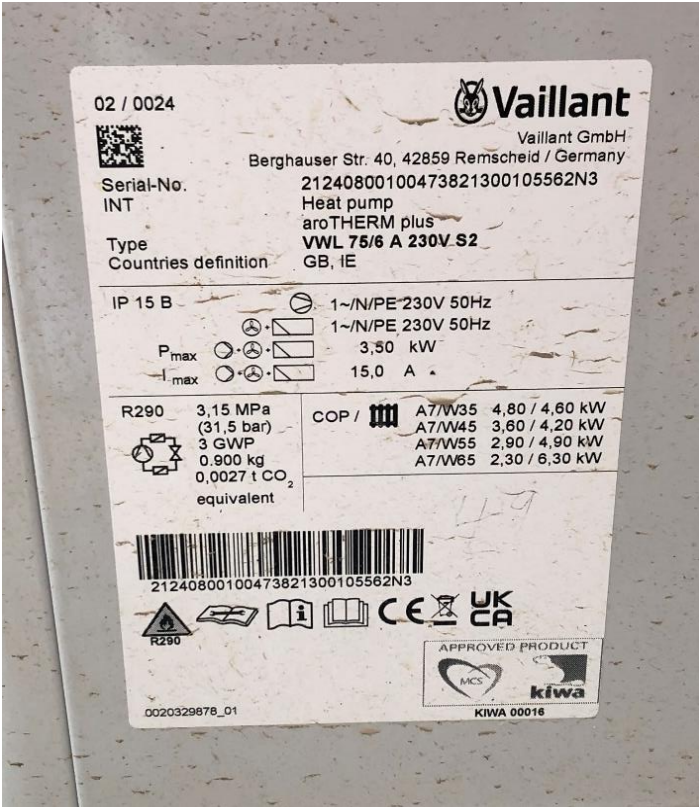
AD L Photo Reference	Example Photographs	What should the OCDEA check from the photographs?	What if the photograph shows a difference to the assessment?
6A – Building services – Space and water heating systems	<div>

</div>	<p><input checked="" type="checkbox"/> Photographs should clearly identify the manufacturer and model of space and water heating systems including the heat generator (boiler, heat pump etc.) and hot water cylinder if applicable.</p> <p>The systems shown in the photographs should be cross referenced against the SAP assessment to ensure the correct systems are accounted for within it.</p>	<p><input checked="" type="checkbox"/> If a different heating system is shown in the photographs or a photograph is missing inform the builder.</p> <p>The SAP assessment should be updated to reflect the system shown.</p> <p><input checked="" type="checkbox"/> If a different hot water cylinder is shown in the photographs or a photograph is missing inform the builder.</p> <p>The SAP assessment should be updated to reflect the hot water cylinder shown.</p>

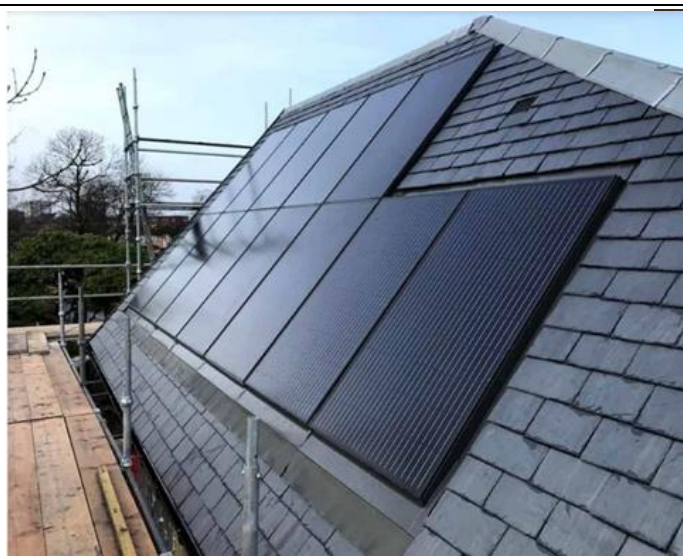
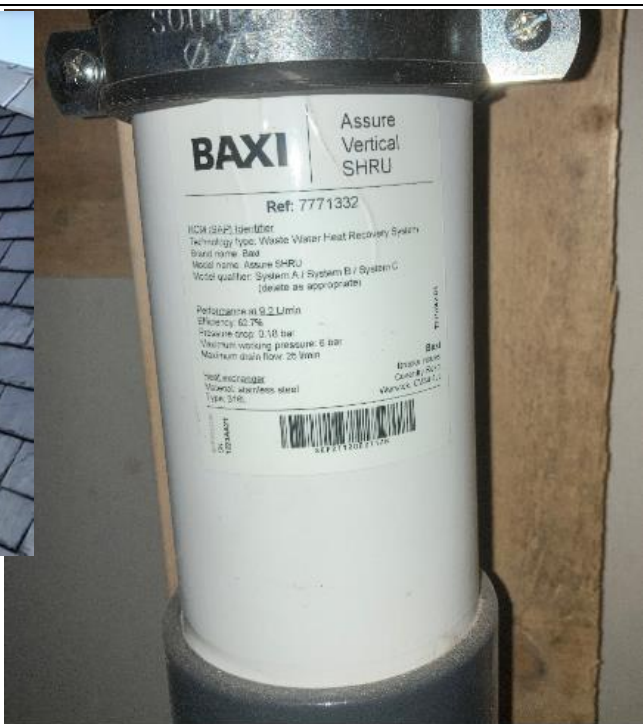
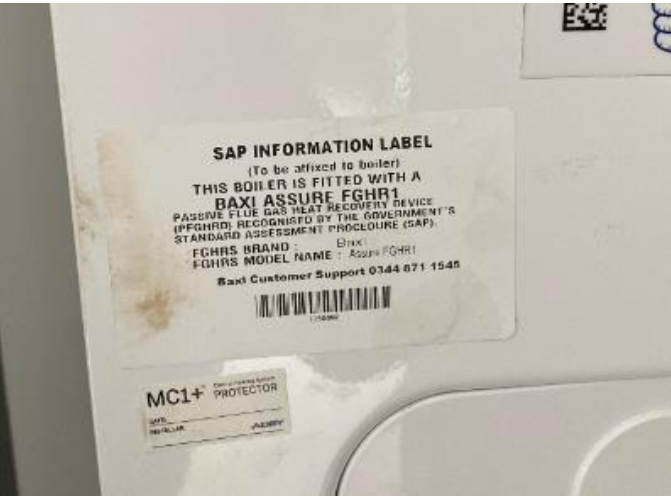
6A – Building services – Low or zero carbon technologies

✓ Photographs should clearly identify the technology present. Elmhurst believes this should include the following technologies;

- Photovoltaic panels
- Battery storage
- PV diverters
- Solar hot water panels
- Wind turbines
- Waste water heat recovery systems (WWHRs)
- Flue gas heat recovery systems (FGHRs)

For Battery storage, PV diverters, WWHRs and FGHRs a photograph of the data label/sticker rather than the entire system is appropriate.

The systems shown in the photographs should be cross referenced against the SAP assessment to ensure the correct systems are accounted for within it.

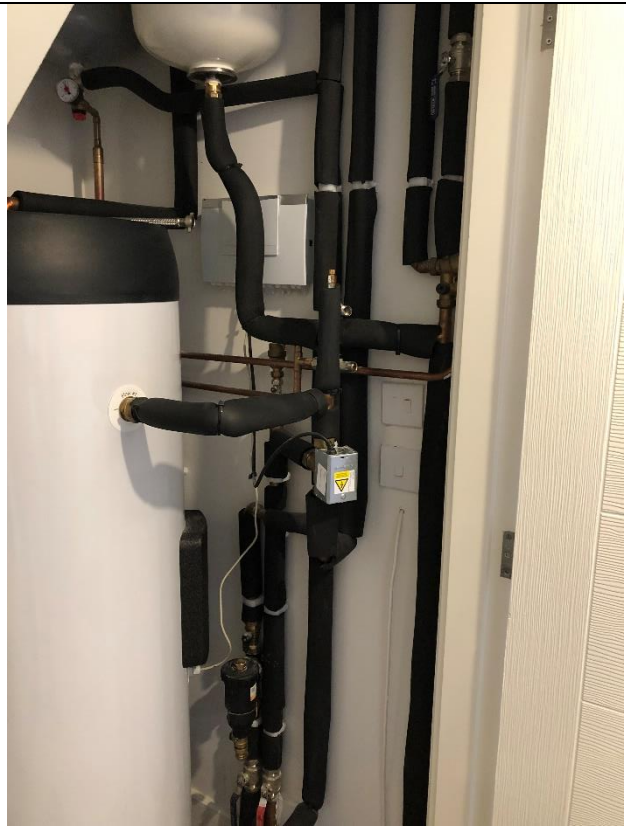
6B – Building Services – Primary pipework

<p>✓ Primary pipework is defined as the pipework running from the heat source (boiler, heat pump etc.) to the hot water storage (hot water cylinder, thermal store, HIU etc.)</p> <p>Photographs should show primary pipework is insulated*. The level of insulation shown on the photographs should be cross referenced against the SAP assessment to ensure the correct primary pipework insulation option is selected in the Hot Water Cylinder section;</p> <div><div>Pipework Insulation</div><div><div>Uninsulated primary pipework</div><div>Uninsulated primary pipework</div><div>First 1m from cylinder insulated</div><div>All accessible pipework insulated</div><div>Fully insulated primary pipework</div></div></div> <p><i>*Photographs are not required for this section where the heat generator and water storage are packaged together e.g. a combi boiler or packaged heat pump/cylinder is present.</i></p>	<p>✗ If a different insulation level is shown in the photographs or a photograph is missing inform the builder.</p> <p>The SAP assessment should be updated to reflect the insulation level shown.</p>

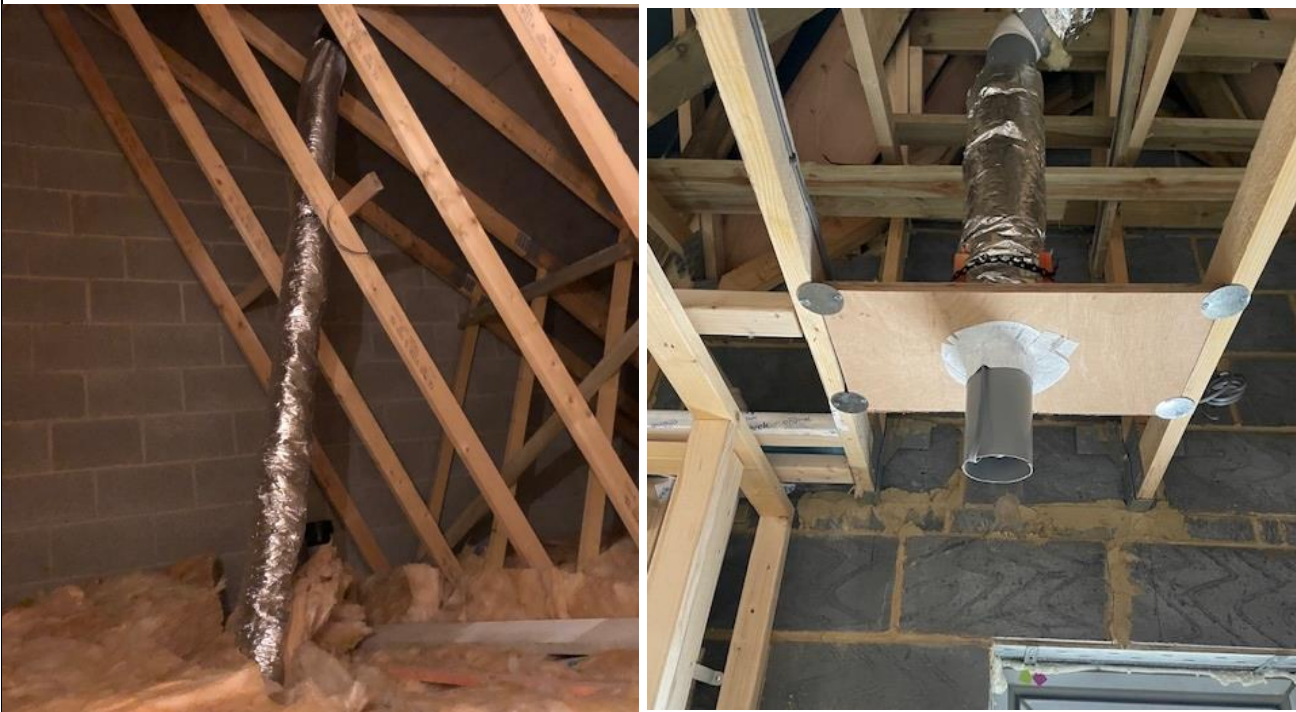
6C – Building Services – Mechanical ventilation ductwork (where outside the thermal envelope)

<p>✓ Photographs should show that mechanical ventilation ductwork in unheated spaces e.g. cold roof spaces is insulated.</p> <p>The presence of insulation shown in the photographs should be cross referenced against the SAP assessment to ensure the correct ductwork insulation option is selected in the Mechanical Ventilation section;</p> <div><div>MVHR System Location</div><div>Outside heated envelope (not insta...</div><div>MVHR Duct Insulation</div><div><div>Insulated Ducts</div><div>Insulated Ducts</div><div>Uninsulated Ducts</div></div></div>	<p>✗ If a different insulation level is shown in the photographs or a photograph is missing inform the builder.</p> <p>The SAP assessment should be updated to reflect the ductwork insulation level shown.</p>
