Annual Inspection

Radford Semele Parish Council

Playing Field

Lewis Road, Radford Semele, Leamington Spa,
Warwickshire, CV31 1 UQ

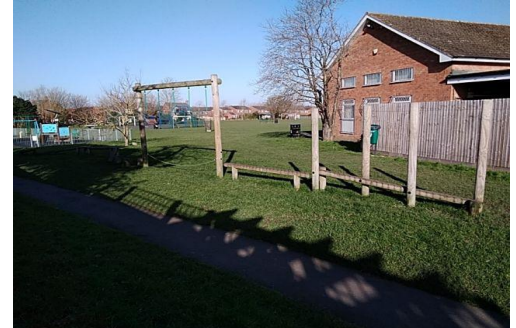
Item: Activity Trail
Manufacturer: A.E.Evans
Surface Type: Grass Matrix Tiles
Item Quantity: 1
Equipment Compliance: Yes
Surface Area Compliance: Yes

The timber has a number of splits/shakes or air cracks and this may affect the stability or allow water ingress which will accelerate the rotting process - Monitor to ensure the splits do not cross through fixing points of the structure and/or cause any instability

The item has been damaged - Monitor for any further deterioration and replace as required

A number of fixing(s) have worked loose - Secure all loose fixings

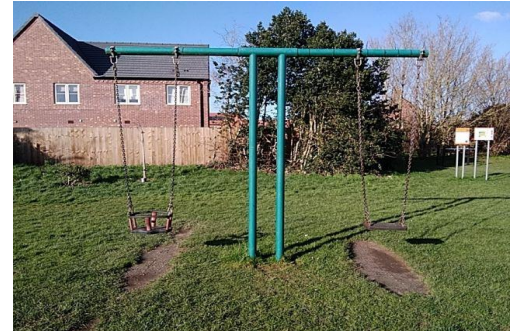
Item: T Swing
Manufacturer: Unknown
Surface Type: Grass Matrix Tiles
Item Quantity: 1
Equipment Compliance: No
Surface Area Compliance: Yes

The bushes are worn or missing - Replace worn or missing bushes

There is no identification label affixed to the equipment - Provide an identification label

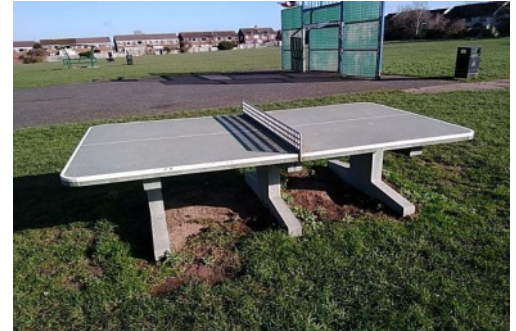
Item: Table Tennis
Manufacturer: Unknown
Surface Type: Grass Matrix Tiles
Item Quantity: 1
Equipment Compliance: N/A
Surface Area Compliance: N/A

This item is satisfactory - no work required -

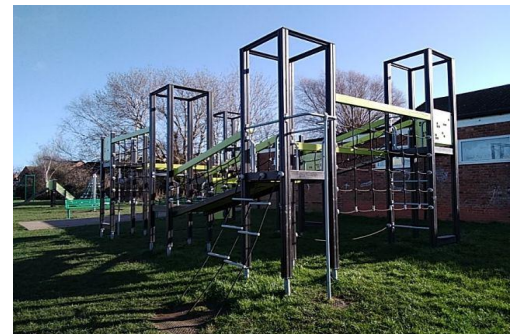
Item: Multi Play (Senior)
Manufacturer: Lappset UK Ltd
Surface Type: Grass Matrix Tiles
Item Quantity: 1
Equipment Compliance: No
Surface Area Compliance: Yes

There is/are bolt cap covers missing or damaged on the item - Replace missing or damaged bolt cap covers

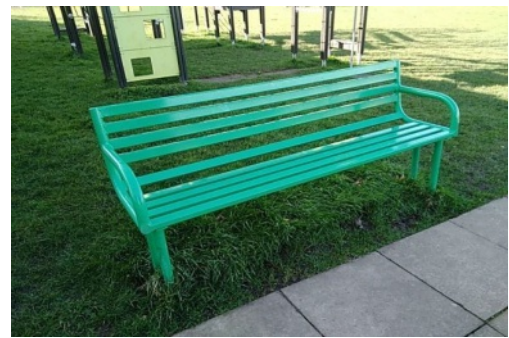
Item: Seat
Manufacturer: Unknown
Surface Type: Grass
Item Quantity: 2
Equipment Compliance: N/A
Surface Area Compliance: N/A

Finding 1
 This item is satisfactory - no work required -

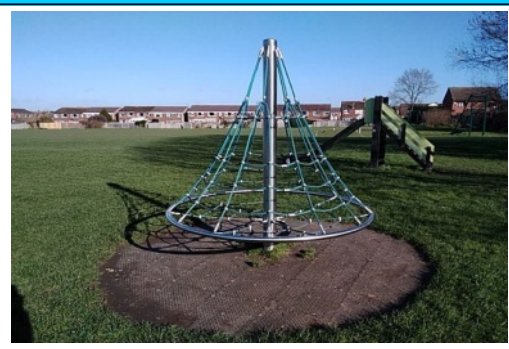
Item: Rotating Net
Manufacturer: Tayplay Ltd
Surface Type: Grass Matrix Tiles
Item Quantity: 1
Equipment Compliance: Yes
Surface Area Compliance: Yes

Finding 1
 This item is satisfactory - no work required -

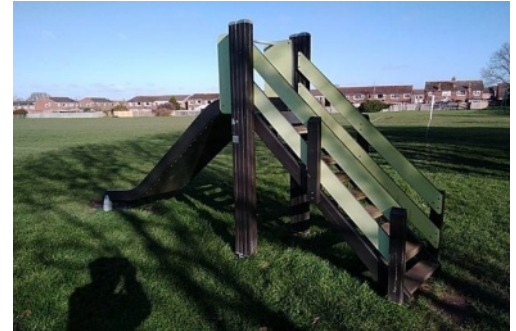
Item: Slide Unit
Manufacturer: Lappset UK Ltd
Surface Type: Grass Matrix Tiles
Item Quantity: 1
Equipment Compliance: Yes
Surface Area Compliance: Yes

This item is satisfactory - no work required -

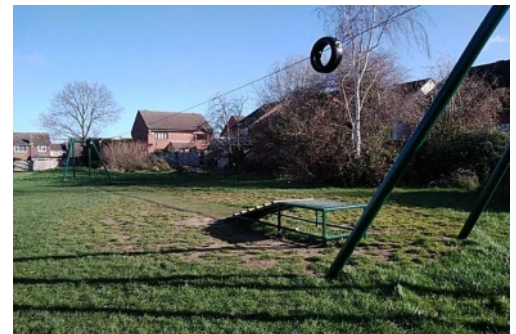
Item: Cable Runway
Manufacturer: Wicksteed Playgrounds
Surface Type: Grass Matrix Tiles
Item Quantity: 1
Equipment Compliance: Yes
Surface Area Compliance: Yes

This item is satisfactory - no work required -

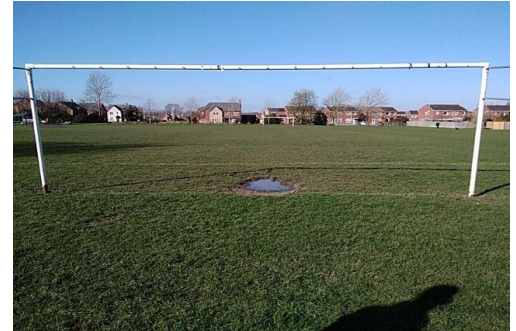
Item: Football Goal
Manufacturer: Unknown
Surface Type: Grass
Item Quantity: 2
Equipment Compliance: N/A
Surface Area Compliance: N/A

| <p>Finding 1

The surface has eroded in some areas - Reinstate the surface</p> | <p>Finding 2
 The item is slightly loose in its foundations - Monitor for any further deterioration and repair as required</p> |

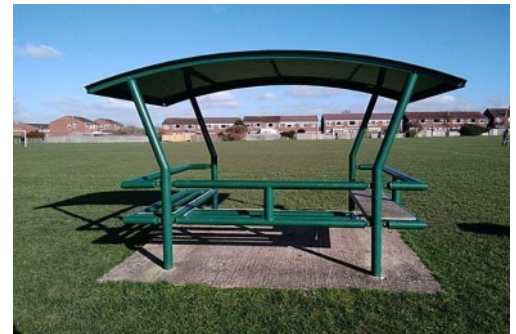
Item: Shelter
Manufacturer: Unknown
Surface Type: Concrete
Item Quantity: 1
Equipment Compliance: N/A
Surface Area Compliance: N/A

This item is satisfactory - no work required -</p> |

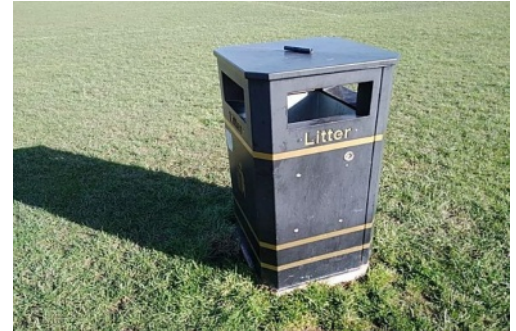
Item: Litter Bin
Manufacturer: Unknown
Surface Type: Grass
Item Quantity: 1
Equipment Compliance: N/A
Surface Area Compliance: N/A

This item is satisfactory - no work required -

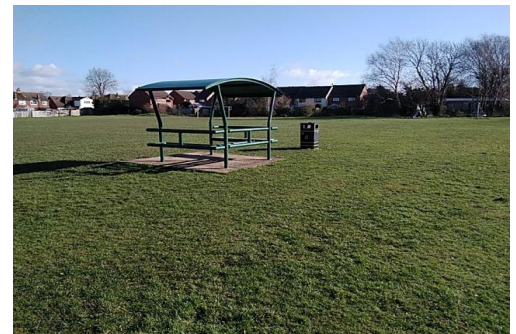
Item: Site General
Manufacturer: Unknown
Surface Type: Grass
Item Quantity: 1
Equipment Compliance: N/A
Surface Area Compliance: N/A

It is recommended that signage, with information including the site address, contact information for maintenance issues and emergency contact details are provided for the facility - Provide in accordance with the recommendations

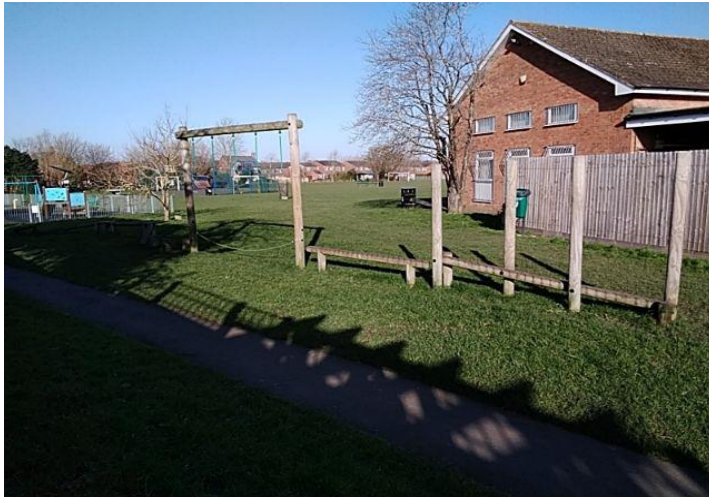
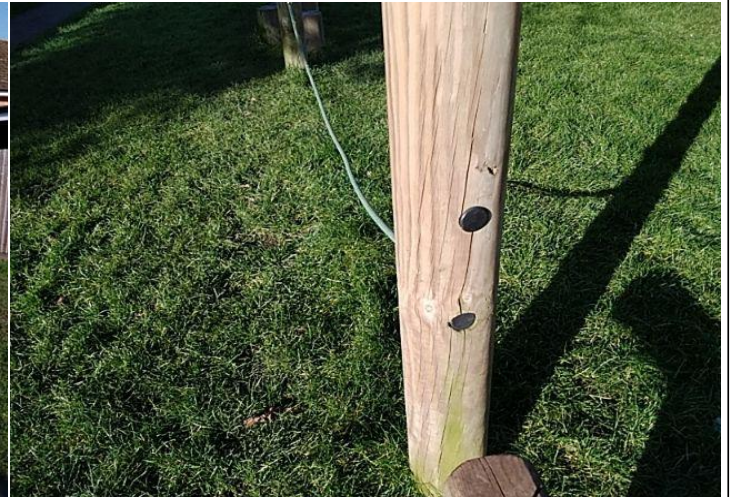
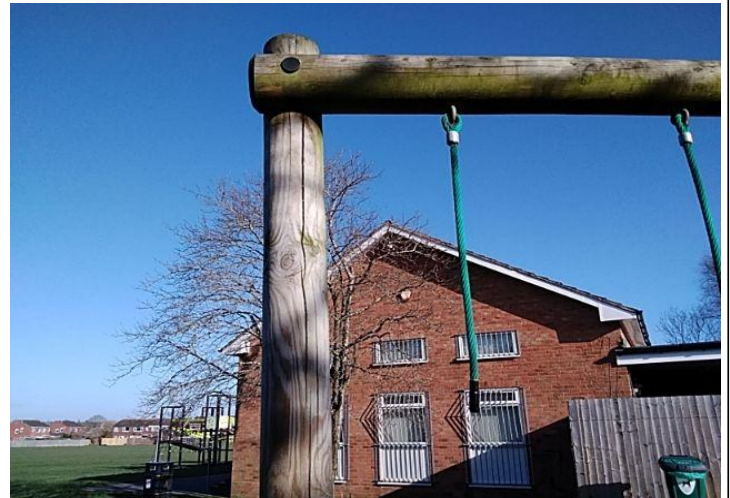
6 - Low Risk (Finding 1)

Item: Activity Equipment - Activity Trail
Manufacturer: A.E.Evans

Finding: The timber has a number of splits/shakes or air cracks and this may affect the stability or allow water ingress which will accelerate the rotting process

Action: Monitor to ensure the splits do not cross through fixing points of the structure and/or cause any instability

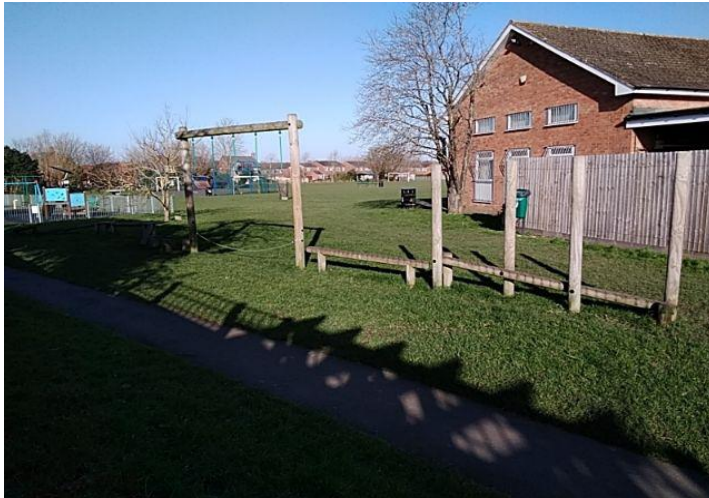
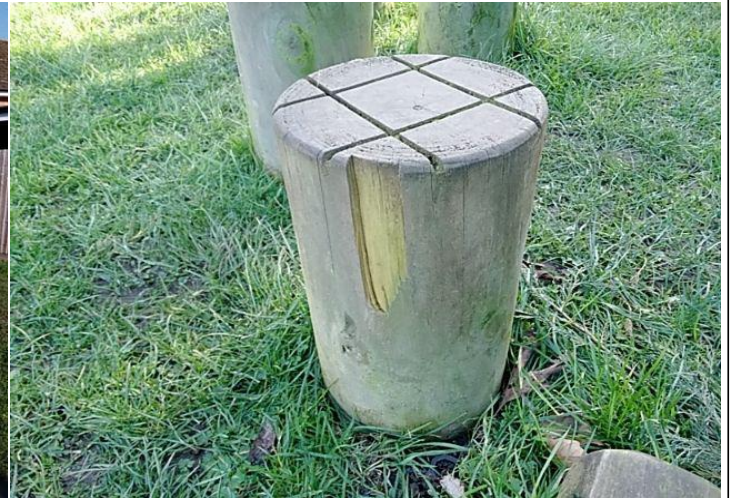
i 6 - Low Risk (Finding 2)

Item: Activity Equipment - Activity Trail
Manufacturer: A.E.Evans

Finding: The item has been damaged

Action: Monitor for any further deterioration and replace as required

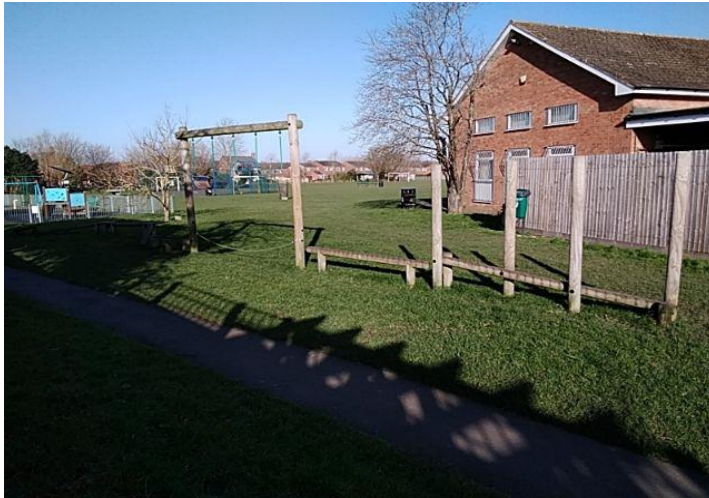
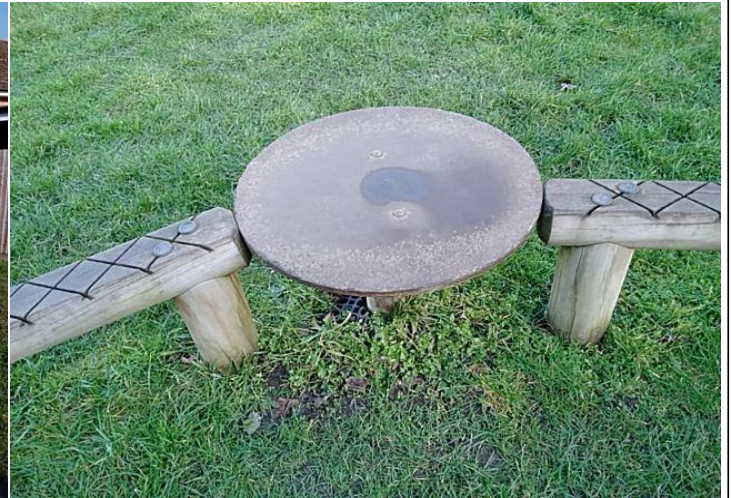
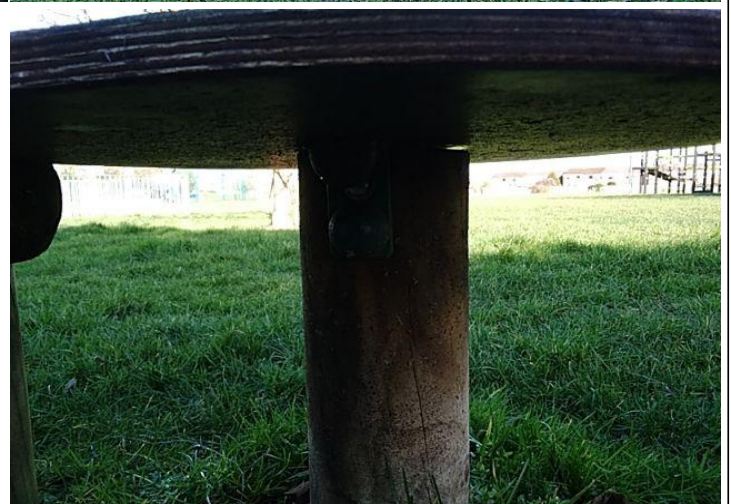
i 6 - Low Risk (Finding 3)

Item: Activity Equipment - Activity Trail
Manufacturer: A.E.Evans

Finding: A number of fixing(s) have worked loose

Action: Secure all loose fixings

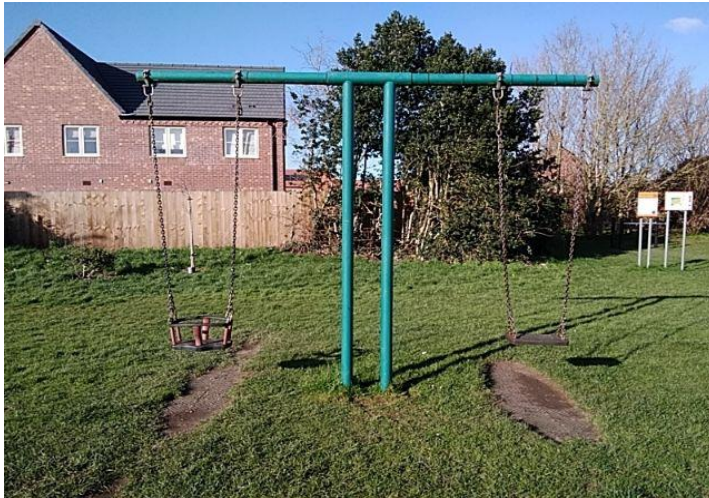
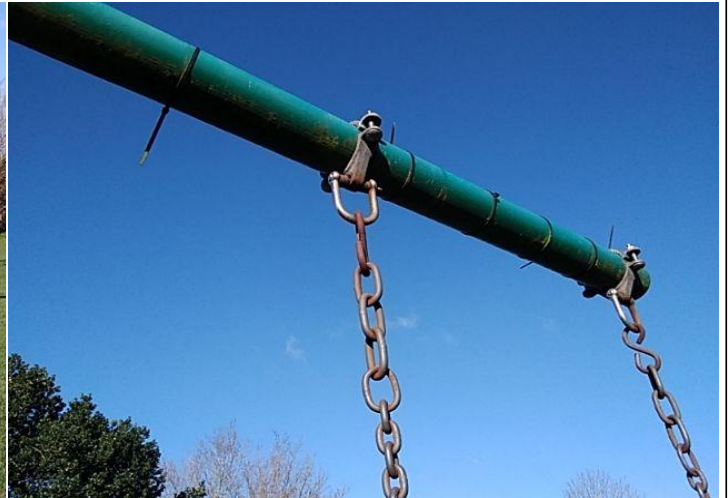
i 8 - Low Risk (Finding 1)

Item: Swings - T Swing
Manufacturer: Unknown

Finding: The bushes are worn or missing

Action: Replace worn or missing bushes

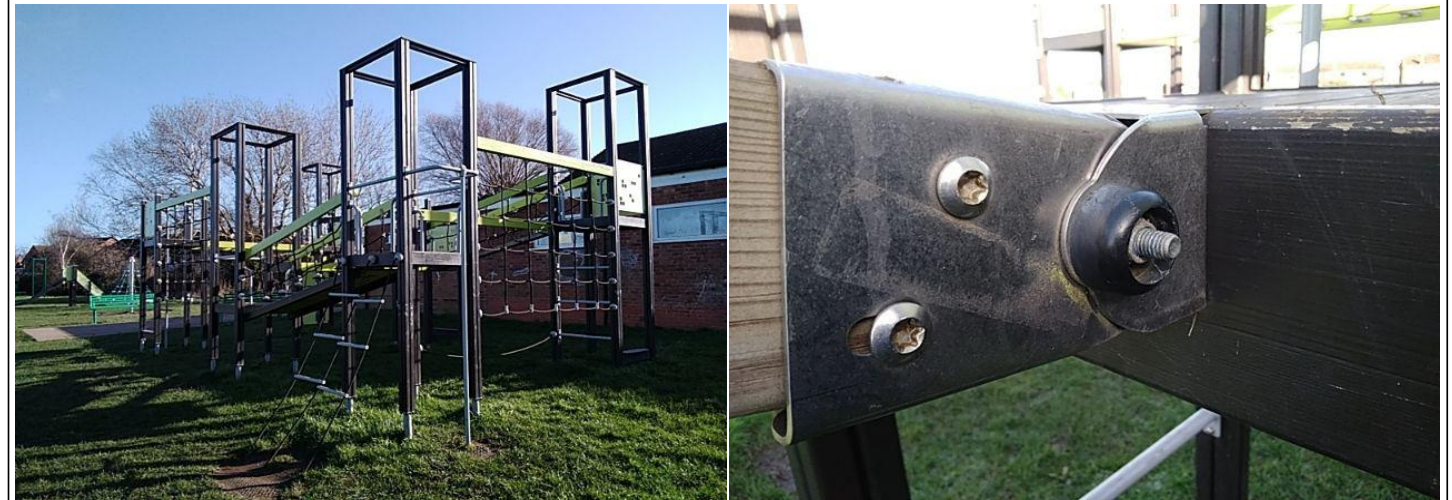
i 4 - Very Low Risk (Finding 1)

Item: Activity Equipment - Multi Play (Senior) **Risk Level:** V - Very Low Risk
Manufacturer: Lappset UK Ltd **Surface:** Grass Matrix Tiles

Finding: There is/are bolt cap covers missing or damaged on the item **Action:** Replace missing or damaged bolt cap covers

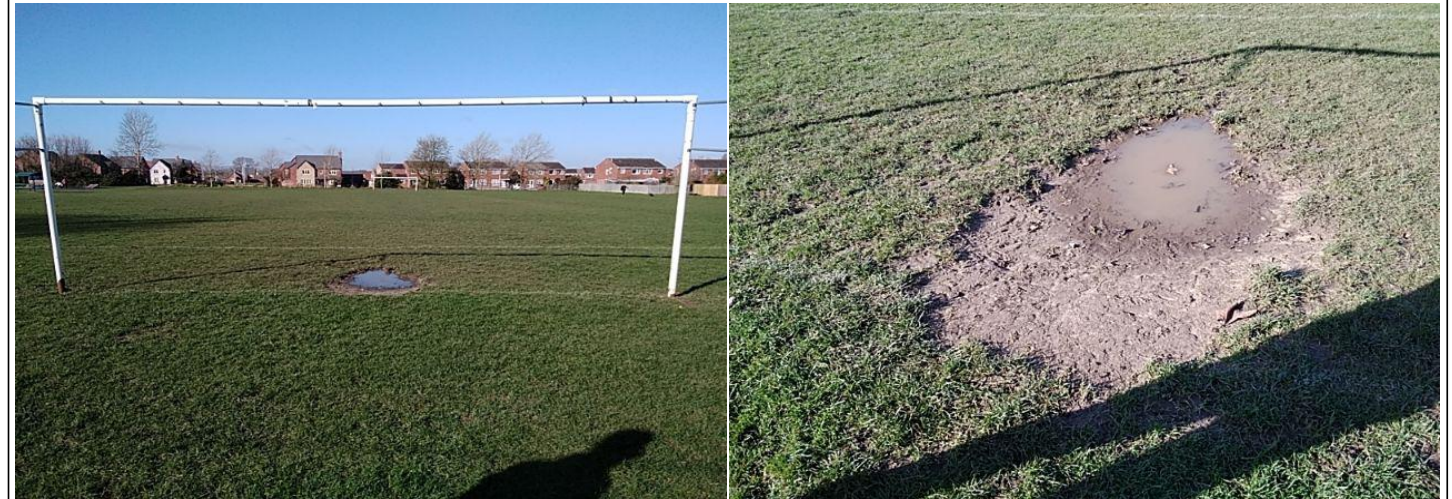
i 6 - Low Risk (Finding 1)

Item: Multi Use Games Area - Football Goal **Risk Level:** L - Low Risk
Manufacturer: Unknown **Surface:** Grass

Finding: The surface has eroded in some areas **Action:** Reinstate the surface
