## Annual Inspection

Radford Semele Parish Council

Skate Area & MUGA

Lewis Road, Radford Semele, Leamington Spa,  
Warwickshire, CV31 1 UQ

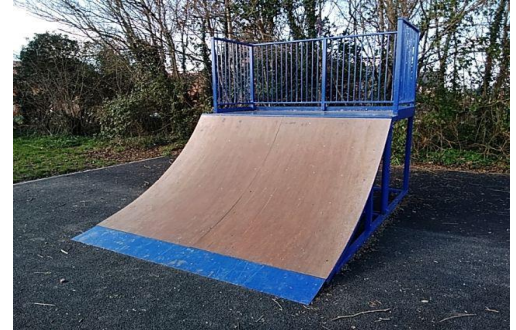
**Item:** Quarter Pipe  
**Manufacturer:** Unknown  
**Surface Type:** Tarmac  
**Item Quantity:** 1  
**Equipment Compliance:** No  
**Surface Area Compliance:** Yes

The height of the barrier is less than 1200mm and fails the requirements of BS EN 14974 - Monitor - No remedial work recommended

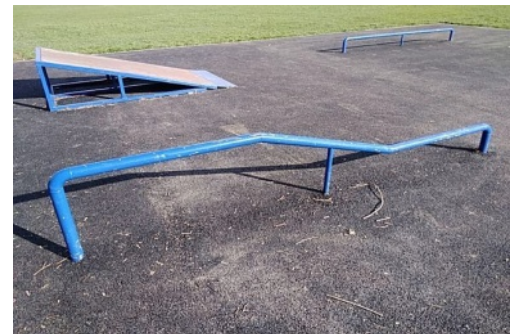
**Item:** Grind Rail  
**Manufacturer:** Unknown  
**Surface Type:** Tarmac  
**Item Quantity:** 1  
**Equipment Compliance:** Yes  
**Surface Area Compliance:** Yes

This item is satisfactory - no work required -

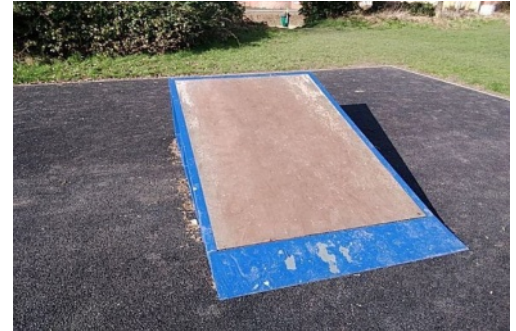
**Item:** Roll Ramp  
**Manufacturer:** Unknown  
**Surface Type:** Tarmac  
**Item Quantity:** 2  
**Equipment Compliance:** Yes  
**Surface Area Compliance:** Yes

This item is satisfactory - no work required -

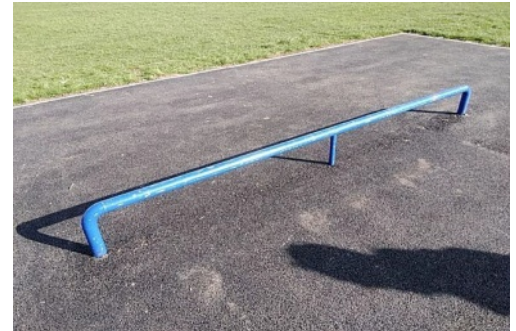
**Item:** Grind Rail  
**Manufacturer:** Unknown  
**Surface Type:** Tarmac  
**Item Quantity:** 1  
**Equipment Compliance:** Yes  
**Surface Area Compliance:** Yes

This item is satisfactory - no work required -

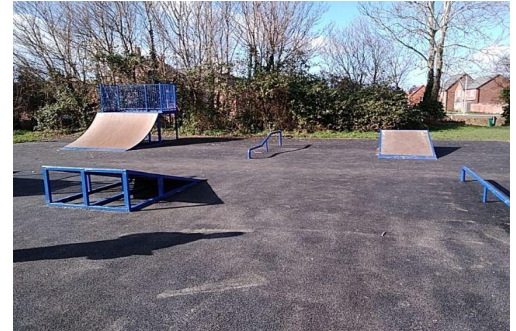
**Item:** Site General  
**Manufacturer:** Unknown  
**Surface Type:** Tarmac  
**Item Quantity:** 1  
**Equipment Compliance:** N/A  
**Surface Area Compliance:** N/A

It is recommended that signage, with information including the site address, contact information for maintenance issues and emergency contact details are provided for the facility - Provide in accordance with the recommendations

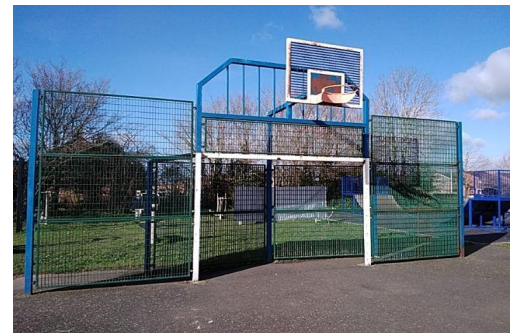
**Item:** Goalmouth and Basketball Post  
**Manufacturer:** Unknown  
**Surface Type:** Tarmac  
**Item Quantity:** 2  
**Equipment Compliance:** N/A  
**Surface Area Compliance:** N/A

There is surface corrosion present on the item - Consider treating the item

A clearly visible facility sign should be provided in a prominent position with the wording as detailed BS EN 15312- the equipment is not intended for children less than 3 years old- the warning - Do not climb on the framework or nets- the warning - Do not hang on the ring (if provided)- the warning - Do not wear rings or other jewellery- name and telephone number of the administrator- number to call in case of accident - Provide signage to BS EN 15312

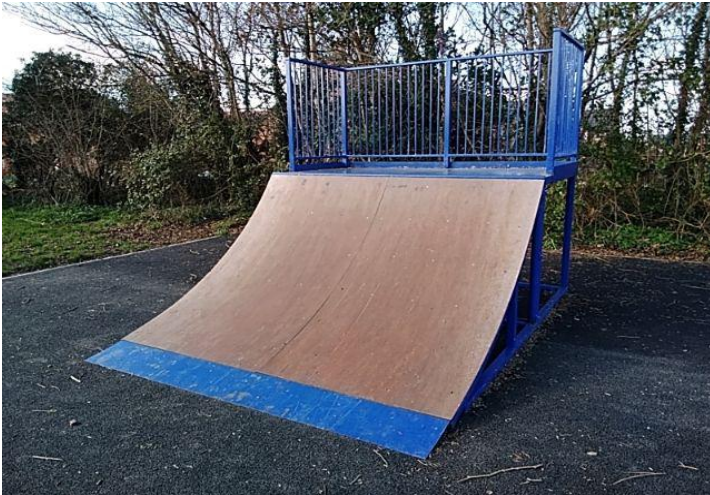
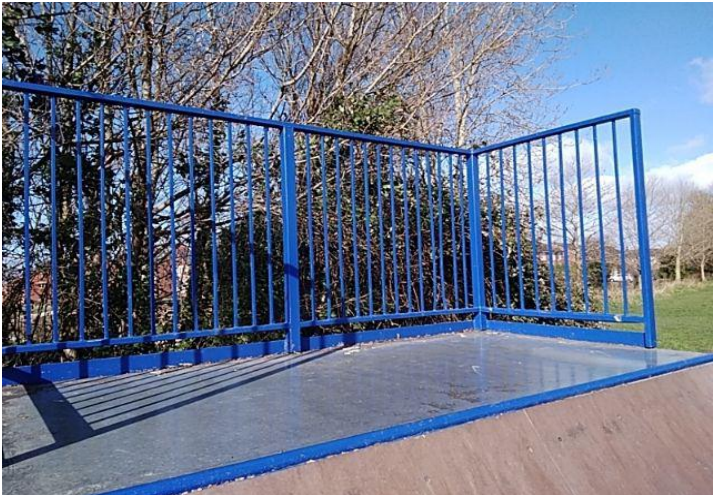
<b>Item:</b>	Wheeled Sports - Quarter Pipe	<b>Risk Level:</b>	L - Low Risk
<b>Manufacturer:</b>	Unknown	<b>Surface:</b>	Tarmac

**Finding:** The height of the barrier is less than 1200mm and fails the requirements of BS EN 14974

**Action:** Monitor - No remedial work recommended

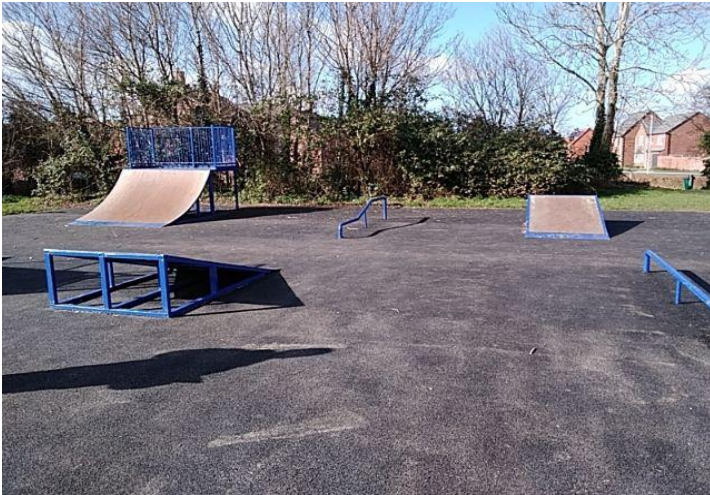
<b>Item:</b>	Ancillary Items - Site General	<b>Risk Level:</b>	V - Very Low Risk
<b>Manufacturer:</b>	Unknown	<b>Surface:</b>	Tarmac

**Finding:** It is recommended that signage, with information including the site address, contact information for maintenance issues and emergency contact details are provided for the facility

**Action:** Provide in accordance with the recommendations

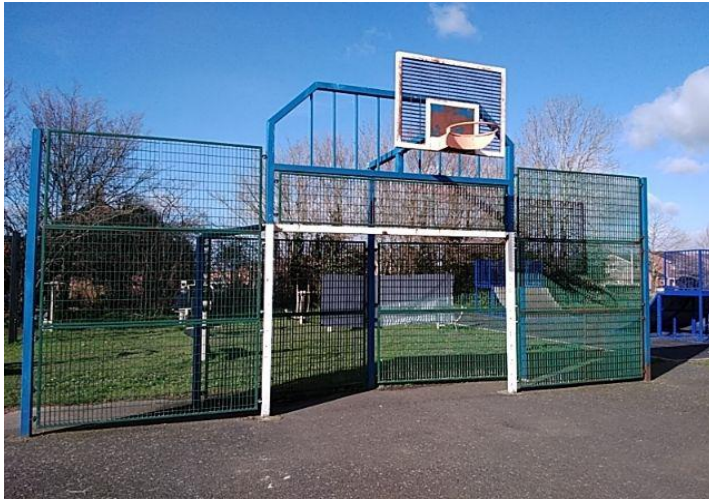
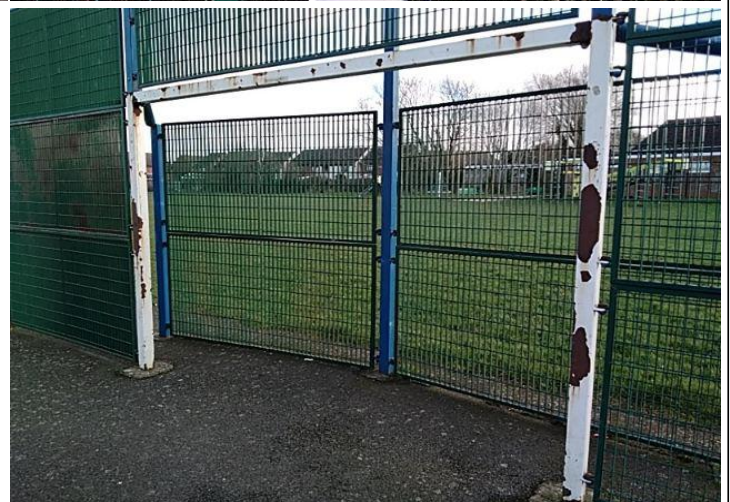
**Item:** Multi Use Games Area - Goalmouth and Basketball Post  
**Manufacturer:** Unknown

**Finding:** There is surface corrosion present on the item

**Action:** Consider treating the item

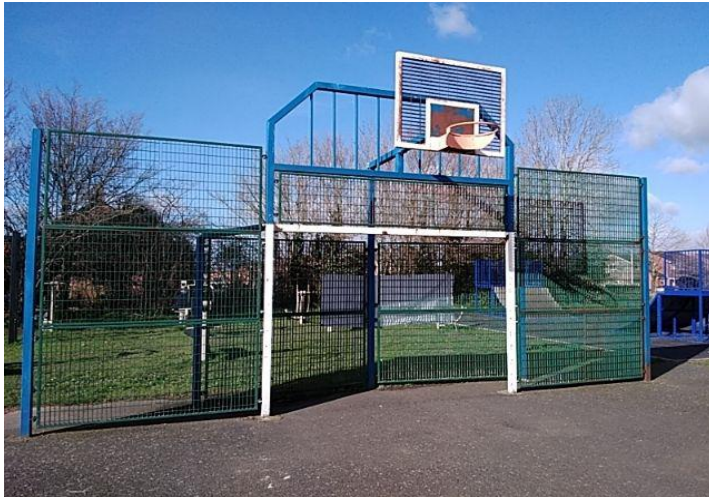
**Item:** Multi Use Games Area - Goalmouth and Basketball Post  
**Manufacturer:** Unknown

**Finding:** A clearly visible facility sign should be provided in a prominent position with the wording as detailed BS EN 15312- the equipment is not intended for children less than 3 years old- the warning - Do not climb on the framework or nets- the warning - Do not hang on the ring (if provided)- the warning - Do not wear rings or other jewellery- name and telephone number of the administrator- number to call in case of accident

**Action:** Provide signage to BS EN 15312
