## **WINTER SURVEY FOR BATS AND BAT ROOSTS AT THE PLASH MILL, LETHAM, ANGUS**

**Report to Letham Feuars Committee**  
**by**  
**Dr Susan M. Swift**

**October 2013**

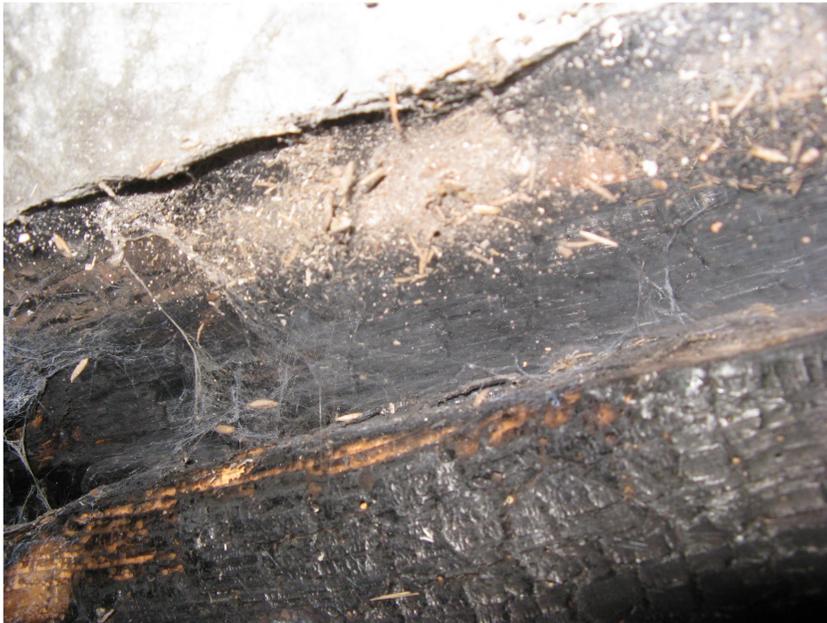
**6.2.1 Actual Roosts.** No roosting bats and no evidence of bats was found anywhere in or around the plash mill building. No staining was recorded on beams, nor at wall tops, and no droppings were found on wall tops, at bases of walls, under lintels or suspended in cobwebs. A quantity of mouse droppings were found in the east section, but no bat droppings. There were also no droppings below ridges in any parts of the building. Crevices above door and window lintels were covered in cobwebs (Plate 1),

confirming that no bats had roosted there. There were also no signs of bats on the outside of the building, on walls, wall tops or stonework

Plate 1. Thick cobwebs across entrances to gaps above lintels confirmed no bats had roosted there

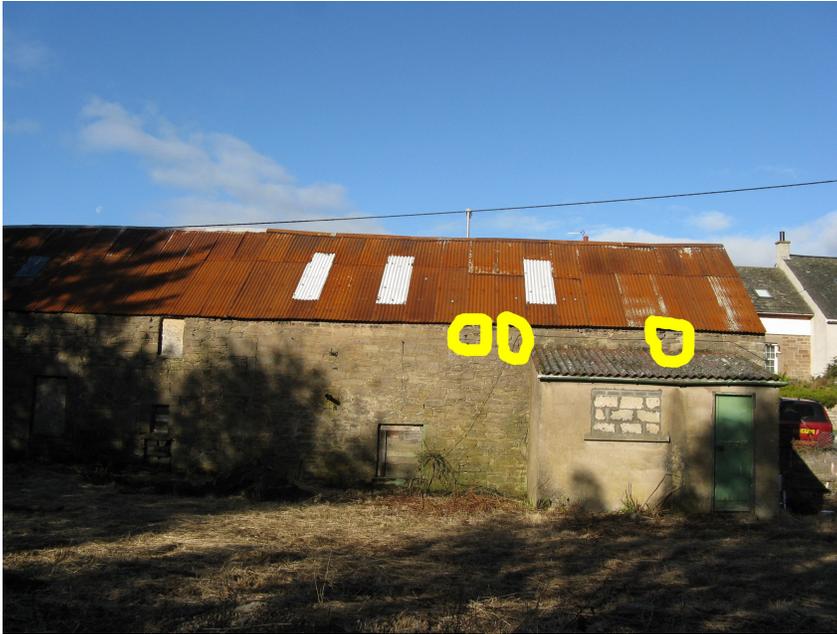
In the absence of sarking or other roof linings, the only potential roost sites were holes in the stonework of the walls. There were a number of holes on both the inside and outside walls where mortar had fallen out. There were also a few gaps at wall top level where holes under the roof would have allowed bats to gain access to roosts on the wall tops. However, these were all checked from the ladder, and no staining or droppings were found. Several of the holes high in the outer walls were deep (at least 10cm), but no signs of bats could be found using the endoscope. Thus, while in the absence of dusk/dawn surveys, I cannot rule out completely the possibility that pipistrelles could use these holes (particularly on the south face; Plate 2) as roost sites, at the moment, there is no evidence at all that they do so.

Plate 2. South face of the mill, showing a few deep holes in the stonework (circled) which are potential bat roosts, although no signs of roosts were found. Care should be exercised when repairing these holes.

**7.3** No signs of pipistrelles were found in or around the building. However, because a summer survey has not been carried out, I cannot rule out a slight possibility that one or two male pipistrelles could, occasionally, roost in deep holes in the stonework on the south-facing wall. However, there is no evidence they do so, and thus work to renovate the building could be carried out without the need for an EPS licence in respect of bats.

**7.5** Because the occasional presence of pipistrelles cannot, at the moment, be completely ruled out, my advice is that reasonable caution is exercised when deep holes in the stonework of the outer walls are filled. A thorough check using a powerful torch would be enough to ensure no bats are in holes, and thus in danger from becoming trapped, when the holes are filled.

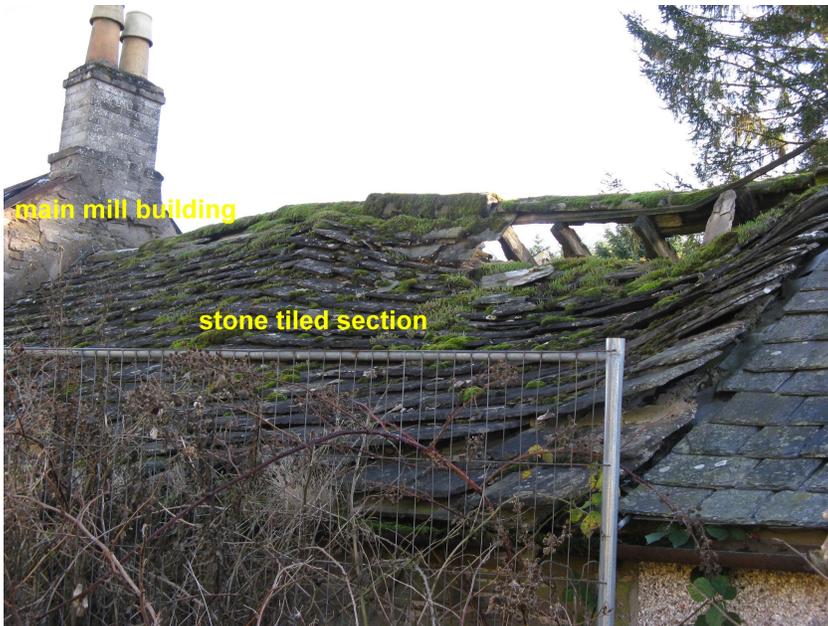
No signs of bats were found in the west section of the building, i.e. the section with a stone-tiled roof. Since there was no sarking or other roof lining, potential roosts under sarking could be ruled out. In addition, the large holes in the roof (Plate 3) and resulting damp, light and draughty conditions in the roof space made this section, in my opinion, very unlikely ever to be used by bats.

Plate 3. The stone-tiled (west) end of the building, from the north side, showing the partially collapsed roof. Water ingress and light conditions (both the ridge and the ceiling have large holes) make the area unsuitable for bat roosting.
