Garden Island Sands

Beach Access and Erosion Management plan

Report prepared for The Friends of Garden Island Creek

July 2023

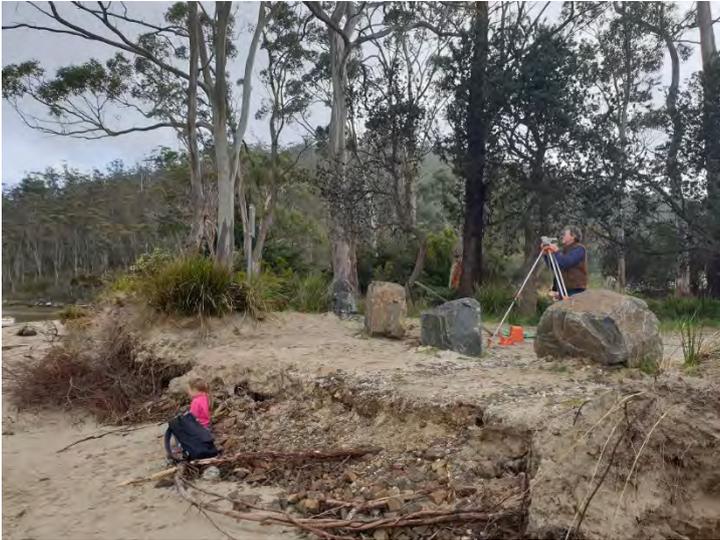
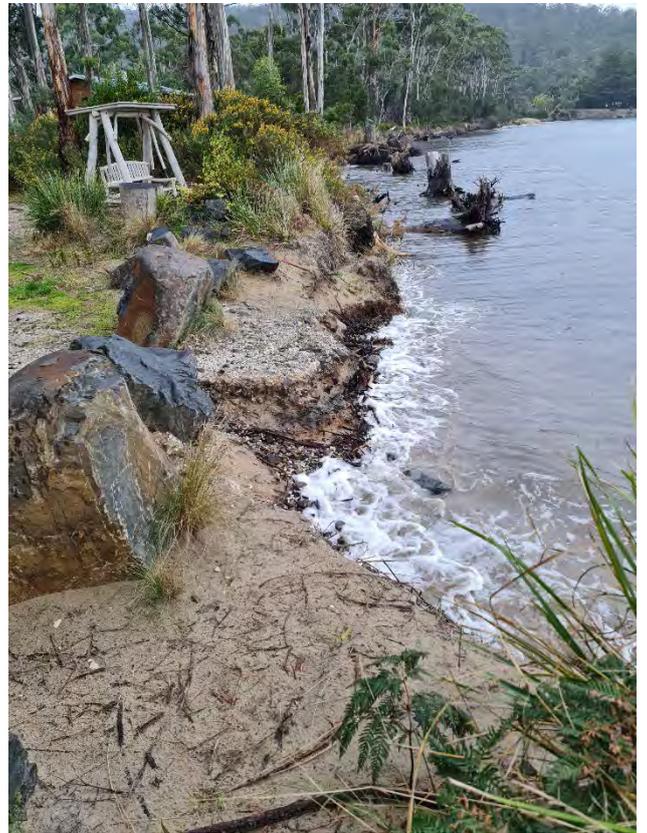
Figure 5. Left: The drop down from road level to the beach at the site of the former boat ramp. Image from FOGIC 2021. Right: erosion has removed the shoreline back to the large rocks visible in the first image. Image from FOGIC 2023

- As of July 2023, there is no safe beach access at the carpark at the end of Lowes Rd. Shoreline erosion has smoothed the drop off that was left after the boat ramp was removed but it still cannot be navigated by many people, including elderly residents. Large rocks were placed to prevent vehicle access when the ramp was removed and the shoreline has since eroded back to this point. (fig. 5).
- The current state of shoreline erosion is continuously undermining the stability of large trees and many have fallen onto the beach over the last two decades (fig. 6).

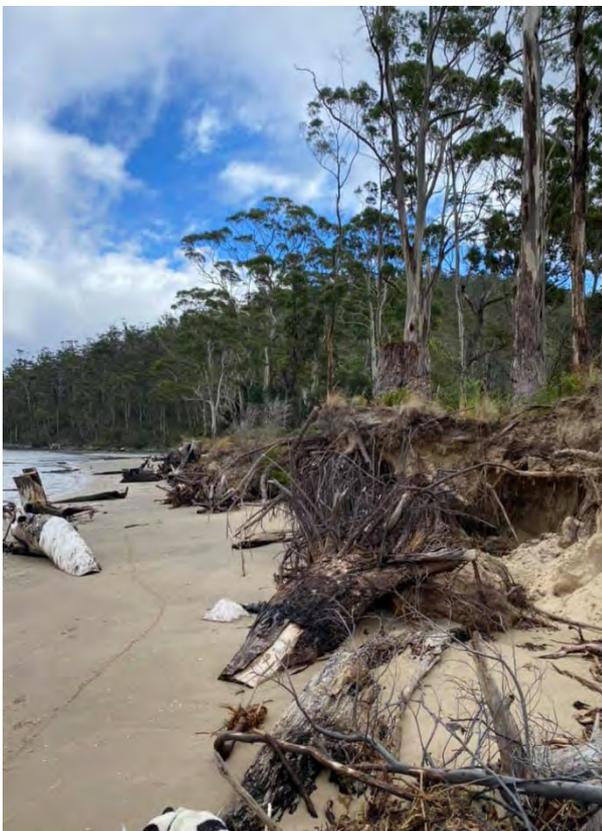
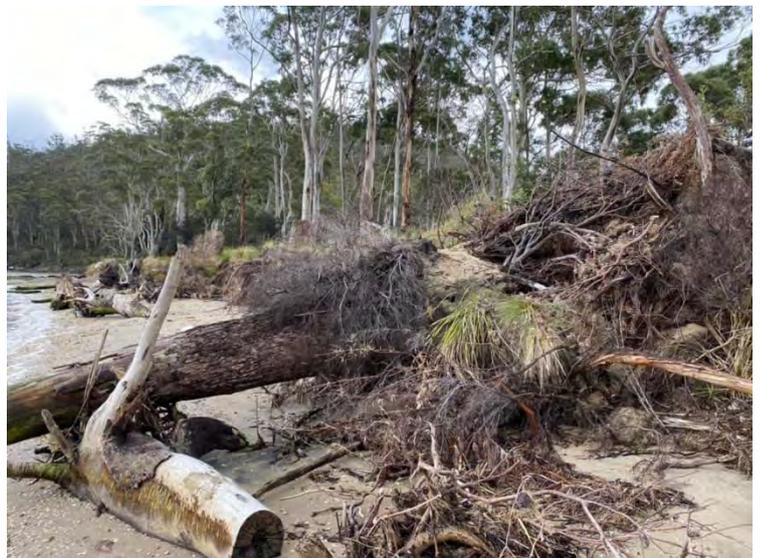
Figure 6. Shoreline erosion has undermined large trees which have fallen, further destabilising the dune. Images from FOGIC 2022

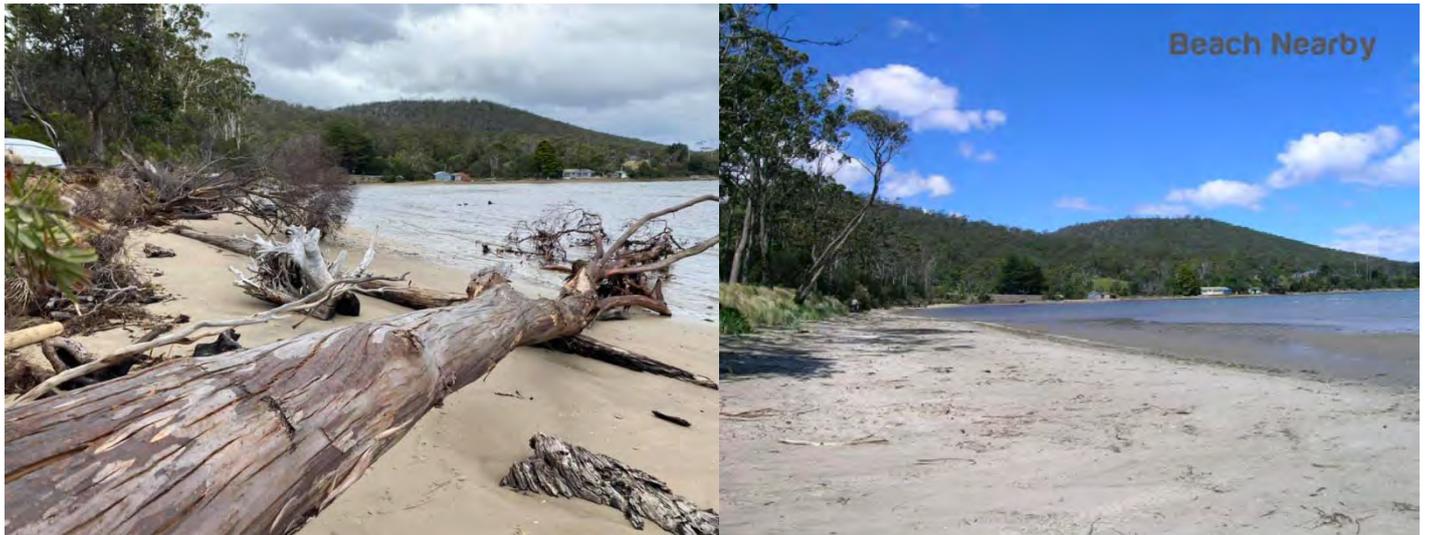
Figure 7. Garden Island Sands, both photos taken in a similar location looking in the same direction. Photo A from FOGIC in 2022. Photo B. from an unknown source. Unknown, likely prior 2000.

- This is a large change from the gentle sloping beach with healthy native vegetation that there once was and reflects the switch from a formerly stable beach and foredune to a progressively eroding and receding shoreline since about 2000 (fig. 7).

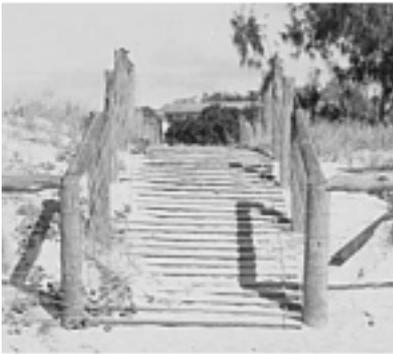
(Figure 8: images of accessways provided in the survey)

A) 'Board and chain walkway'. B) concrete steps, a quick sketch by Mick Kelly. Both of these ideas will have to go through engineering to see what's possible.

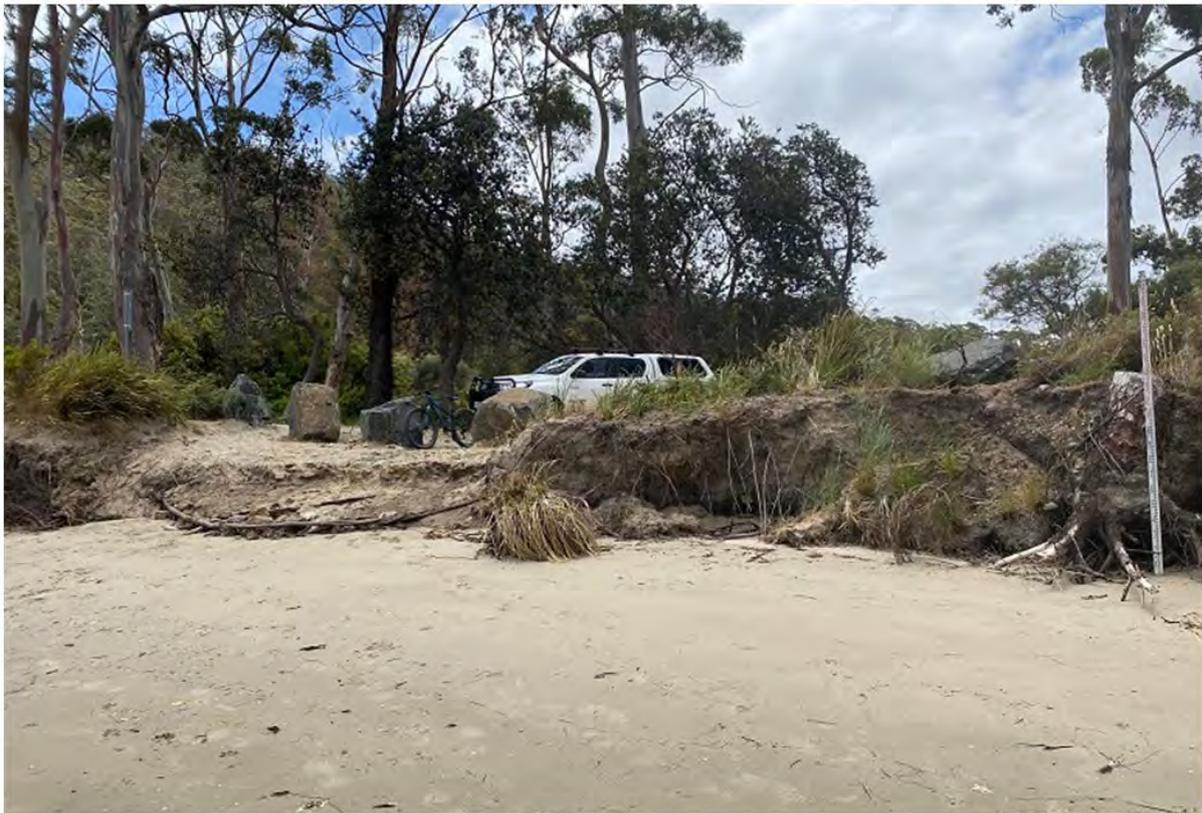
Figure 12. The current eroding access from Lowes Road onto Garden Island Sands Beach.

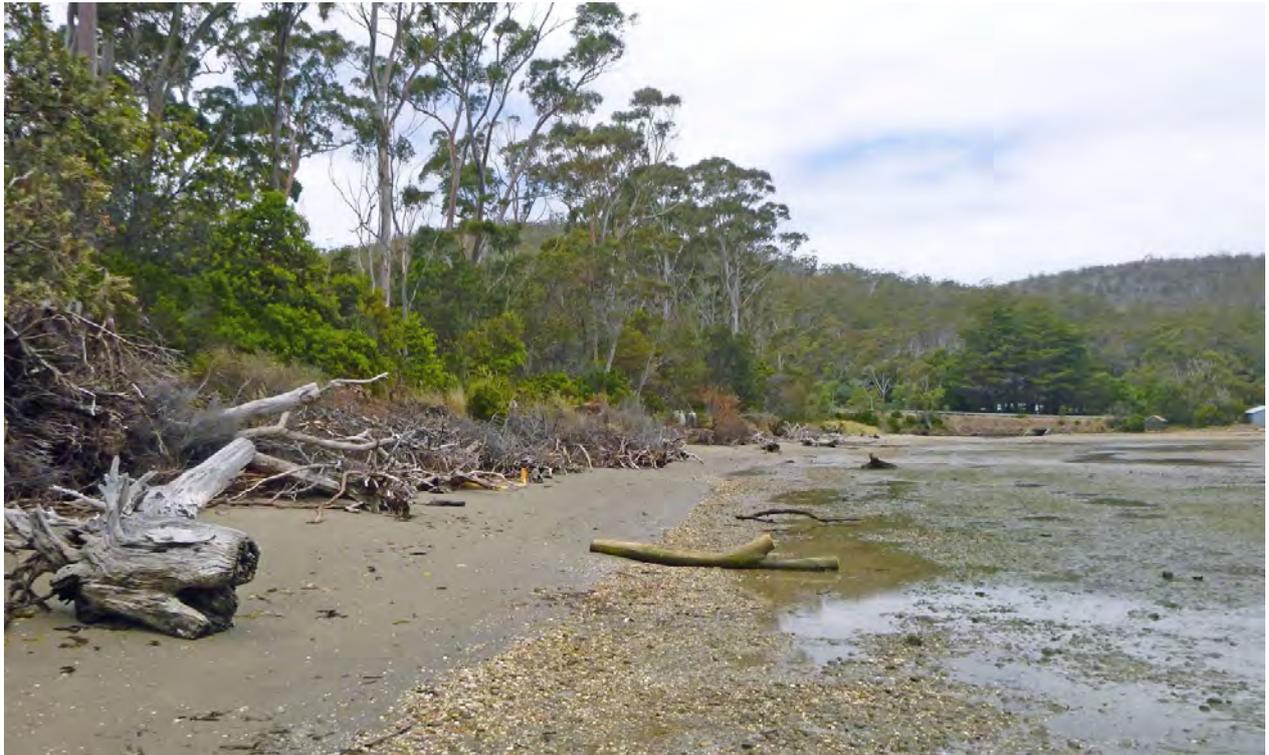
Figure 3: View eastward along the east end of Garden Island Sands Beach at close to low tide (3rd January 2022). This view shows a damp narrow upper sandy beach above the very broad flat wet sandy low tide terrace which here exhibits pebbles and shelly material. The cut woody debris artificially piled against the foredune on the left is covering a very fresh erosion scarp of recent origin (see also Figure 5).

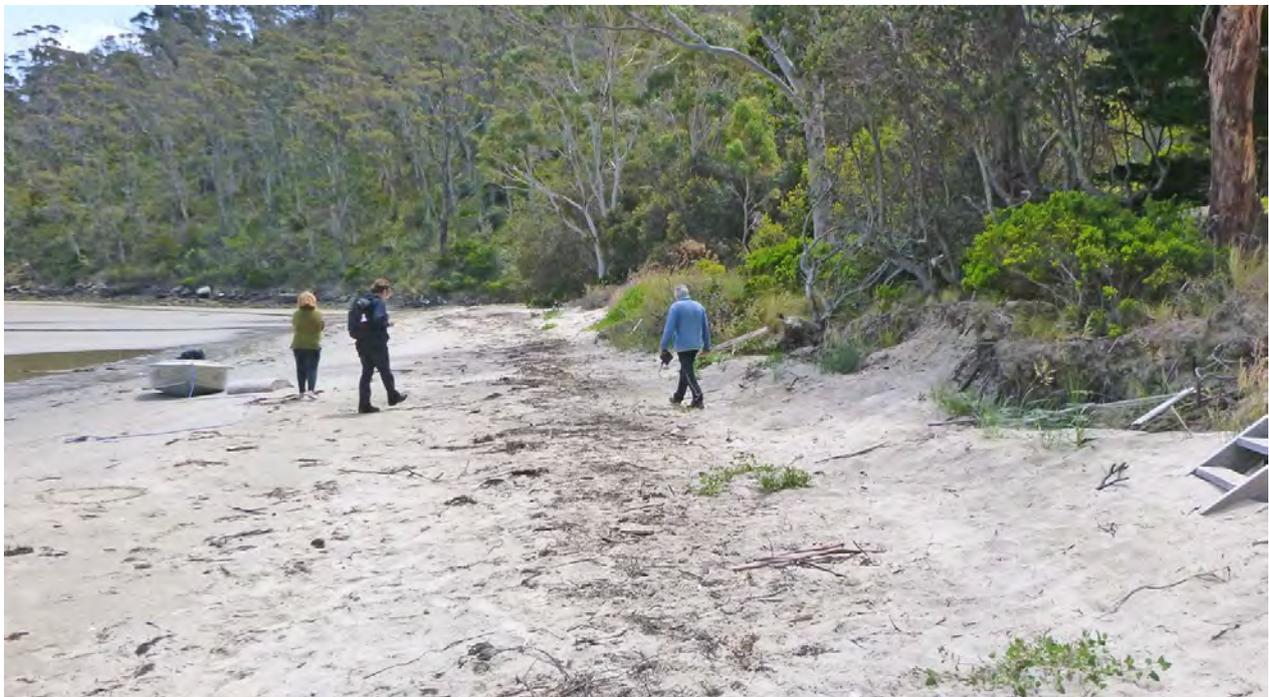
Figure 4: View westwards along the west end of Garden Island Sands Beach at close to low tide (3rd January 2022). Compared to the eastern end of the beach (see Figure 3 above), this view clearly shows a much wider and drier upper beach above the broad flat wet low tide terrace to the left. Although an old erosion scarp is visible in the foredune at the right, it is becoming buried beneath the accreting incipient foredune at its foot, which has grown as sand has been returned to the beach following the last erosion event. This older and more recovered dune scarp contrasts with relatively fresh recent erosion scarping in the central to eastern part of the beach (see Figure 5).

Garden Island Sands Beach is a 470 metres long, south- to south-southwest facing beach of fine-grained yellow-grey sand. Short (2006, p.141) has classified the beach as a steeper “reflective” upper beach (low-energy and wave-dominated) fronted by very broad (~400 metre wide) intertidal to sub-tidal sand flats. At the time of writing (2022), the beach above the low tide terrace is notably narrower (~3-4m) and wetter in its central to south-eastern areas (Figure 3) than it is near its wider (~8-9m) and drier north-west end (Figure 4). This pattern of a wider and drier

and more rounded, with significant sand accreting over the scarp in the form of an incipient foredune (see Figure 4). This part of the foredune has lost less width since 2000.

The north-western quarter (~100 m) of the upper beach was mostly dry over a width of ~8 – 10m above the wet low tide terrace (see also Figure 4) and was backed by a relatively old foredune erosion scarp which shows evidence of significant recovery, having been partly buried by an incipient foredune which has accreted following the last erosion event that affected this part of the beach (see Figure 15 including photo A).

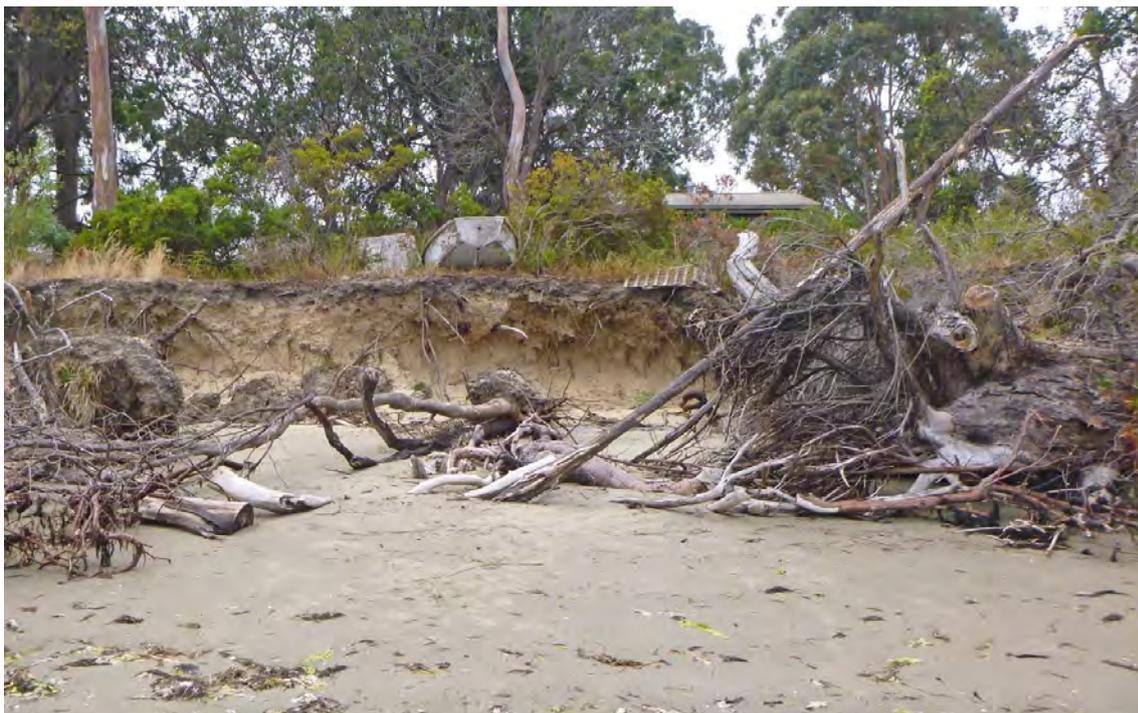
Figure 5: Landwards view of freshly eroded foredune scarp in the central area of the beach at close to low tide (3rd January 2022). This freshly eroded scarp is of similar size, character and freshness to that shown in Figure 3 (above) but has not been covered with cut branches. The woody debris scattered across the beach in this view mainly comprises mature trees formerly growing on the foredune, which have been undermined and toppled by storm wave erosion in recent times (precise storm dates unknown).

The central to south-eastern two thirds of the beach mostly exhibited a fresh or “active” foredune erosion scarp with little slumping or incipient foredune accretion when inspected during 2022 (as shown in Figure 5). This part of the foredune has lost the greatest width since 2000. In contrast the foredune scarp along the north-western third of the beach was at the same dates looking less active

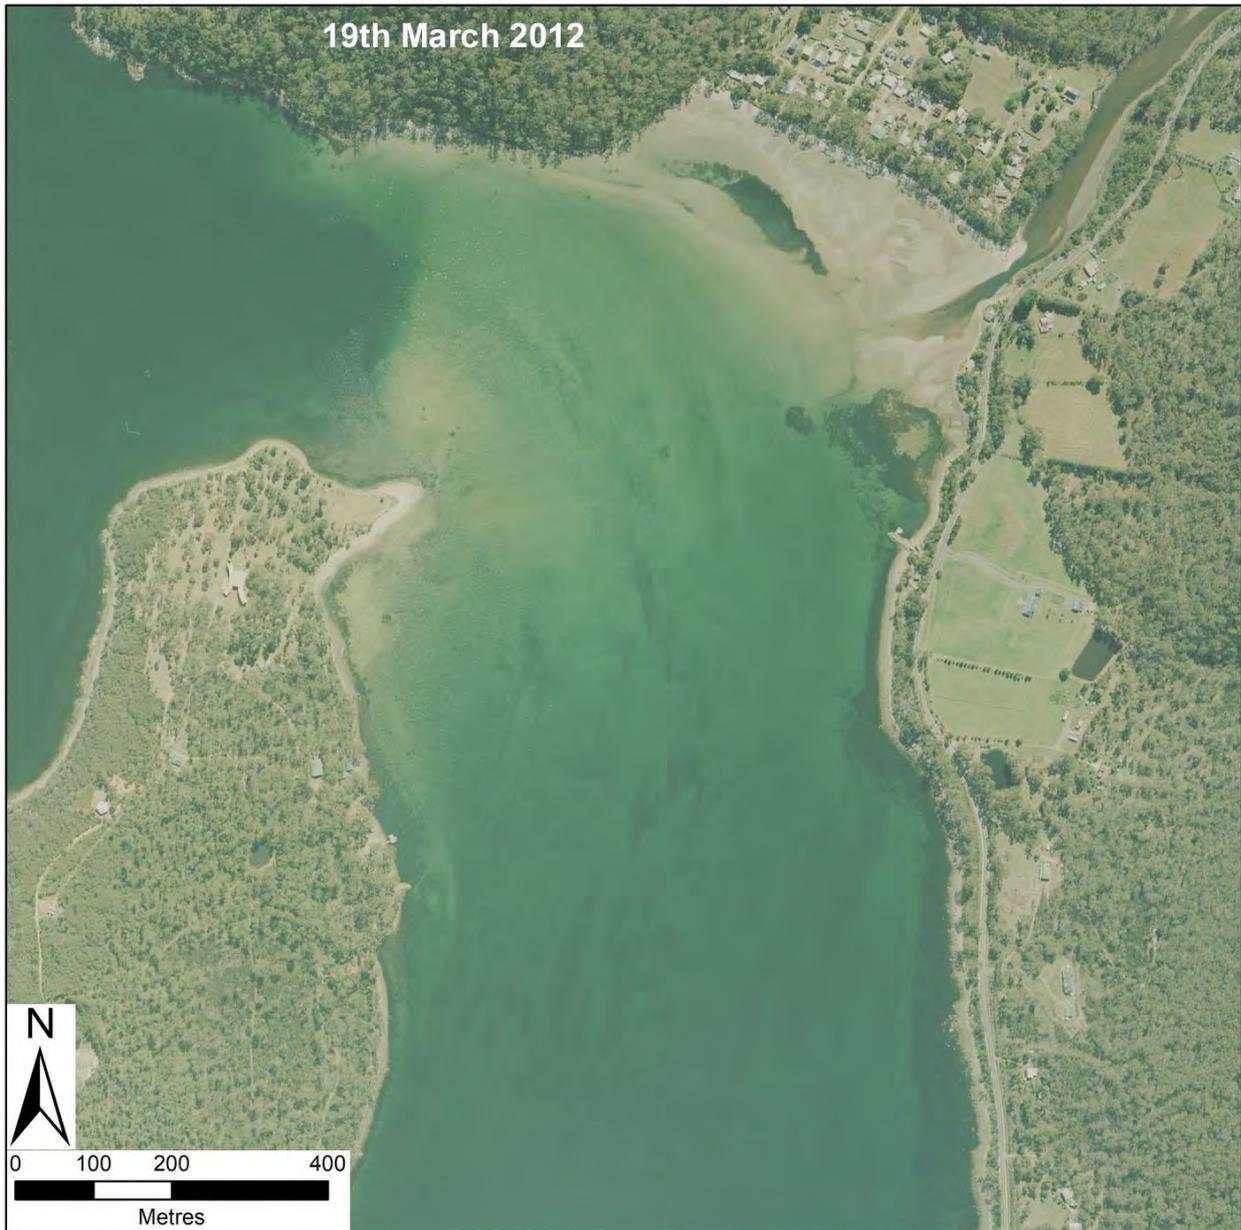
Figure 8: Distribution of shallow sandy seabed in relation to Garden Island and Garden Island Sands Beach. This image is a vertical colour air photo dated 19th March 2012 which provides a particularly clear view of the shallow sandy seabed free of surface water reflections (compare Figure 7). This view demonstrates the “sand trap” nature of the area between Garden Island and the Garden Island Sands Beach embayment. Most of the very ‘bright’ sand close to the vegetated shoreline is submerged in very shallow water but may be partly or wholly exposed at low tide. Dark patches in the sandy seabed are mainly seagrass beds. Air photo © NRE.

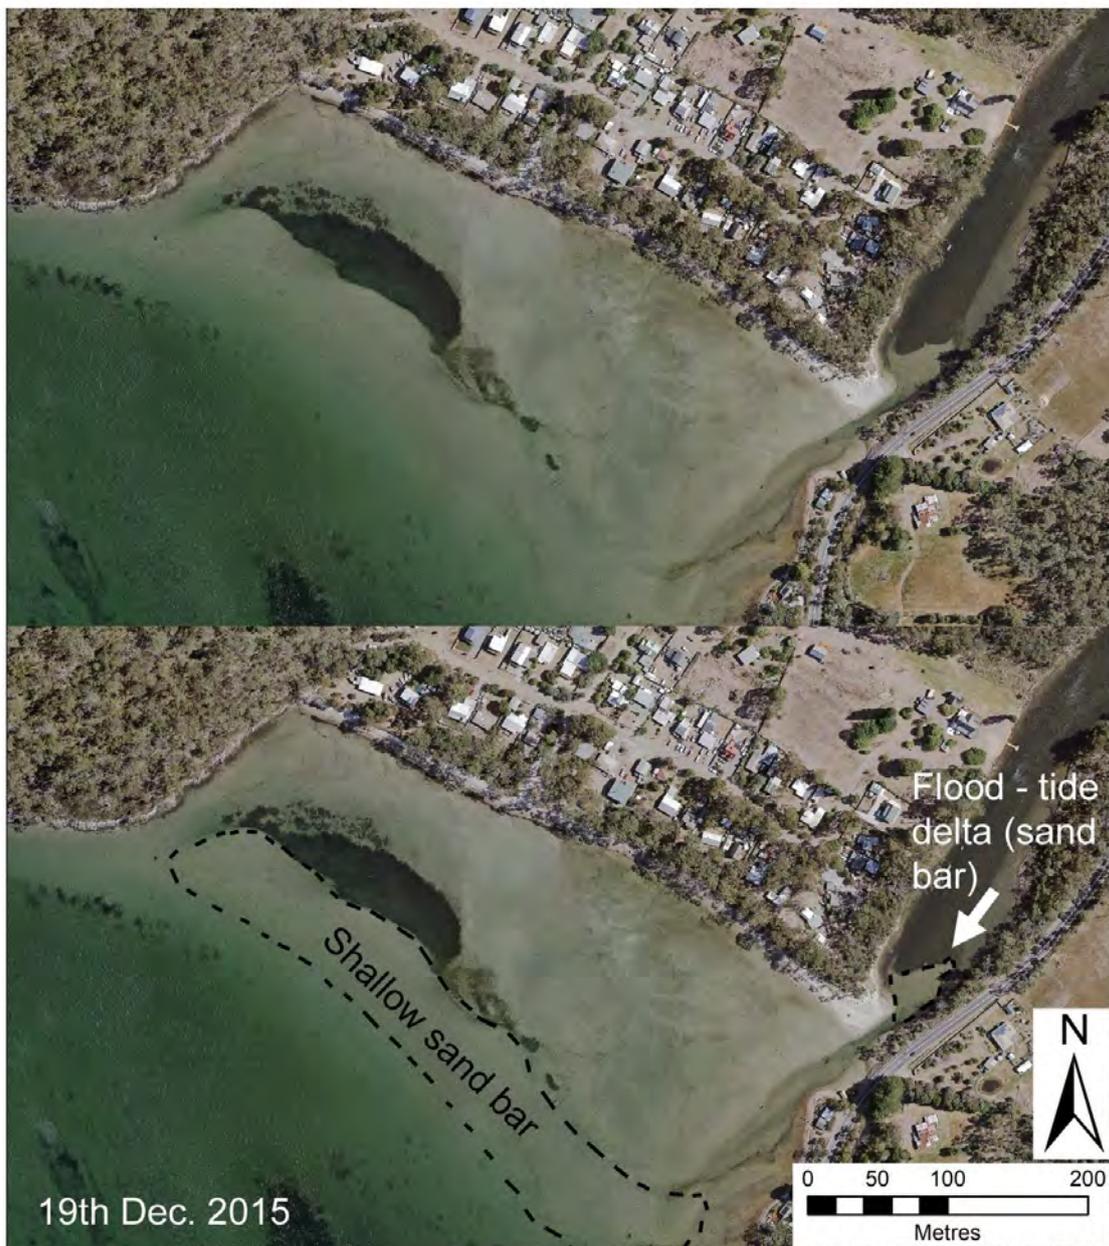
Figure 9: Air photo of Garden Island Sands showing shallow sub-tidal sand bar features. Original photo dated 19th Dec. 2015 (top) and annotated version (bottom) showing ephemeral sandy flood-tide delta in estuarine lagoon and shore-parallel shallow offshore sand bar encroaching landwards over the margins of a large seagrass bed. Air photo © NRE

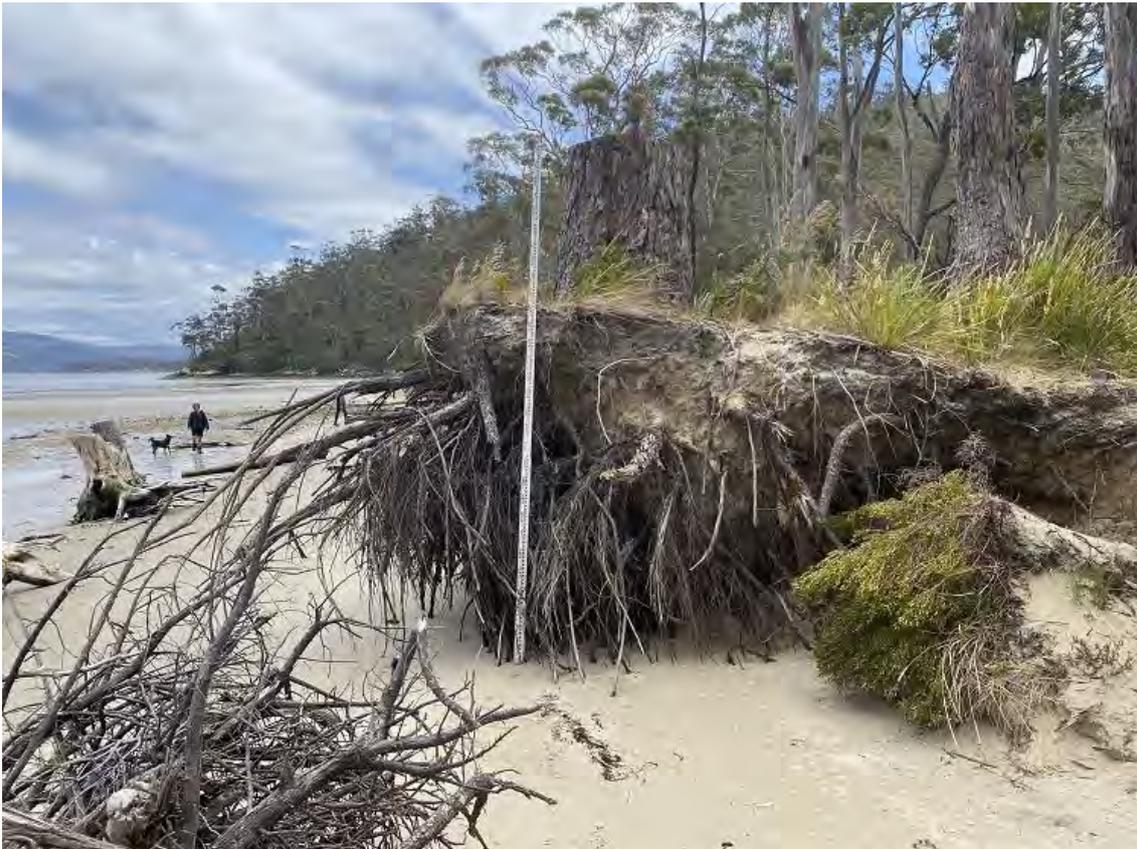
Plate 1. View west-northwest along Garden Island Sands Beach in January 2022, showing active coastal erosion. Sharples (2023) has indicated the present scarp at the rear of the beach has retreated landwards 7 – 10m since 1948.

Coastal erosion of the beach has concerned residents for some time, and its landward retreat may be accelerating (Plate 1). Beach amenity is being lost and property is increasingly threatened.

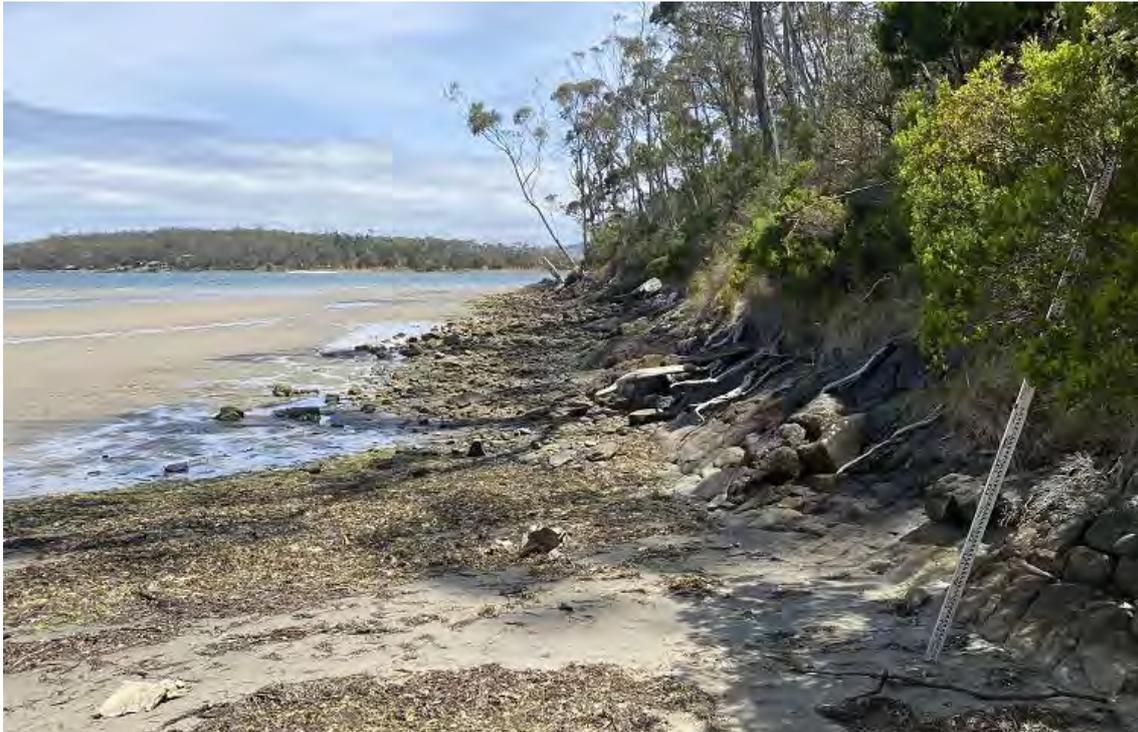
Plate 2 (above). View southwest from the western end of Garden Island Sands Beach, across the Huon River to Garden Island. Fractured, relatively fresh and unweathered dolerite bedrock crops out in the bank (arrowed, at right), and is exposed on a narrow wave-cut platform at low tide (arrowed, centre). The staff at right is 2m long. (Photo: 3 January 2022).

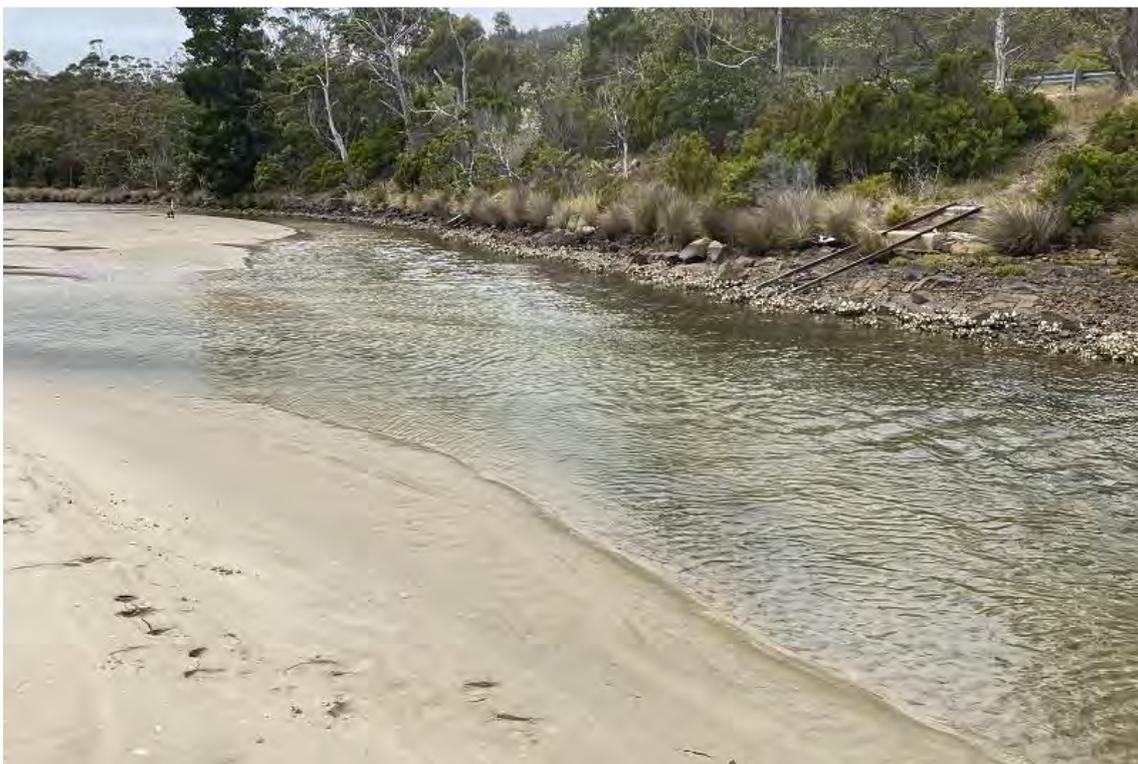
Plate 4 Layers 1 and 2 sand in test pit B. The detail shows types of gravel present in Layer 2. Layers 1 and 2 materials are reasonably typical of materials in all six test pits, and by inference, beneath the full length of the beach. The large numbers on the scale are decimetres.

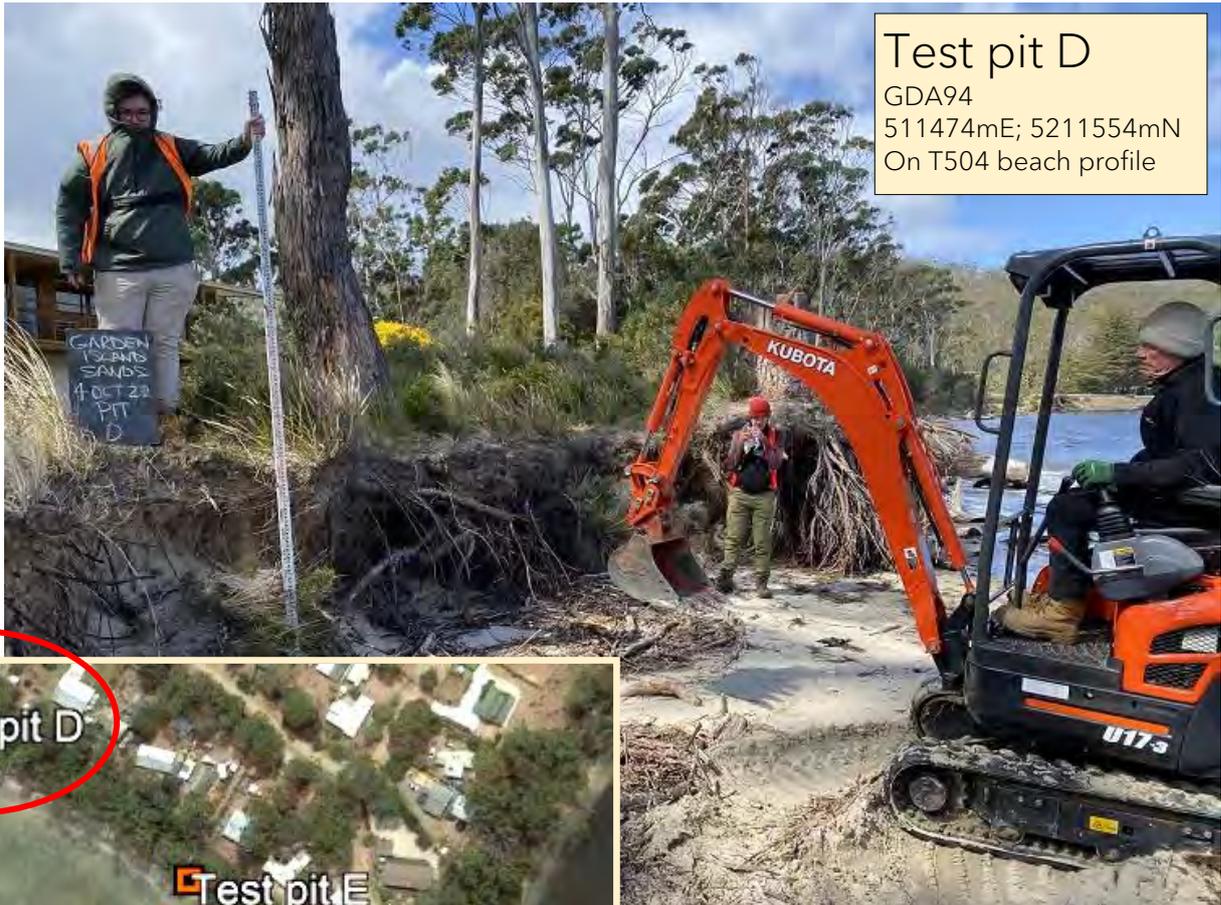
Test pit D

GDA94
511474mE; 5211554mN
On T504 beach profile

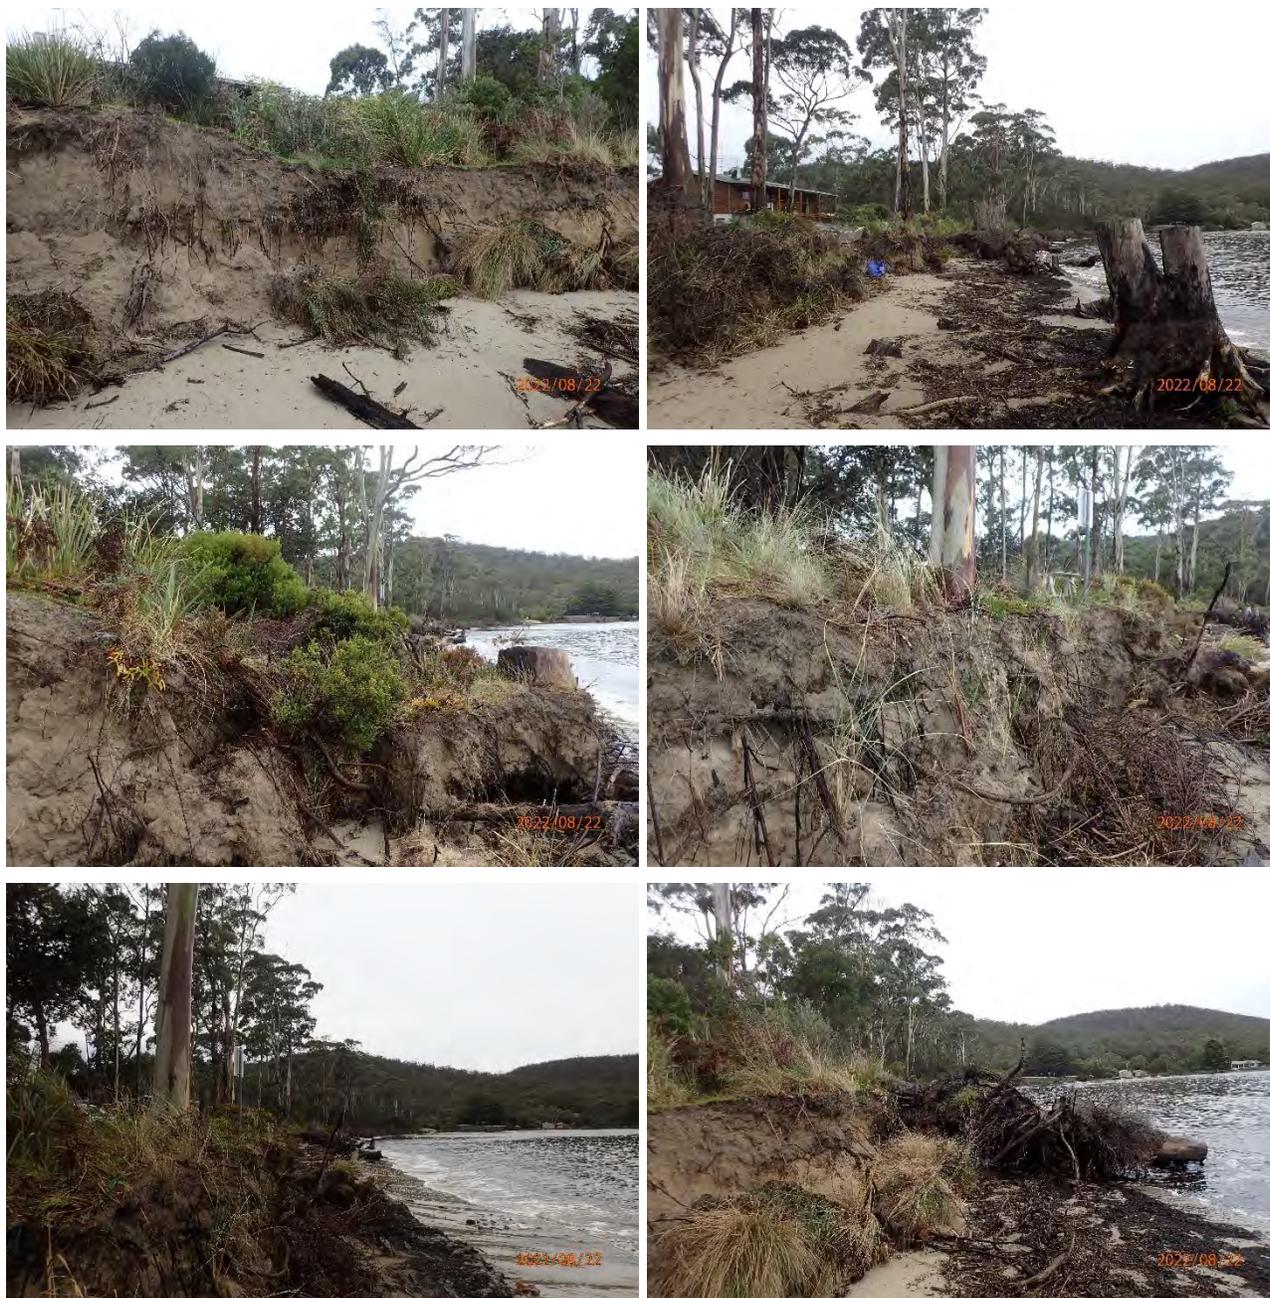
Plates 1-6. Examples of active coastal erosion along face of study area

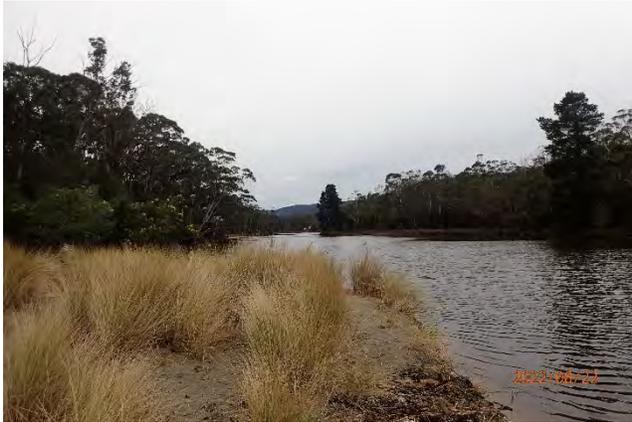
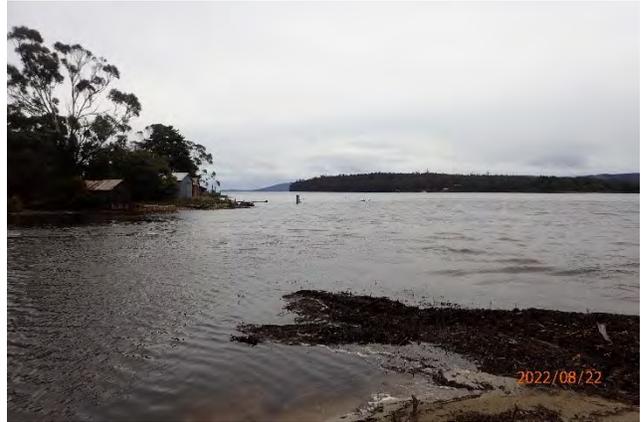
Plates 7 & 8. Mouth of Garden Island Creek at southeast end of study area

The study area is topographically simple comprising flat terrain a metre or so above a variable width sandy beach with a steep front subject to ongoing coastal erosion (Plates 1-6). There are no marked drainage features present within the actual study area, although Garden Island Creek forms the southeastern boundary (Plates 7 & 8) and an unmarked but seemingly permanent creek forms the northwestern boundary (Plates 9 & 10). The study area supports mainly native forest dominated by *Eucalyptus viminalis* (white gum) with a variably dense understorey (Plates 11 & 12), with some areas impacted by local activities resulting in canopy and understorey modification to the point of local areas being classified as some form of modified land (Plates 13 & 14). The shifting sandspit at the mouth of Garden Island Creek is locally dominated by *Ammophila arenaria* (marram grass) – Plates 15 & 16. Lowes Road extends from the crossroad with Sunset Drive to extend between 14 & 16 Sunset Drive to access an informal car parking and turning circle at the site of the old jetty (Plates 17 & 18). There is also a narrow walkway between 30 & 32 Sunset Drive that provides access to the reserve.

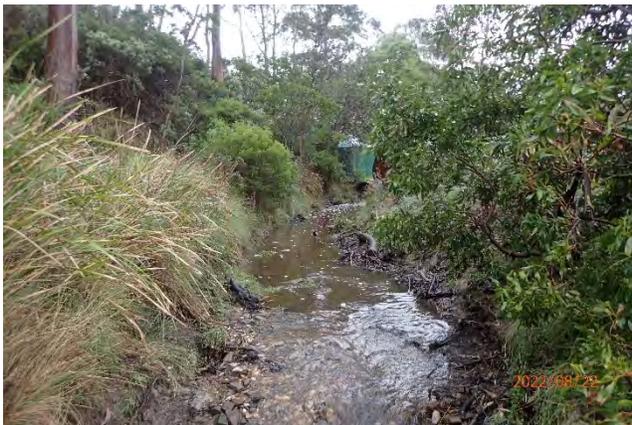
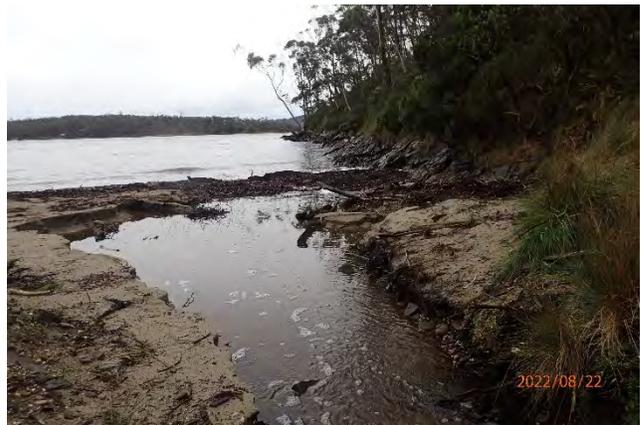
Plates 9 & 10. Small unmarked and un-named creek at northwest end of study area

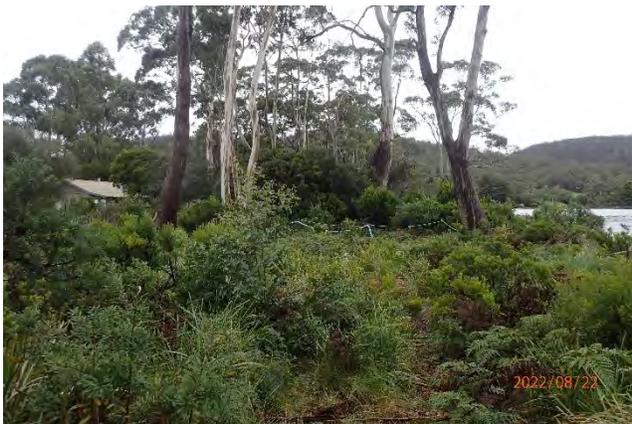
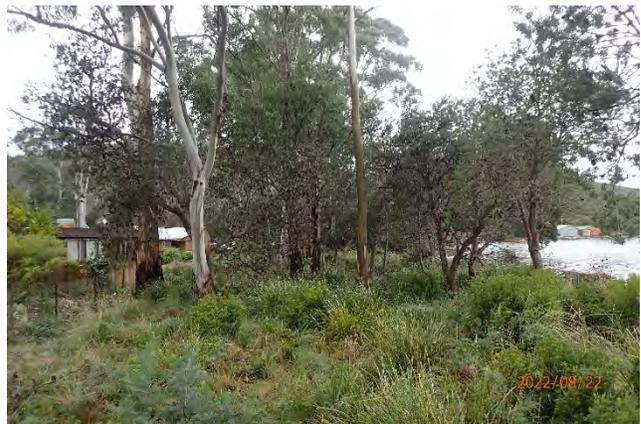
Plates 11 & 12. Examples of *Eucalyptus viminalis*-dominated forest that dominates the study area

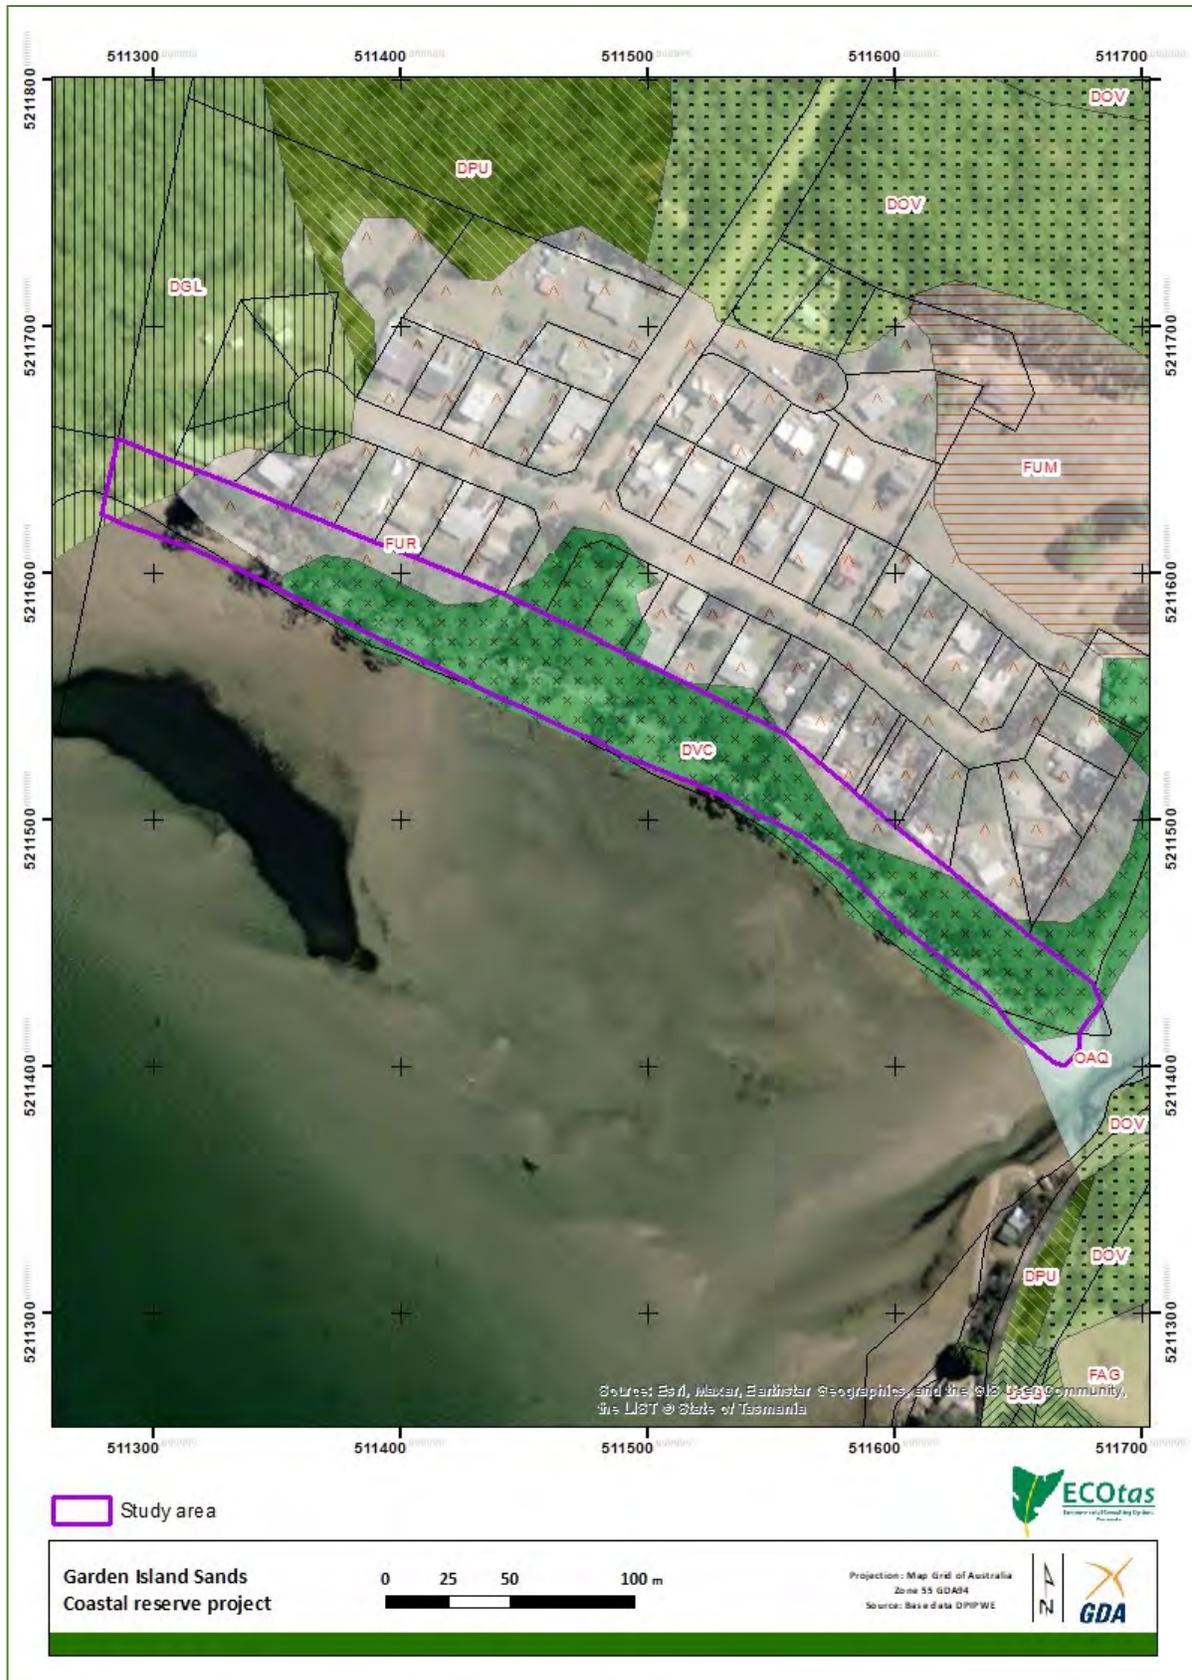
Figure 10. Study area and surrounds showing existing TASVEG 3.0 & 4.0 vegetation mapping (see text for codes)

In the case of the present study area, TASVEG 3.0 & 4.0 are identical (Figure 10) but TASVEG Live is marginally different (Figure 11), with the study area and surrounds as:

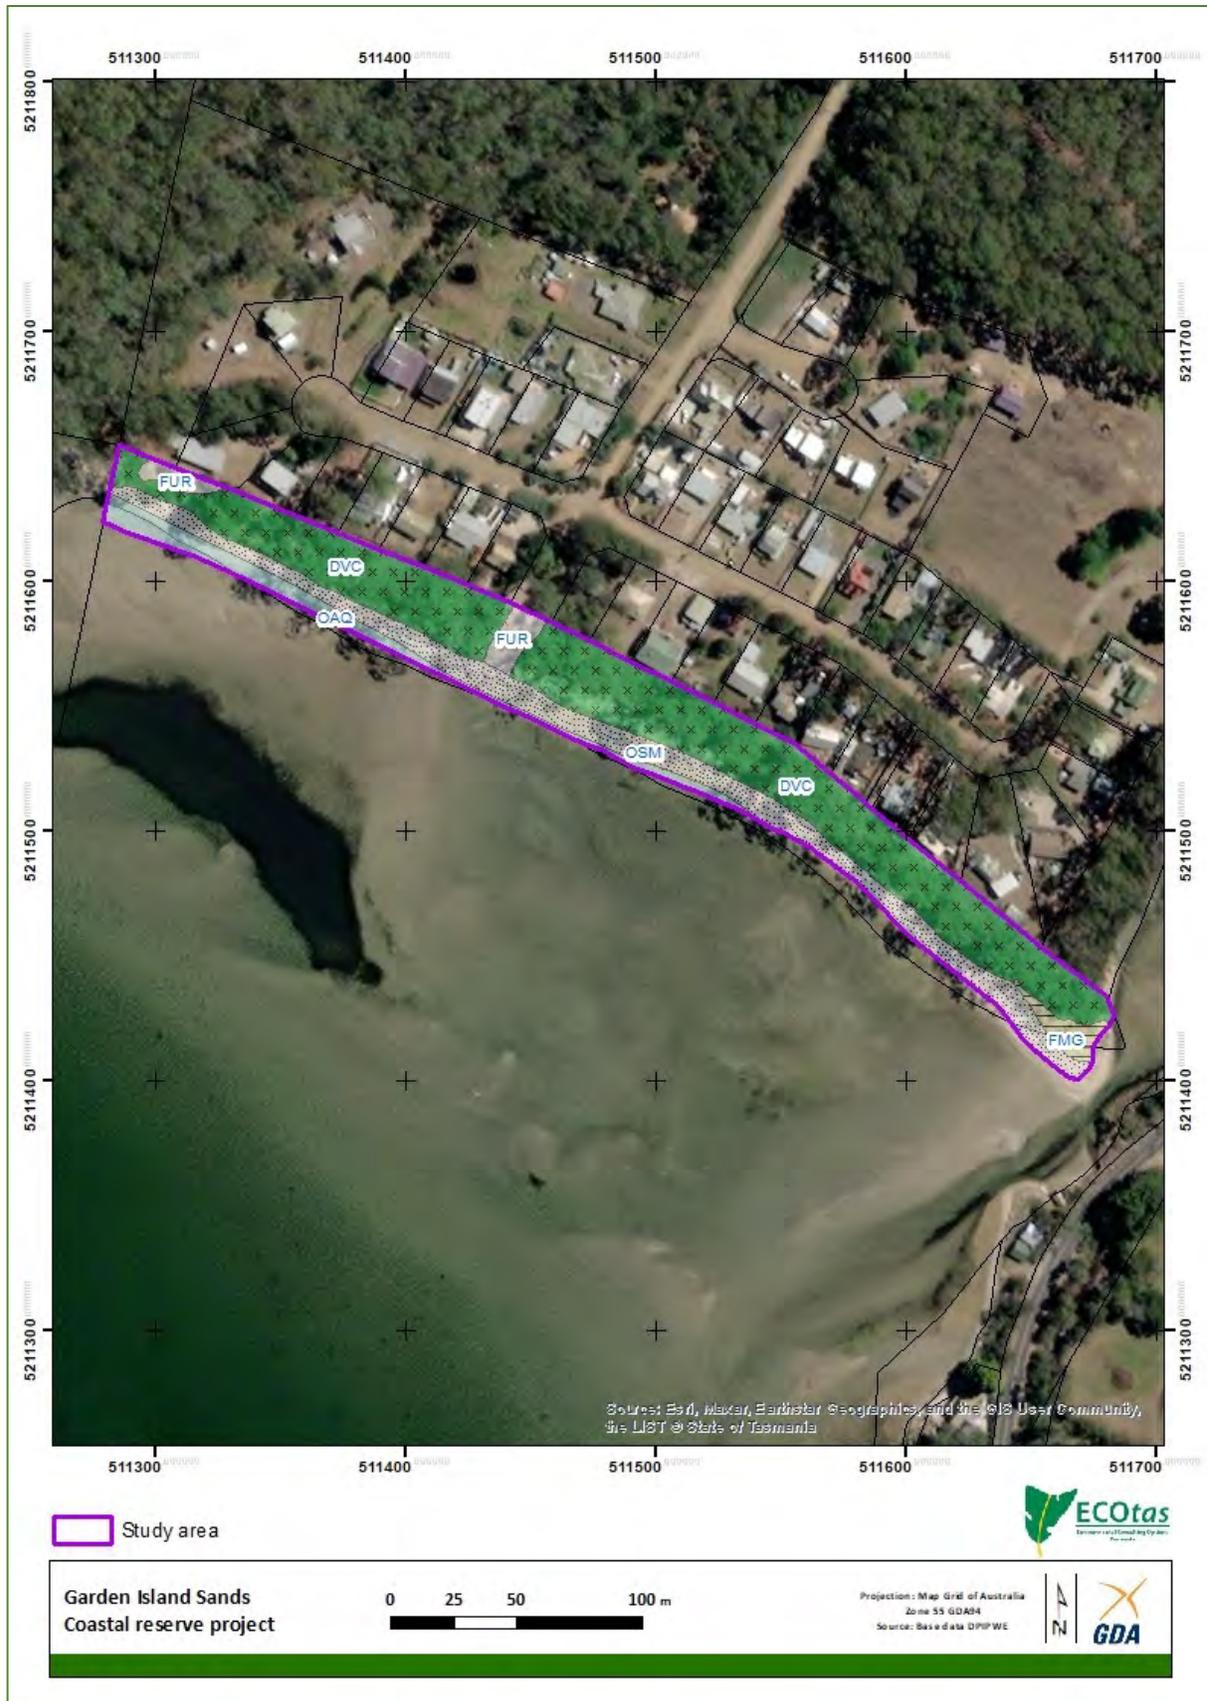
Figure 12a. Revised vegetation mapping: overview (see text for codes)

Existing vegetation mapping (Figures 10 & 11) and revised vegetation mapping (Figure 12) indicates that no such threatened ecological communities occur within or adjacent to the study area. There are no implications under the Commonwealth *Environment Protection and Biodiversity Conservation Act 1999* in relation to vegetation types.
