Garden Island Sands

Beach Access and Erosion Management plan

Report prepared for The Friends of Garden Island Creek

July 2023

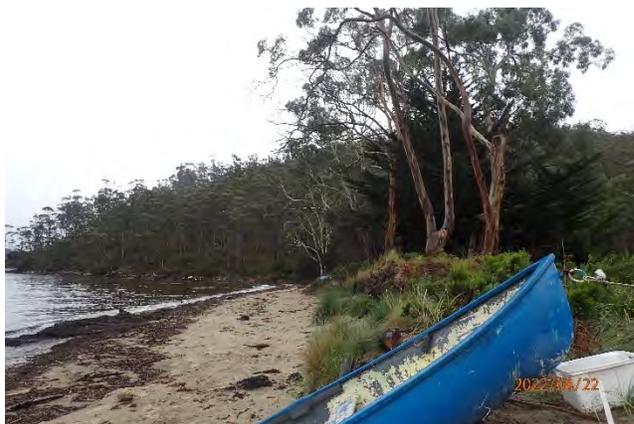
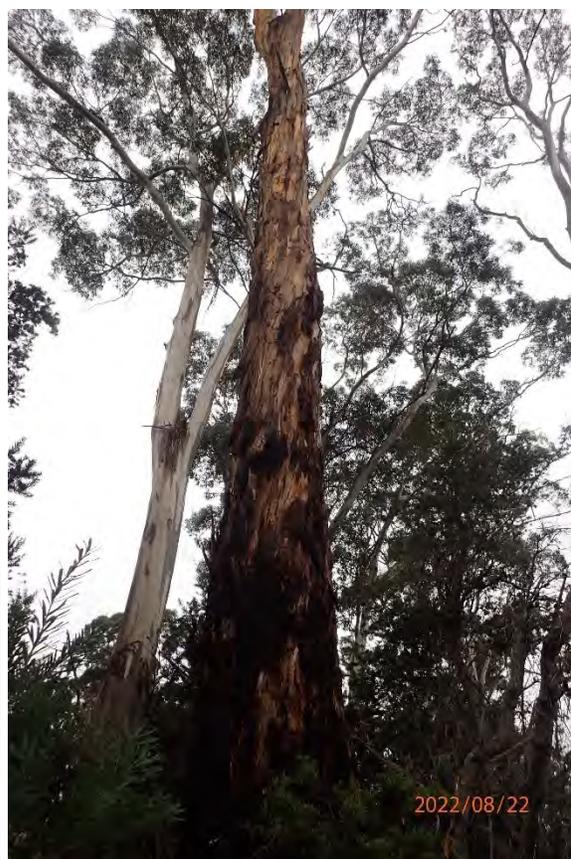
Plate 35. (LHS) Two trees with symptoms of “ginger tree syndrome” near the mature macrocarpa pine (one each side of apparently healthy tree in middle)

Plate 36. (RHS) View of the single tree showing symptoms of “ginger tree syndrome” in eastern part of study area

Several individuals of *Eucalyptus viminalis* within the study area appear to be suffering “ginger tree syndrome” (Figure 16, Plates 35 & 36). At some point, these trees may become “unsafe” and require removal. It may be prudent to monitor any further development of “ginger tree syndrome” and manage trees accordingly, including consideration of supplementary planting to offset any loss.

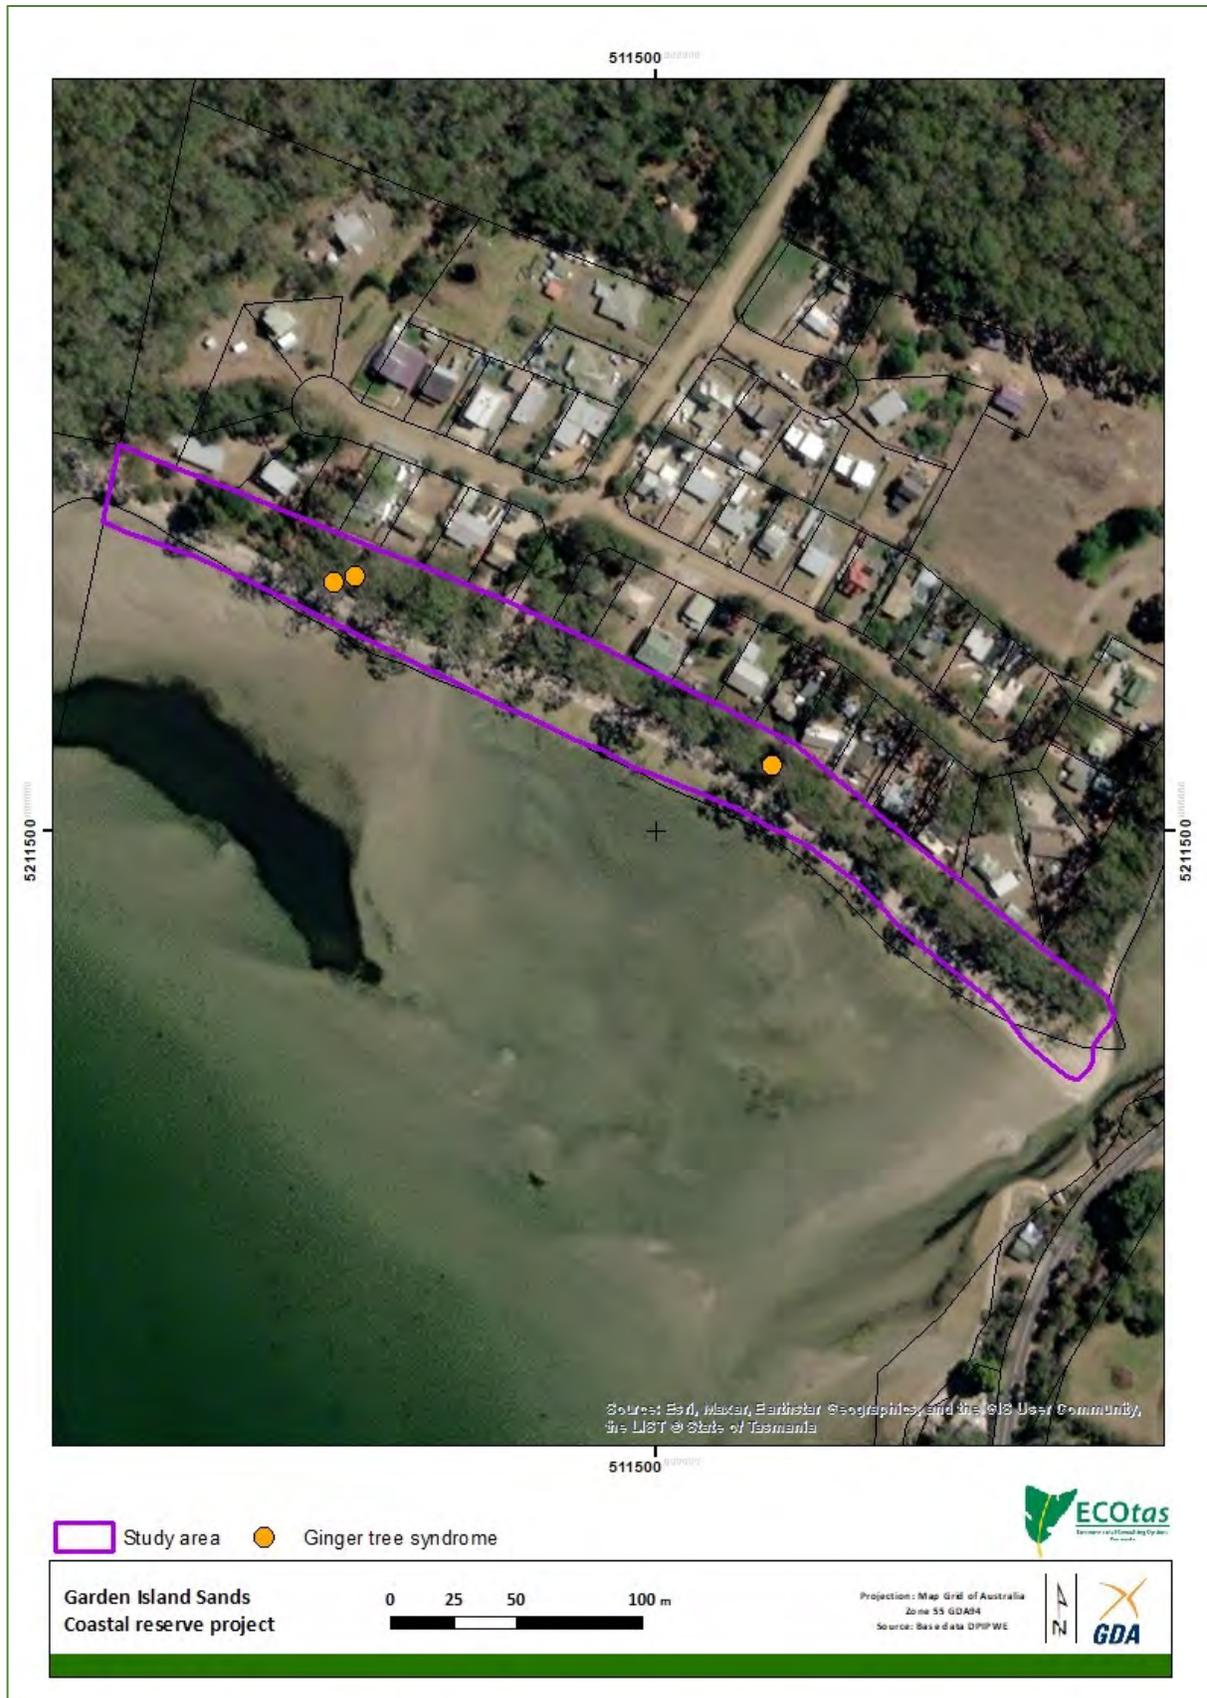
Figure 16. Location of trees showing symptoms of “ginger tree syndrome”

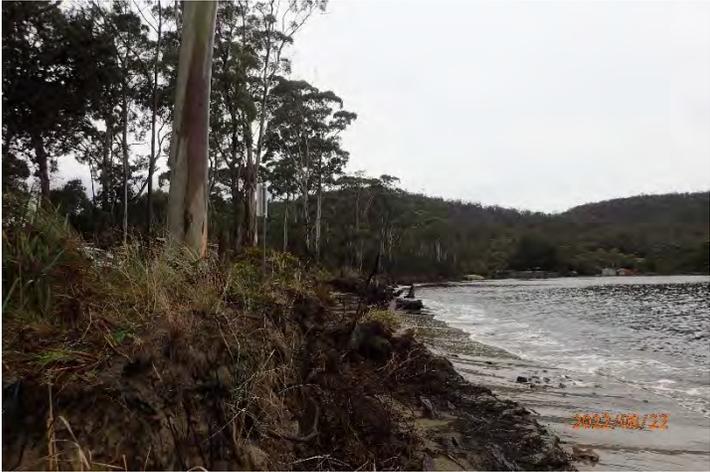
View east along foreshore showing eroding DVC		
Stratum	Height (m) Cover (%)	Species (underline = dominant, parentheses = sparse; + = present only)
Trees	30 m 30%	<u><i>Eucalyptus viminalis</i></u> [weeds: <i>Hesperocyparis macrocarpa</i>]

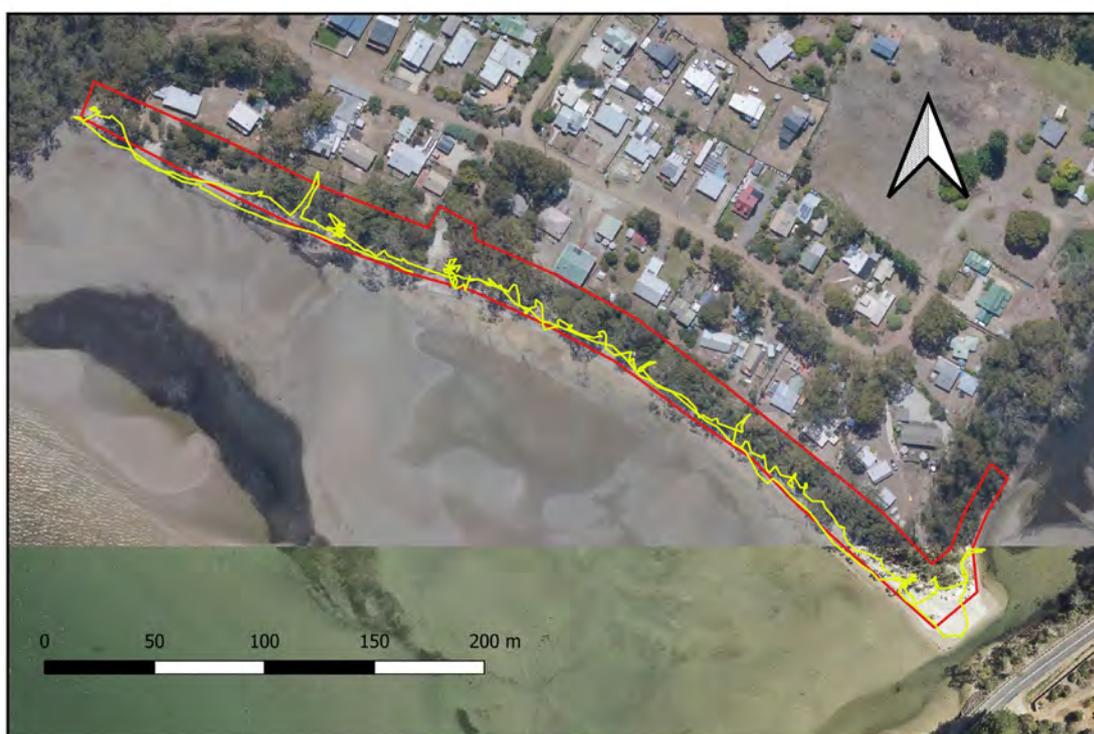
Figure 13: Aerial photo showing the PIA (red) and informal transects (yellow) following the extent of the eroded foredune.

Field methods employed for the assessment involved the undertaking of pedestrian transects of the beach and the exposed cutting where mitigation works are to take place. Given the narrow width of the PIA, informal transects following the eroded bank were employed (Figure 8). Vegetation cover inland from the

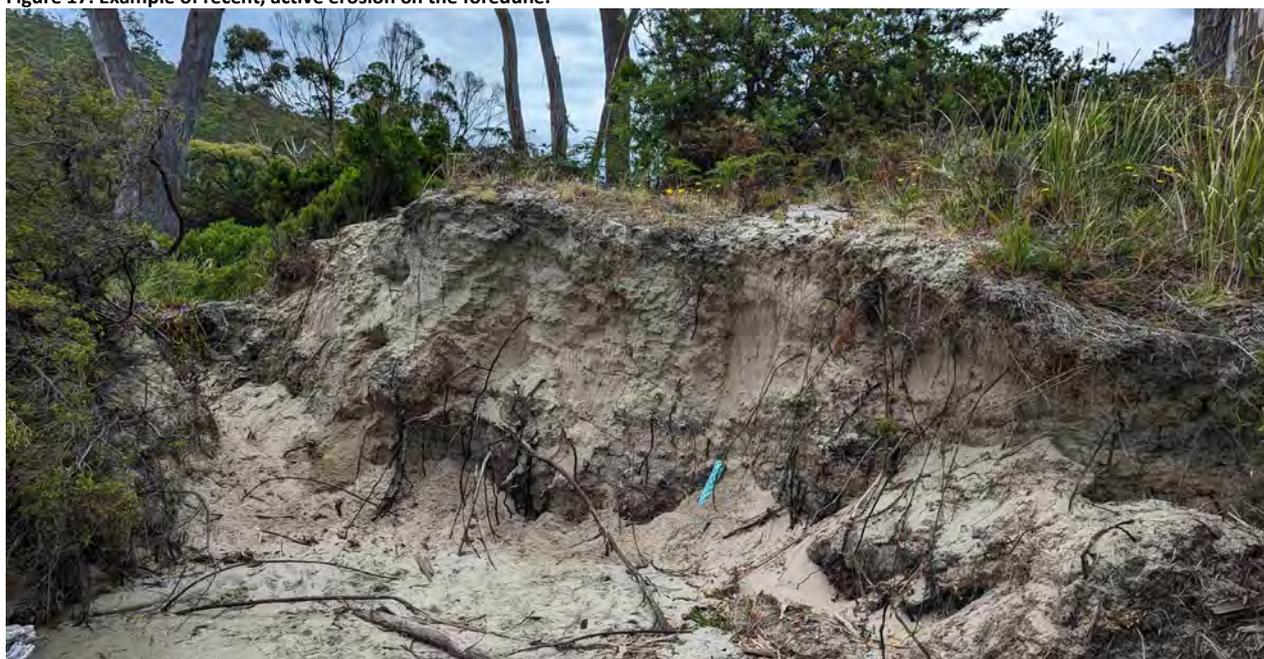
Figure 18: Example of recent, active erosion on the foredune.
