Westland Whirlwind Mk.I, P7056 'Pride of Yeovil'

Whirlwind Fighter Project

Autumn Interim Update 2025

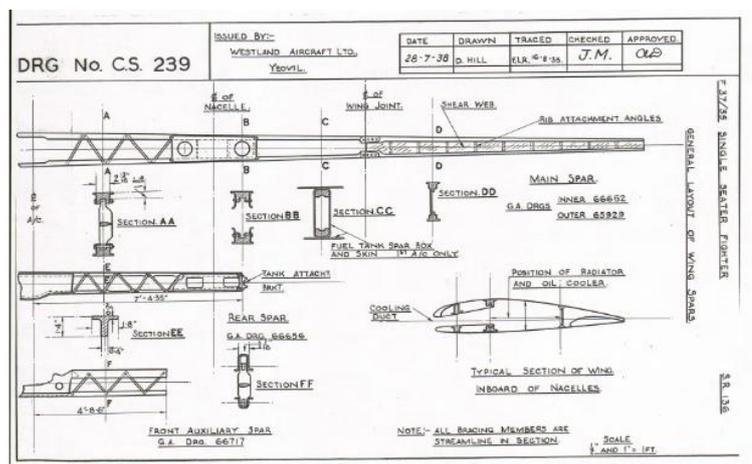
Whilst drawing up the CAD model from surviving Westland drawings, Gunnar Olsen noticed some discrepancies around the wing centre section that couldn't be easily explained. In discussion with Pete Smith, our Chief Engineer, they concluded that the model produced from the drawings, such as the one here, to not be consistent with the information used to build the model for the cockpit and fuselage. There was clearly something amiss.

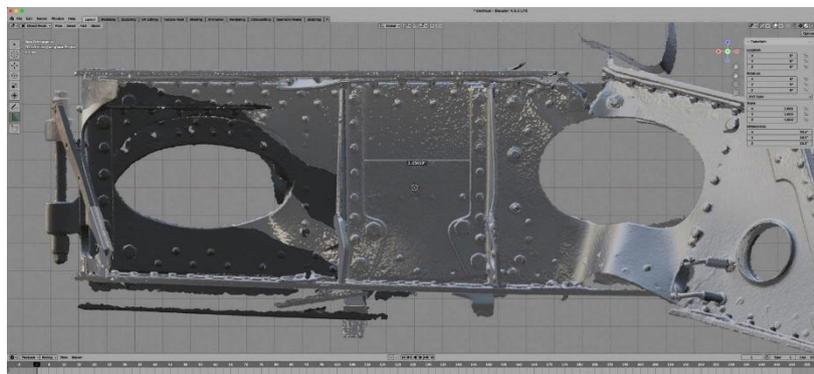
These scans are very useful and important. Scanned image of a part without a drawing imported to Gunnar's modelling package.

Fortunately, we had wreckage from P6966, specifically the spars behind the nacelles, and various laser scans of these parts by our 3D printing expert Jamie of Merlins-R-Us (tech that would be unimaginable in 1979) produced results that did not match the drawings.

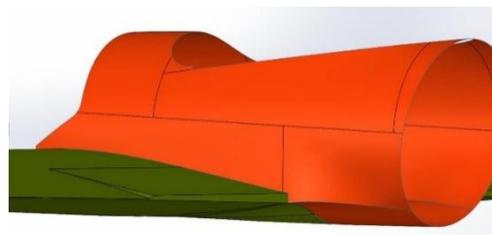
The first image is the actual drawing used to create the first model, the pre-production wing.

It turned out that the spar depicted in the surviving General Arrangement drawings was an early, superseded design, and by the time of the first production aircraft (which just happened to be P6966) there was a new, slightly different spar. All later drawings have long since disappeared.

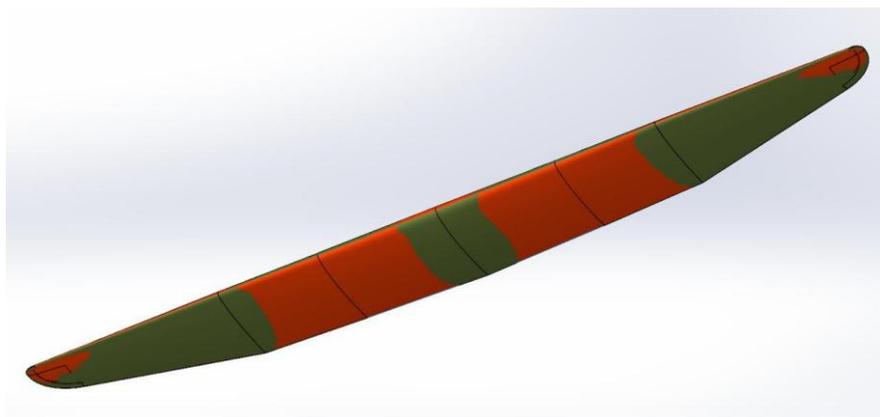
Lower surface – location of internal changes:

The 3D images show the difference between the original model and the corrected model. The orange areas are the original, the green are the new profiles. This fuselage/wing image shows there has been a small profile change at the wing root intersection. It's really small – but there all the same. The changes in the nacelle areas are more significant.

Of course, previous model kits and scale drawings have been based on the GAs and APs surviving from Westland and the Air Ministry - so this new information will have the side effect of rendering them all slightly 'wrong' in that the wing profile is slightly 'off' - in the areas that are green in the image above. Our Whirlwind, however, will be 100% accurate.

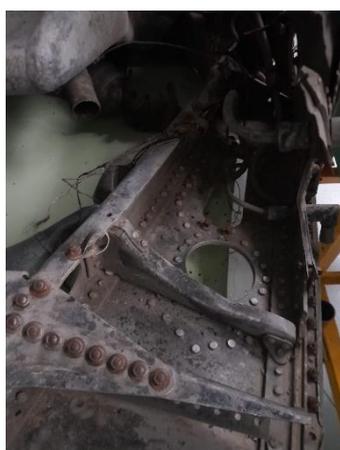
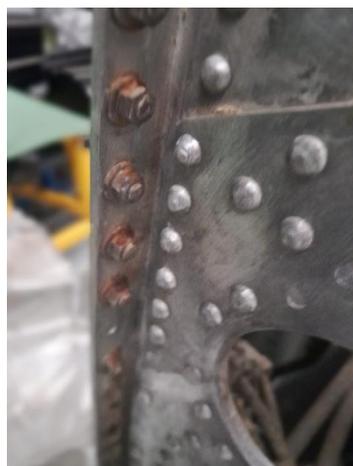
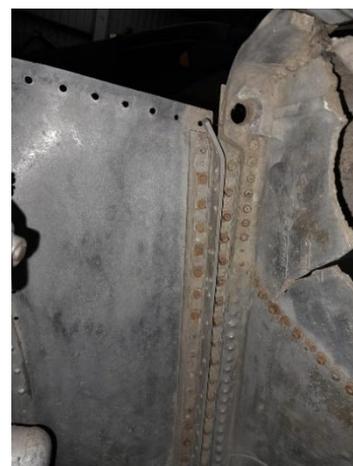
Pete and Jamie did also get into the inner recesses of the deformed parts of P6966 available to us – and took a number of pictures, and some measurements. Here's some that demonstrate that the strength of the aircraft really lay in the construction of the wing centre section. It was built like a tank.
