Inspection Report

Property Address:
123 Your Street
Decatur AL

20/20 Home Inspections LLC.

Date: 8/21/2014	Time:	Report ID:
Property: 123 Your Street Decatur AL	Customer: Mrs. Jane Sample	Real Estate Professional:

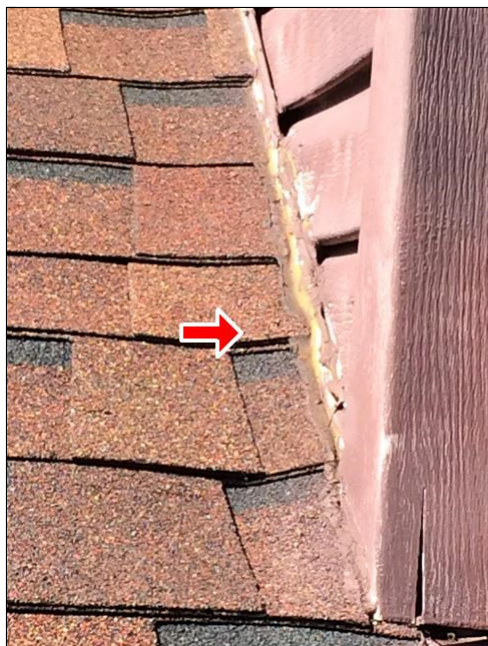
1.2 Item 1(Picture)

Picture #1 Previous repair between chimney and shingles is an indication that this area may not be flashed properly. It is likely that the water observed on the decking in section 5.5 is coming from this area.

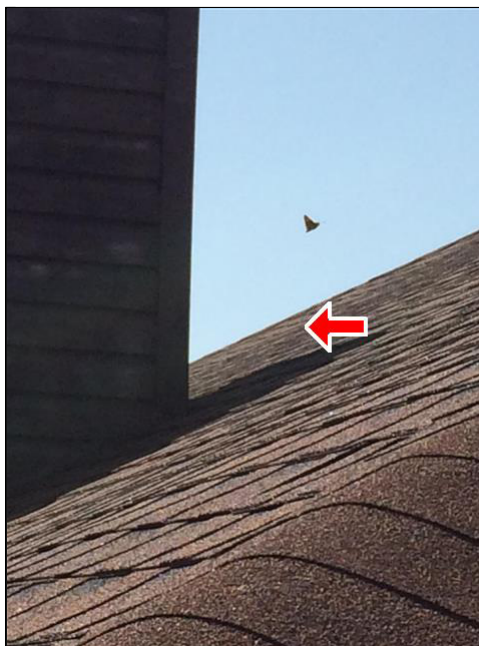
1.2 Item 2(Picture)

Picture #2 Back side of chimney should be equipped with a cricket so water is diverted away from the chimney. Recommend repair by a licensed roofing contractor.

As of a re inspection the roof repairs appear to be satisfactory but there had been no rain since the repairs were made. It is recommended that the buyers monitor this area for leaks and retain all warranty documentation for this repair from the seller before closing.

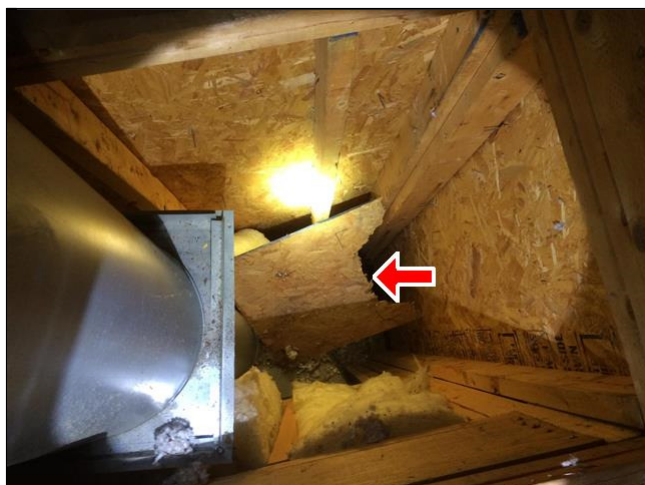
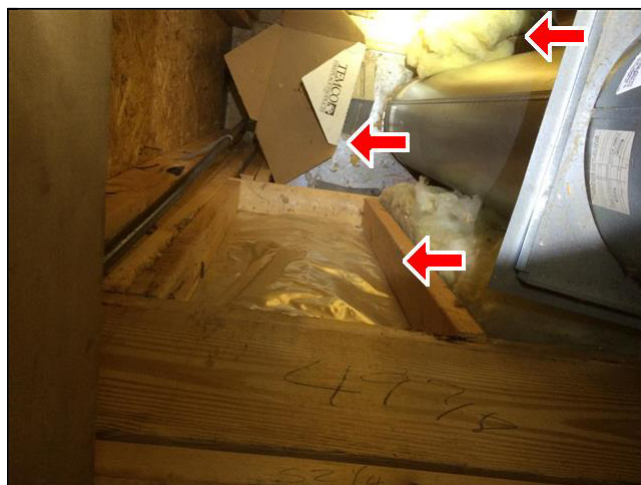
1.2 Item 3(Picture)

Picture #3&4 Roof decking, insulation and cardboard lying on top of the fire box as observed from the attic. This appears to have happened during the roof repairs and needs to be removed immediately as this is a fire hazard. Fallen insulation needs to be replaced in the wall cavity.

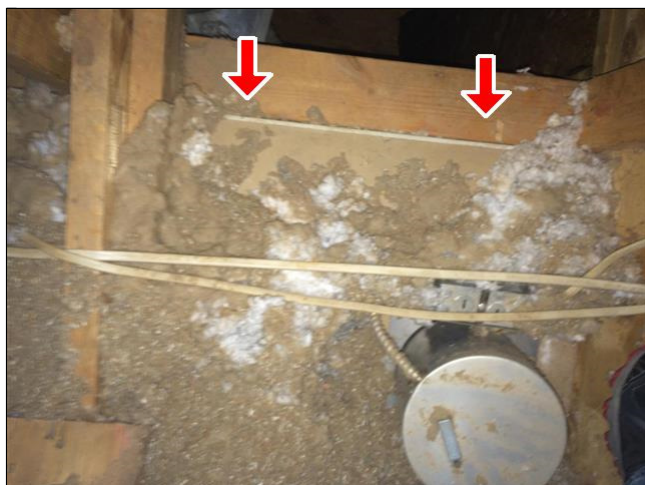
1.2 Item 5(Picture)

Picture #5 Insulation appears to have been displaced above the fireplace on the ceiling during the repairs and needs to be replaced. This will allow excess heat/cold to enter the home through the uninsulated walls and ceiling.

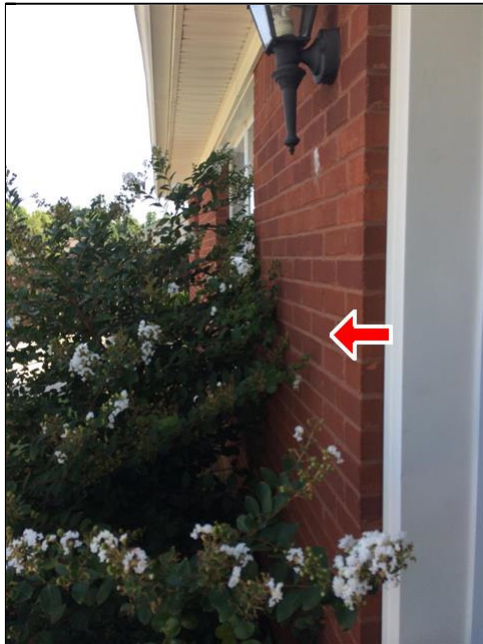
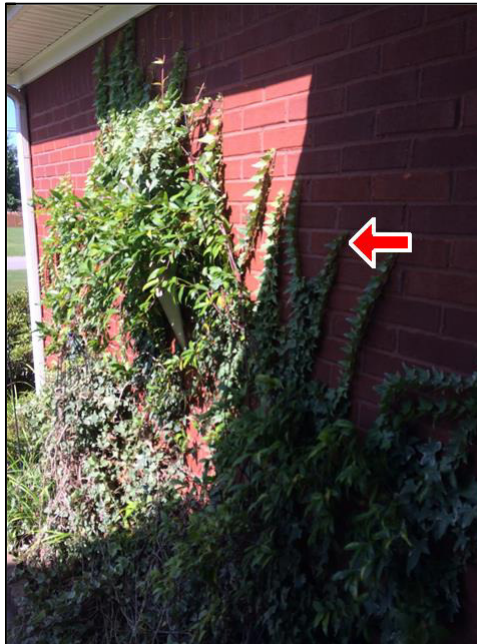
2.4 Item 1(Picture)

Picture #1,2 All landscaping should be pruned away from the house.

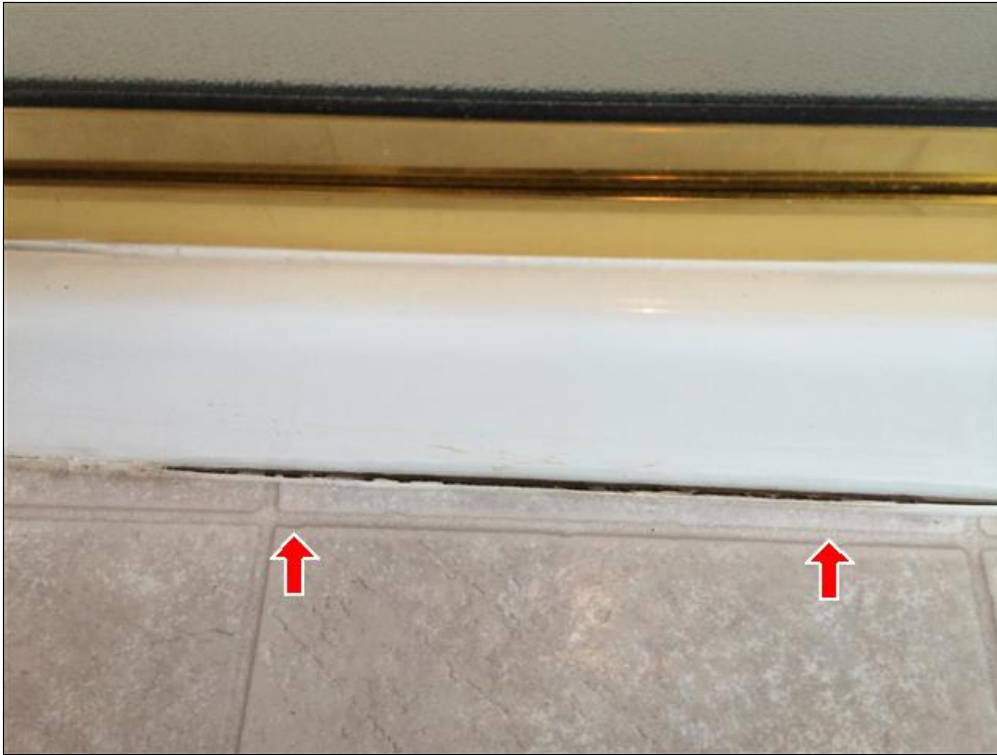
4.2 Item 1(Picture)

Picture #1 Laminate needs to be caulked next to shower in master bathroom.

This area appears to have been properly repaired as of re inspection.

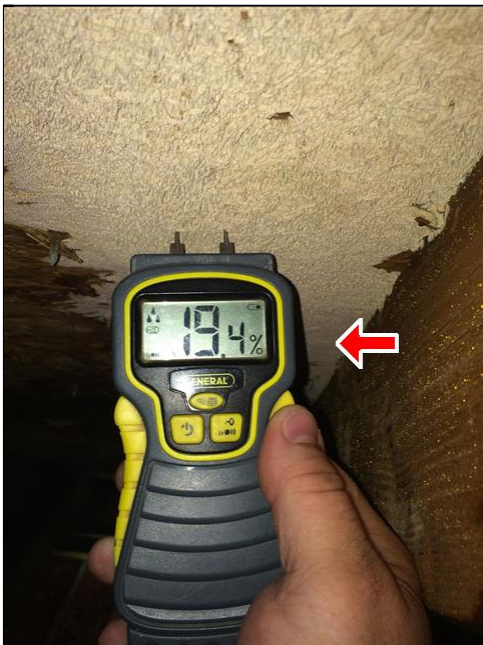
5.5 Item 1(Picture)

Picture #1 Active water leak to the left and below chimney. There is also fungal growth in this area. Recommend further evaluation by a licensed roofing contractor and a licensed environmental contractor.

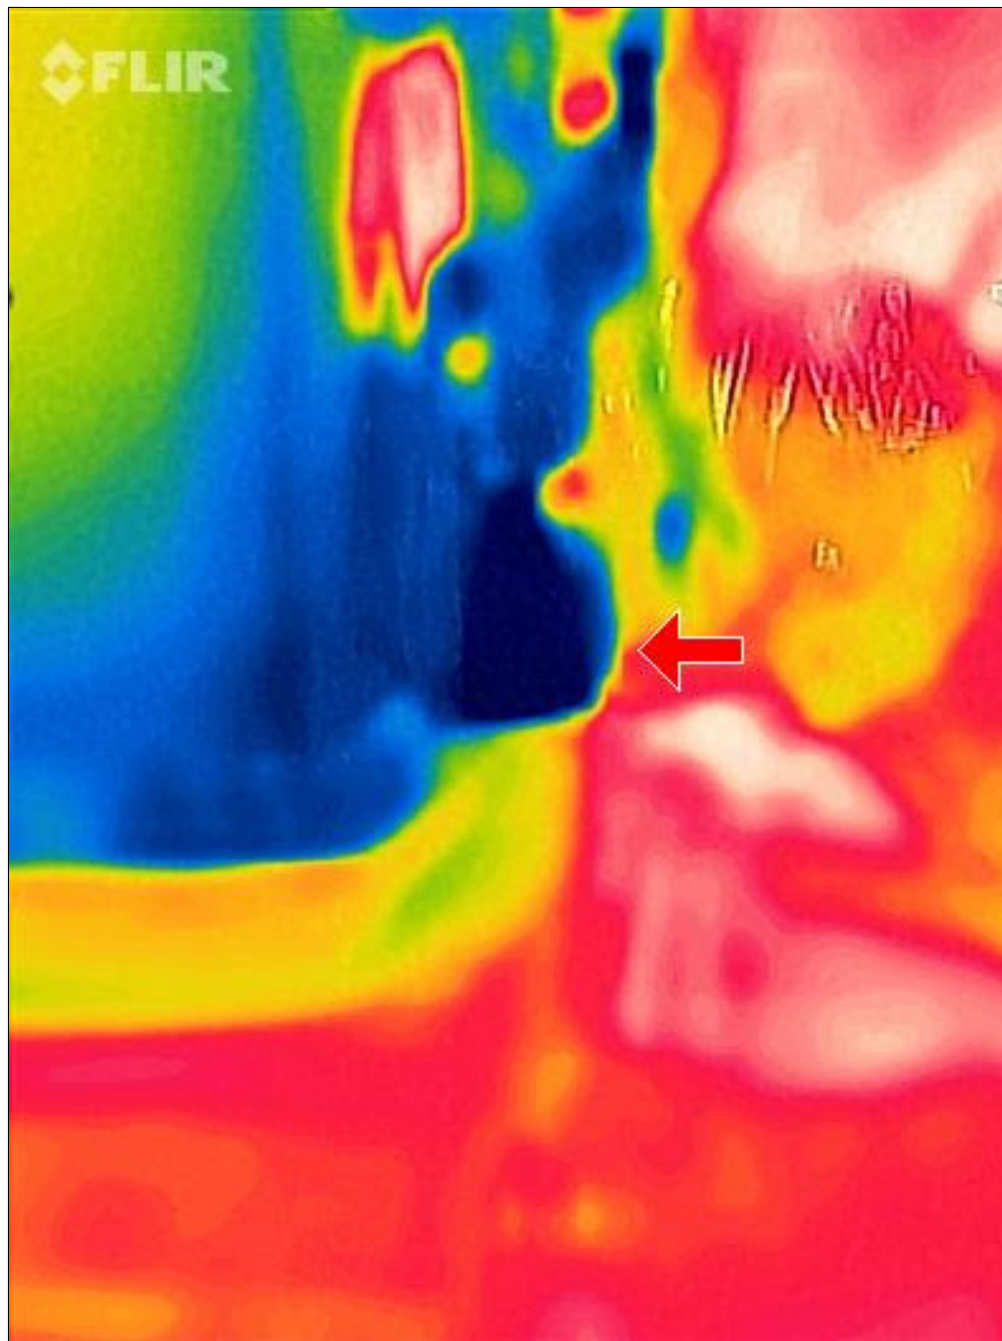
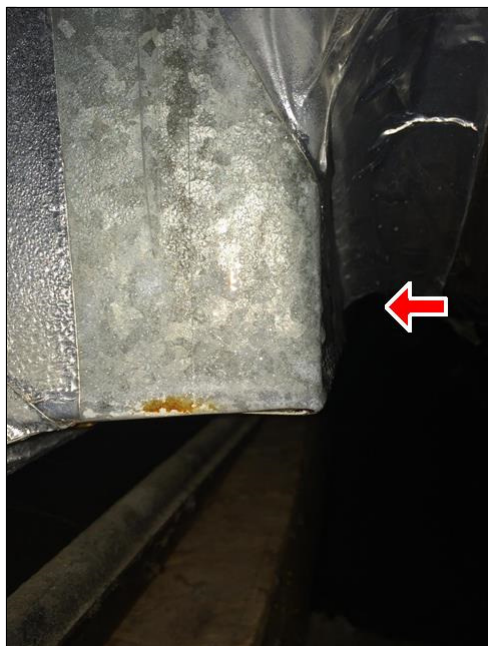
8.3 Item 1(Picture)

Picture #1,2 Air leak where air handler connects to ductwork which is causing heavy condensation in this area. Recommend repairs by a licensed HVAC contractor.

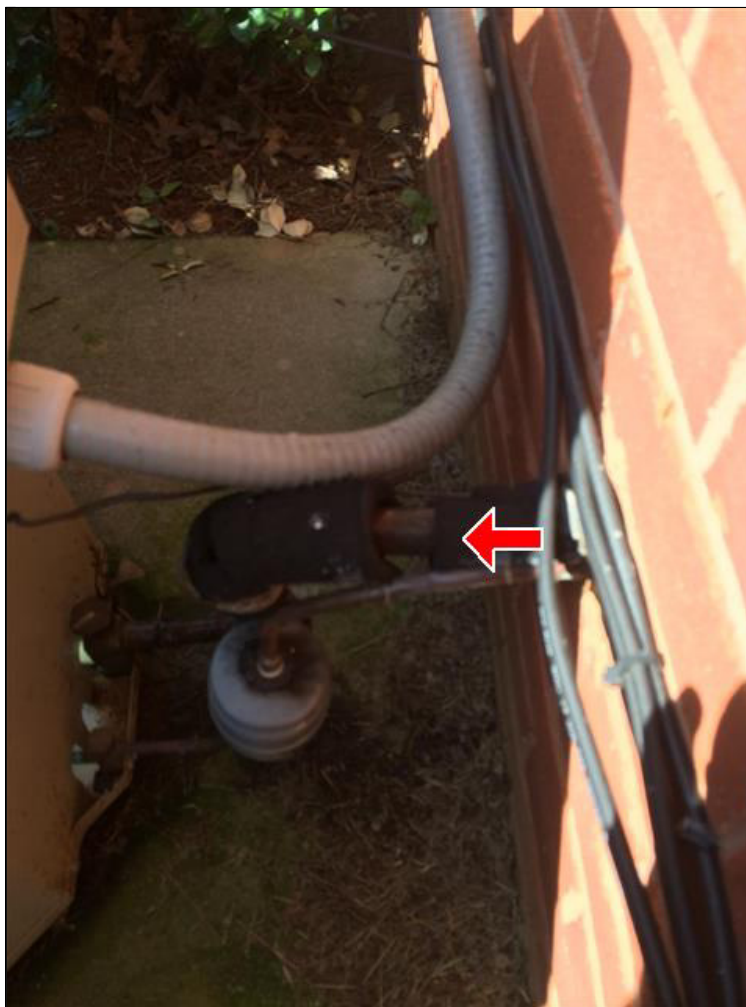
8.3 Item 3(Picture)

Picture #3 Missing insulation on outside HVAC evaporator line. This needs to be replaced.

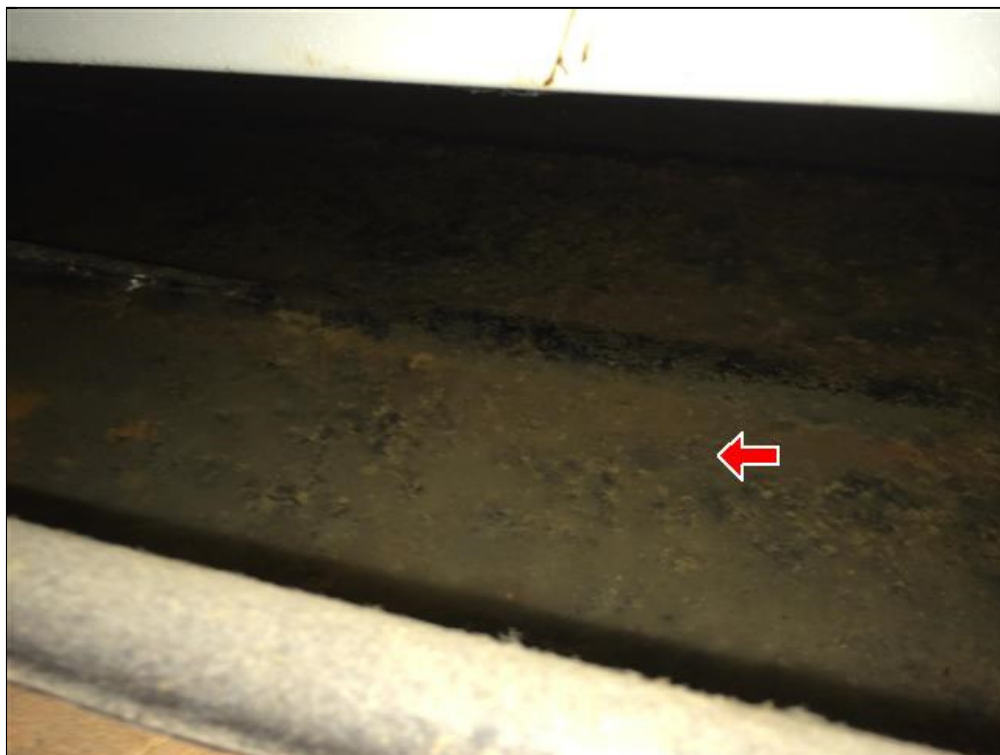
8.3 Item 4(Picture)

Picture #4 HVAC drain pan is full of water. There should be no water in this pan unless the primary drain line is stopped up. Recommend repair by a licensed HVAC contractor. Water was visibly dripping from the unit into the pan at time of inspection.

Primary drain line appears to have been repaired as no water was in the drain pan at time of re inspection.

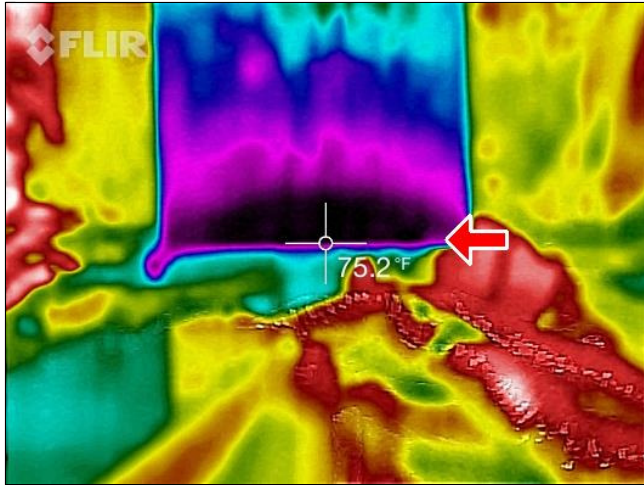
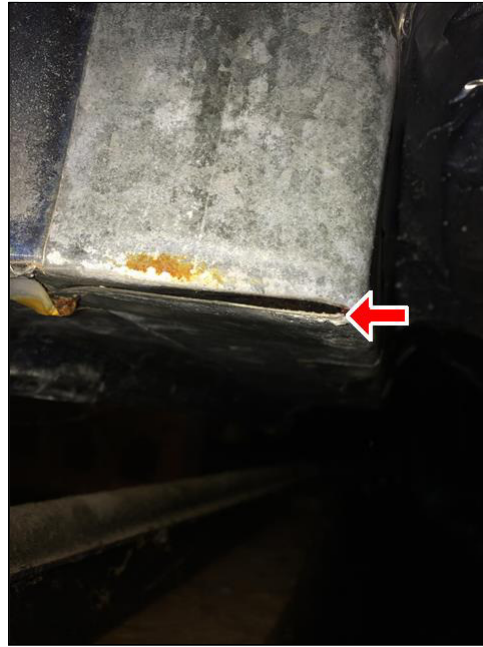
8.3 Item 5(Picture)

Picture #5,6 Air handler is still leaking at the bottom corner where it attaches to the ductwork.
