# **Inspection Report**

# **Nexus Home Inspections LLC**

> Property Address 123 Main Street, Hittsville, NY 12345

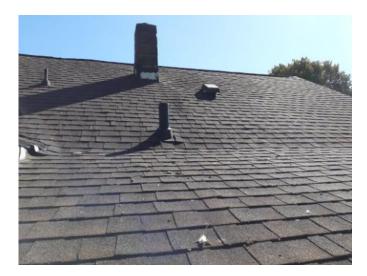
Monitor/Maintenance: Very minor moss covering was observed on the roof. While mostly cosmetic and not immediately harmful, this condition can indicate a moisture-related condition. This condition may also be seasonal depending on tree/leave coverage and the position of the sun during the changing seasons. The client should consult a roofing contractor or roofing supply company regarding maintenance related issues and products that can reduce this condition.

moss

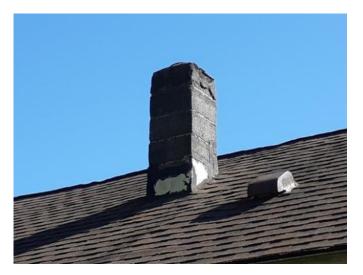
4.8) Chimney Conditions

Monitor/Maintenance: Recommend monitoring the chimney for any cracks or loose blocks. This can be common in older chimneys. The chimney did appear to be in a serviceable condition at the time of inspection.

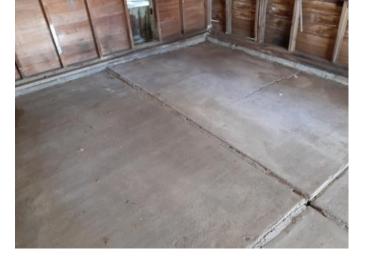
5.7) Window Conditions

Repair/Replace: Garae window was broken at the time of inspection. It is suggested that a "Licensed Electrical Contractor" be contacted for further evaluation and repair.

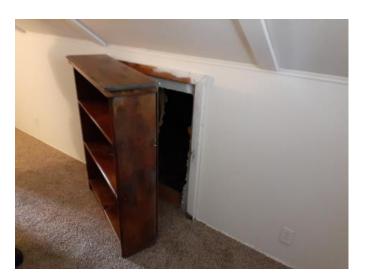
Possible mold/mildew like substance

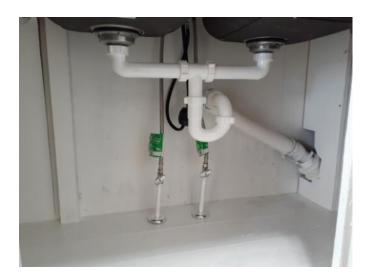
The kitchen sink appeared to be in serviceable condition at the time of the inspection. The faucet appeared to be in serviceable condition at the time of the inspection. The visible areas of the plumbing under the kitchen sink appeared to be in serviceable condition at the time of the inspection.

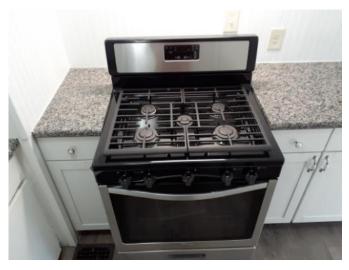
Stove-Range appeared serviceable at the time of the inspection

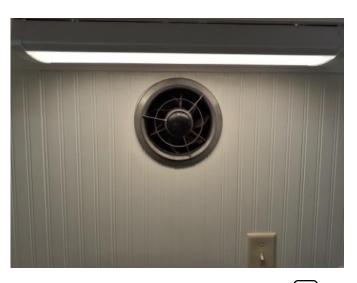
The fan/hood and light were in operational condition at the time of the inspection. The fan does get noisy but was working at the time of inspection.

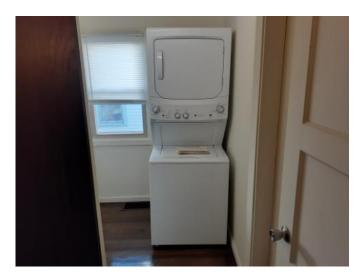
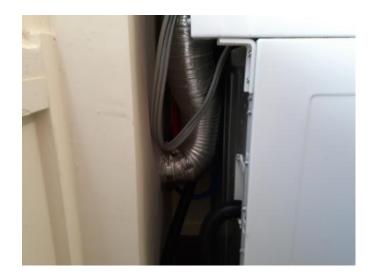
Appeared serviceable at the time of the inspection

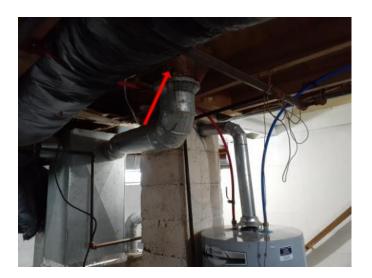
The visible and accessible portion of the venting flue appeared to be in serviceable condition at the time of the inspection.

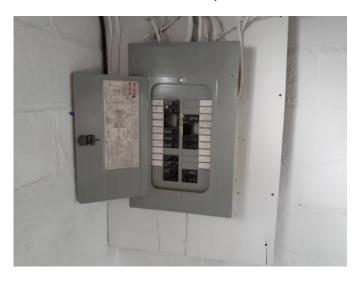
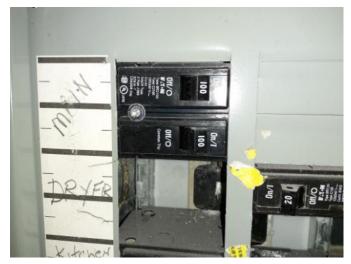
Main shut off

Safety Concern: The panel was missing covers where breakers were not installed. Recommend the installation of standard plastic covers for safety.

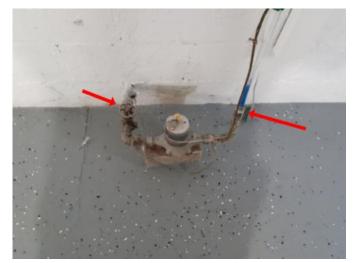
Shut offs

The main valve is located at the basement.

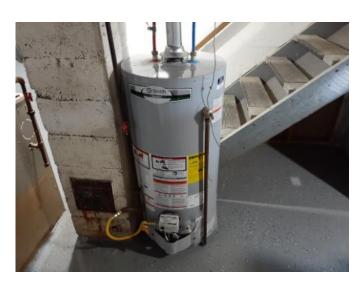
The water heater was operable at the time of inspection. This does not however guarantee future performance, operation, or condition.

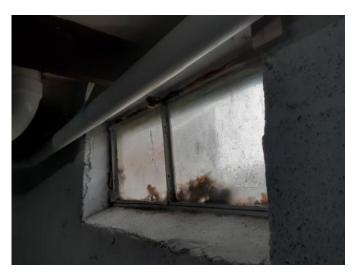
Missing glass panes

Repair/Replace: Most of the basement windows did not shut properly and one window was missing the glass panes. It was also noted that tape appeared to be holding some of the panes in. It is suggested that a "Licensed General Contractor" be contacted for further evaluation and repair.

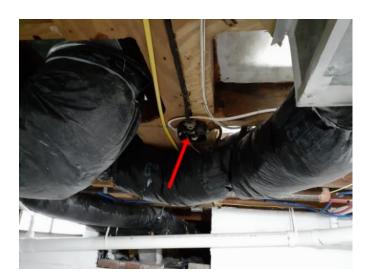
Appeared serviceable at the time of inspection

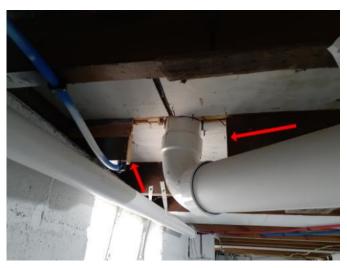
Cut stringer

Monitor/Maintenance: There was a cut stringer board where new plumbing was added for the rear bathroom. Recommend monitoring this area for any sagging, squeaking, or softness in the floor. This area may need resupporting at some point.
