ISSUED FOR USE  
EBA FILE: W14103028-01

Lansing Point Condo Association  
111-134 Seine Square  
Whitehorse, YT Y1A 3C3

**Subject:** Geotechnical Observations – Building B Foundation Recommendations  
134 Seine Square, Whitehorse, YT

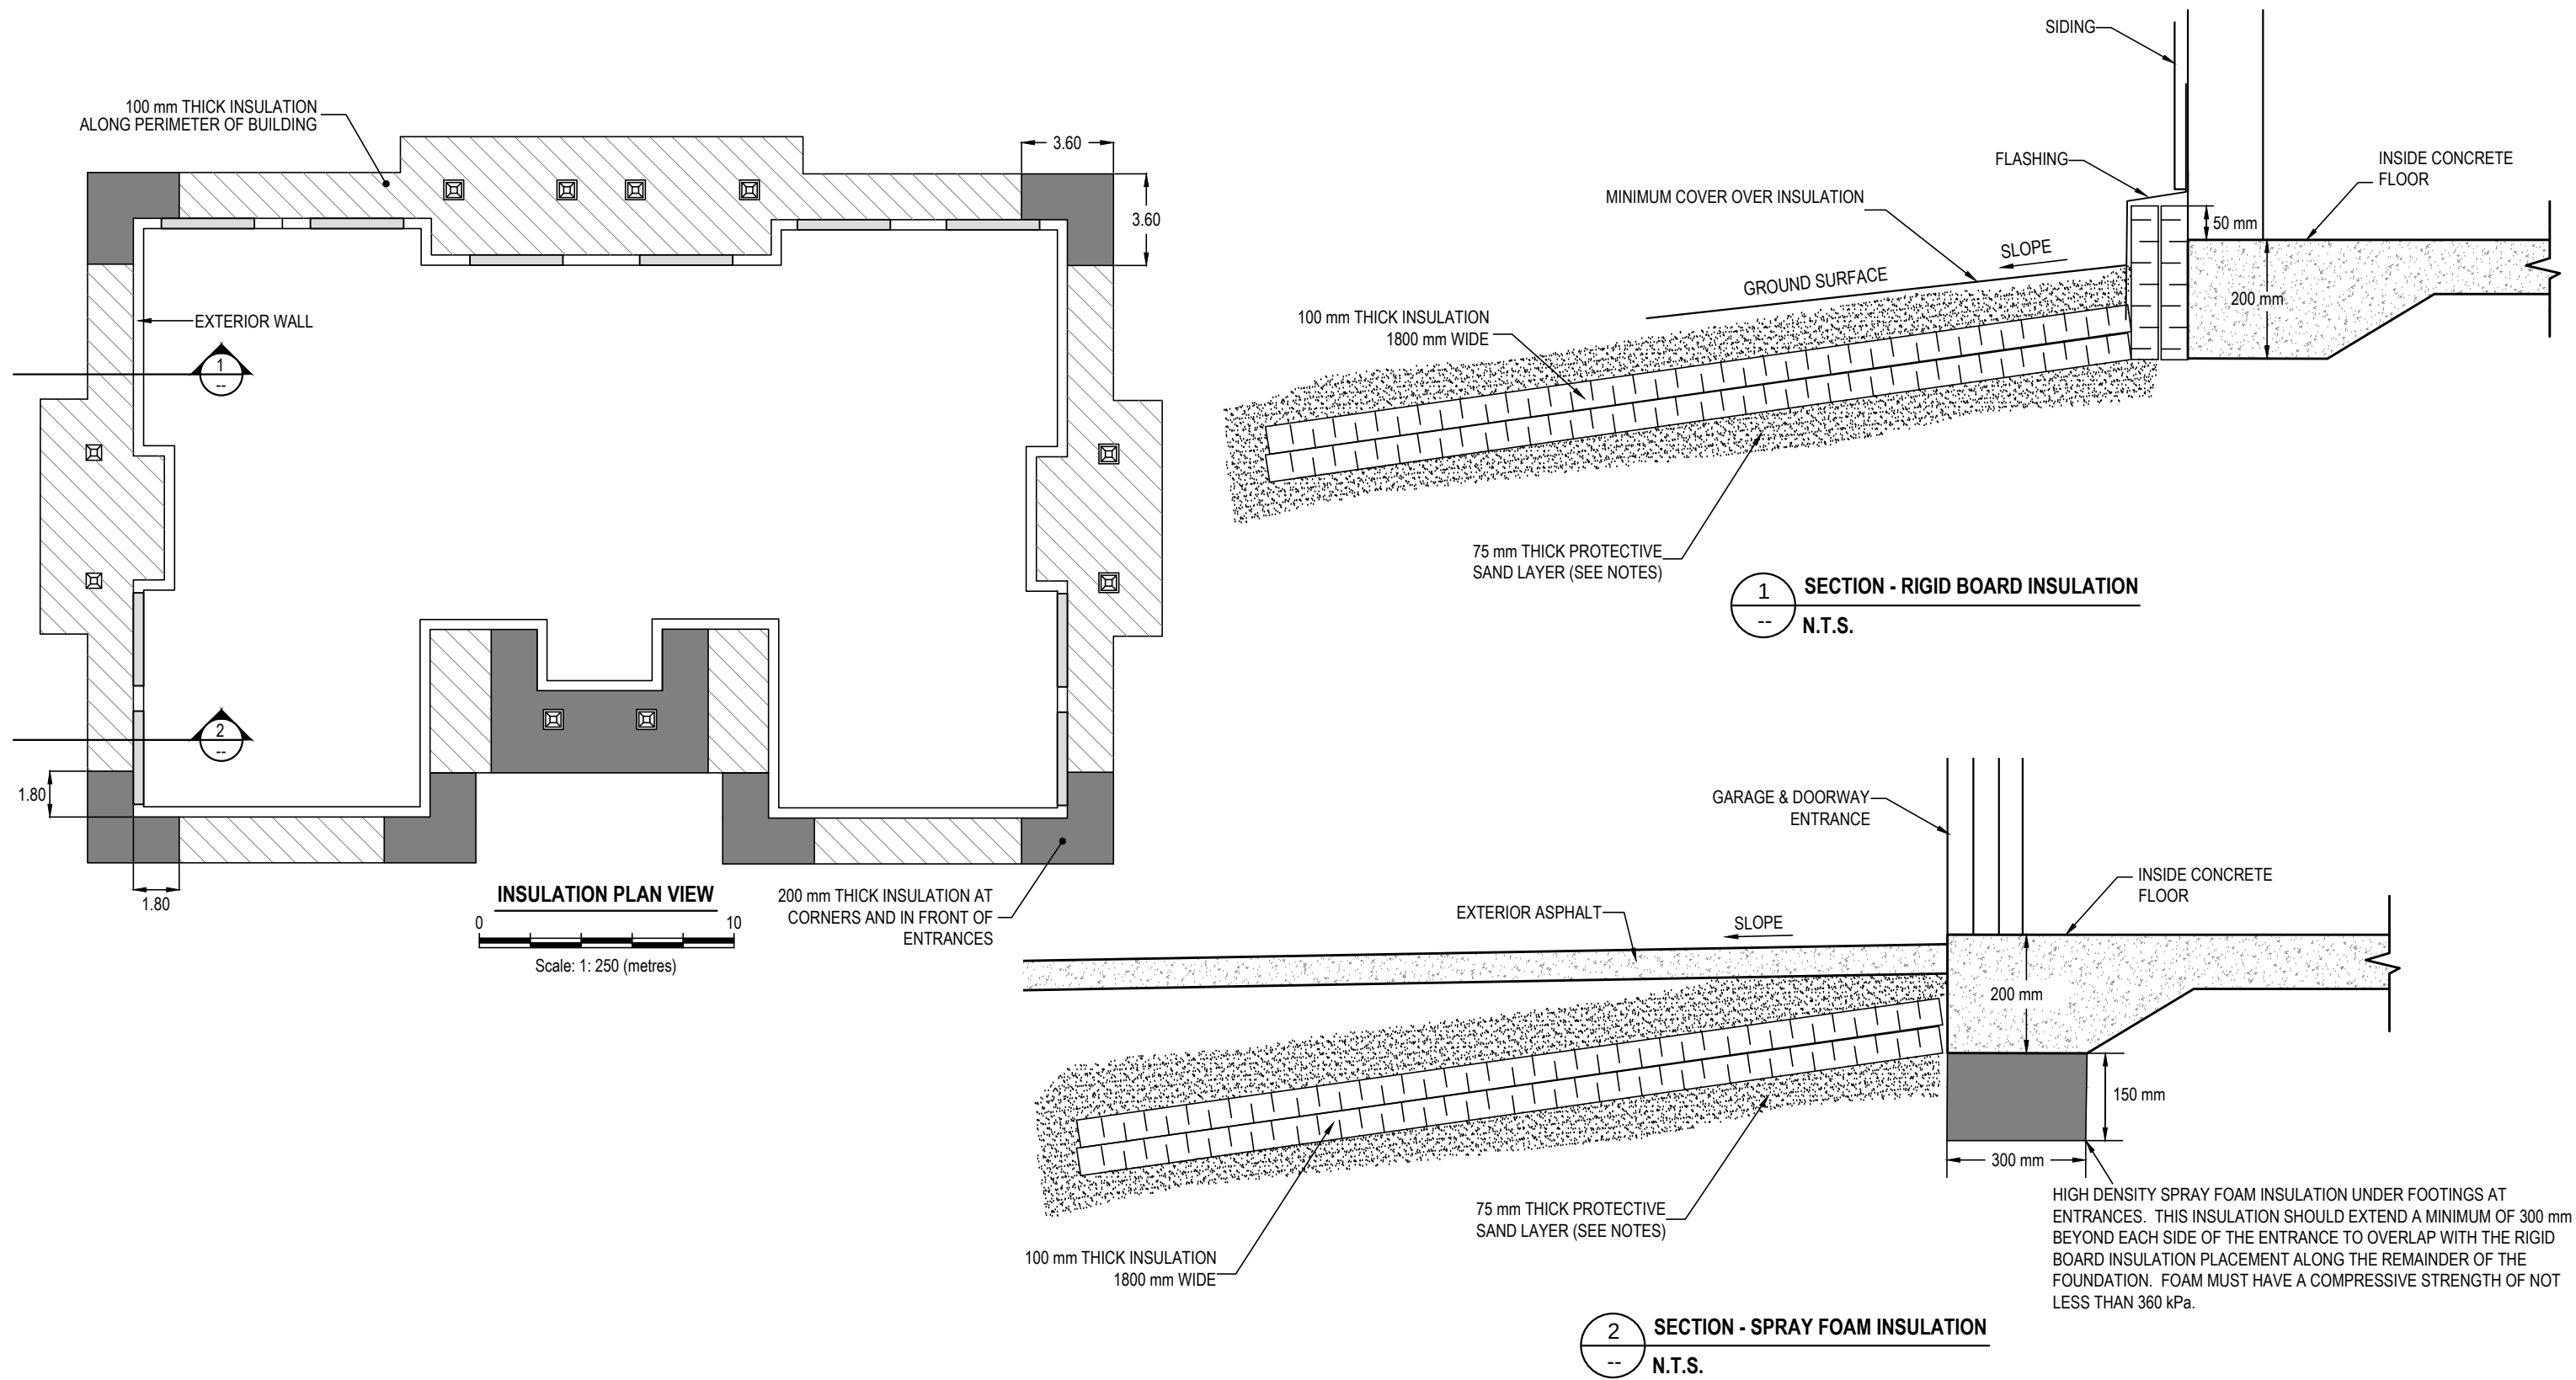
| | PROJECT NO.<br>W14103028-01 | DWN<br>CB | CKD<br>CPC | REV<br>0 | Figure 2 | |

The perimeter area along Building B was excavated approximately 2.4 m from the exterior edge of the building and exterior deck columns, down a minimum depth of 200mm from the bottom of the concrete perimeter footings to allow for the placement of 75 mm of bedding sand (Photos 1 and 2). 100 mm of rigid board insulation was then placed sloping away from the exterior edge of the concrete footing out 1.8 m on the prepared bedding sand surface and covered with 75 mm layer of bedding sand. An additional 100 mm of insulation was placed at the corners of the building 1.8 m in each direction from the corner (shown on Figure 1). The 100 mm of insulation was also placed vertically along the exterior side of the concrete footings up to the bottom of the exterior siding in the landscaped areas (Photo 3) and to the underside of the asphalt in the paved areas.

- NOTES:
- THE INSULATION (DOW CHEMICAL HI SERIES STYROFOAM OR POLYURETHANE OR APPROVED EQUIVALENT) SHOULD BE MOISTURE RESISTANT AND SUITABLE FOR BURIAL UNDER VEHICULAR TRAFFIC AREAS.
  - A MINIMUM BEDDING THICKNESS OF 75 mm OF FINE TO MEDIUM GRAINED SAND SHOULD BE PLACED ABOVE AND BELOW THE INSULATION FOR PROTECTION.
