Survey Report

23 & 24/03/2021
M/Y (CONFIDENTIAL)

| <i>Type:</i> | <u>Motor Yacht</u> |
| <i>Type of survey:</i> | <u>Condition survey</u> |

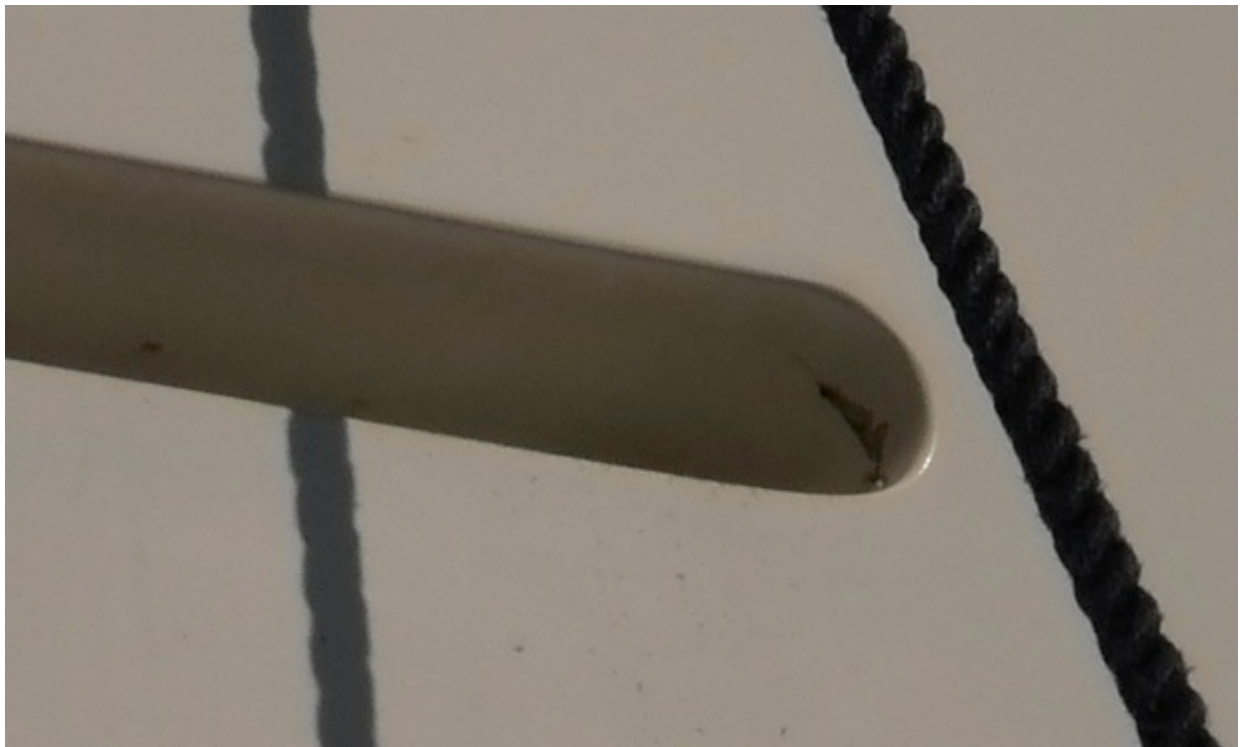
Photo 5

- TEAK HANDRAIL. Needs attention as necessary (see photo 5)
- TEAK MAIN DECK 16 MM THICK. D 6 DECK-BOLLARDS.
- 10 STAINLESS STEEL FAIRLEADS.
- 2 ELECTRIC ANCHOR-WINCHES 3000 WATT 380V WITH CONTROL FROM BOW, WHEELHOUSE AND FLYING BRIDGE.

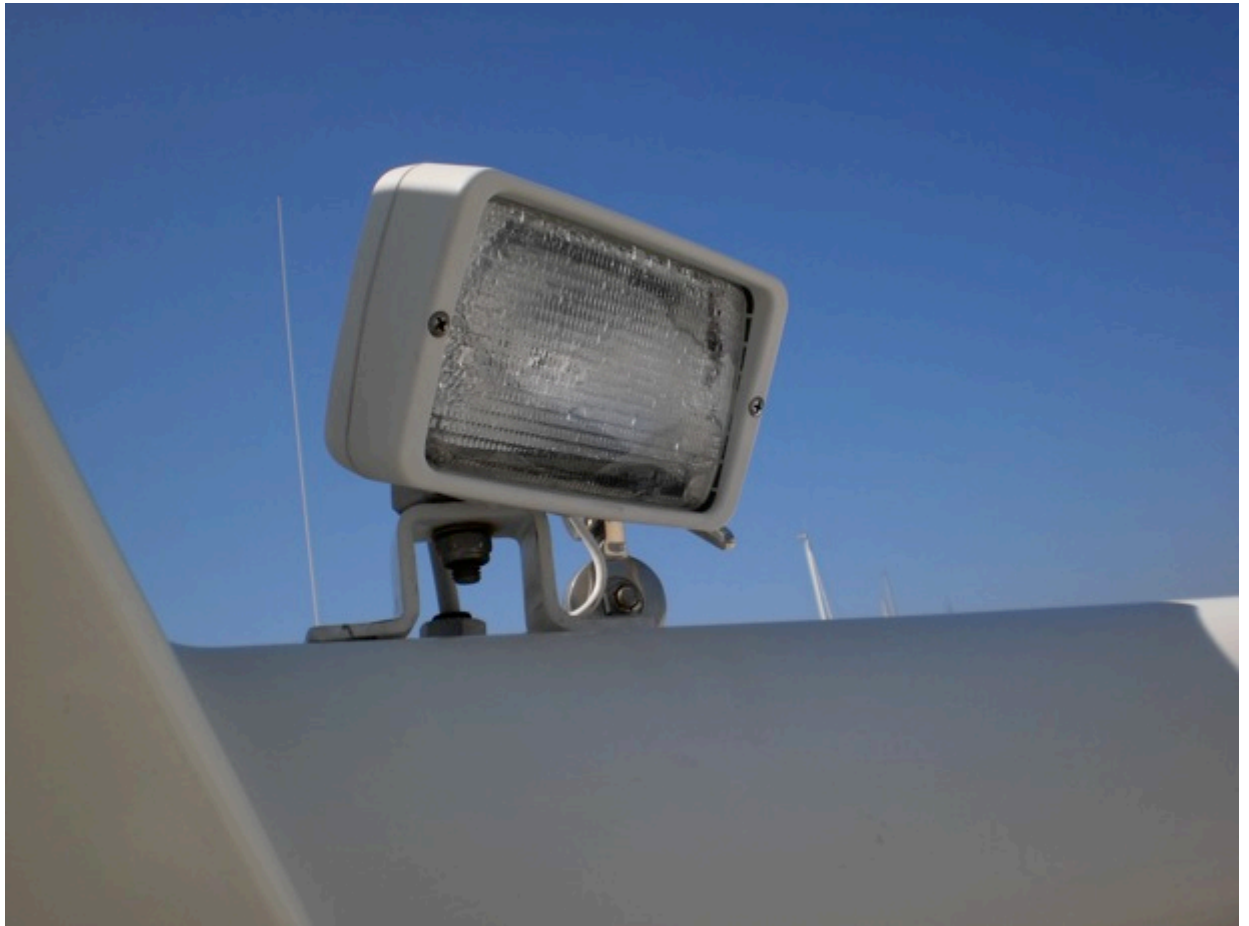
Photo 7

- 2 STEREO SPEAKERS.
- SEARCH LIGHT (P&S) WITH REMOTE CONTROL (ALSO FROM WHEELHOUSE). (SEE PHOTO 7)
- PNEUMATIC REGULATION HORN.
- 2 MULTIUSE LOCKERS FOR FRIDGE, ICE MAKER AND SINK.

Priority (P):
Starboard Search Light
needs repair as necessary
