Fir Tree Strong Park

Bill Olsen: Town of Cathlamet Forester

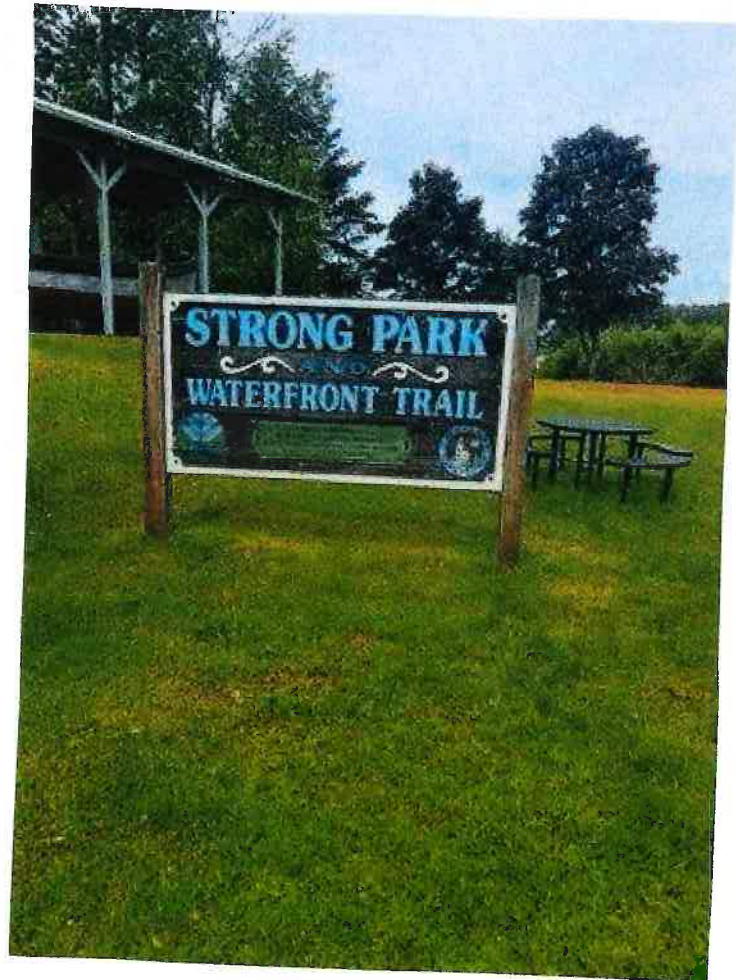
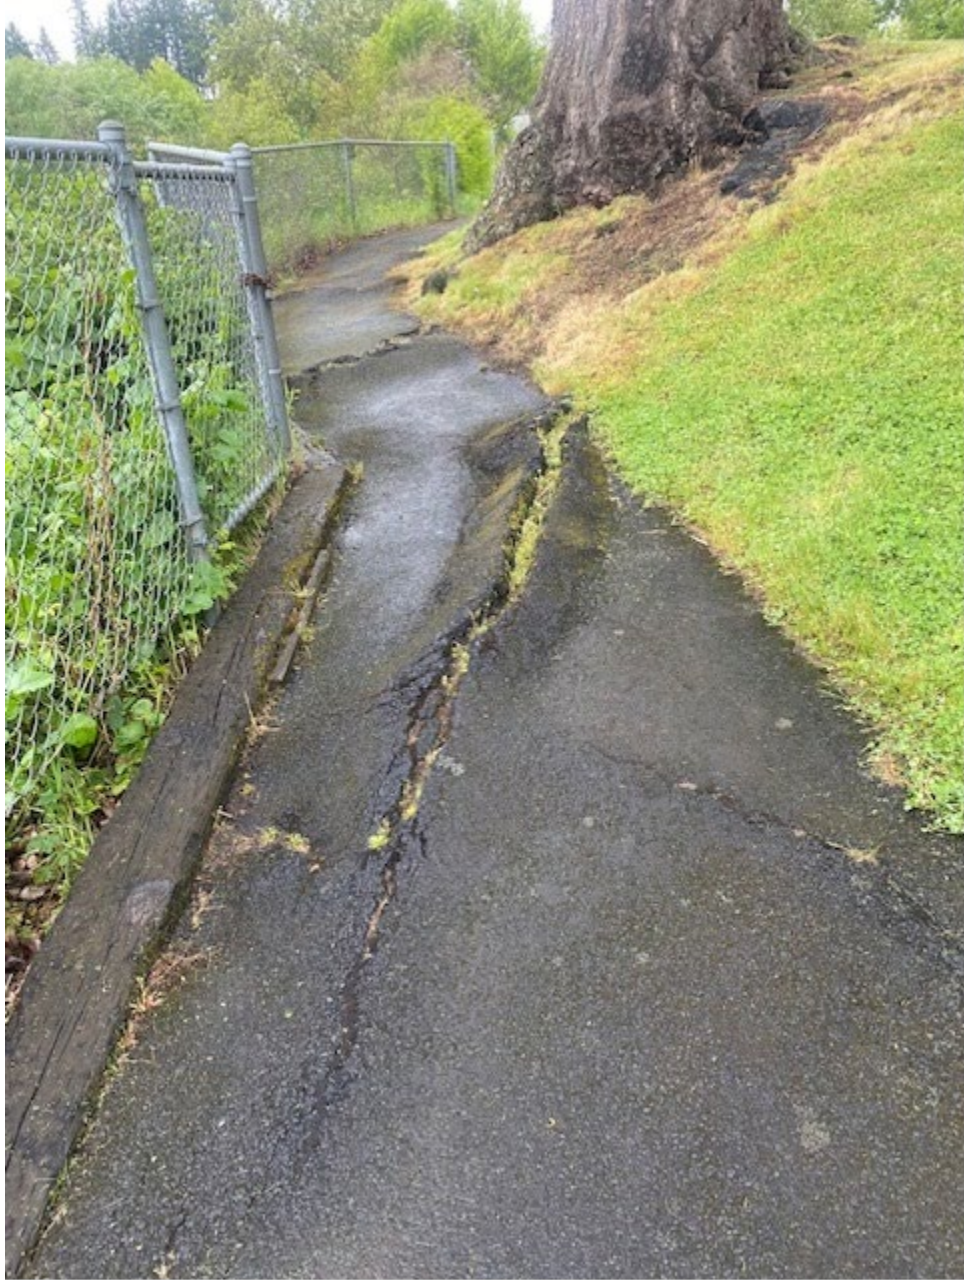
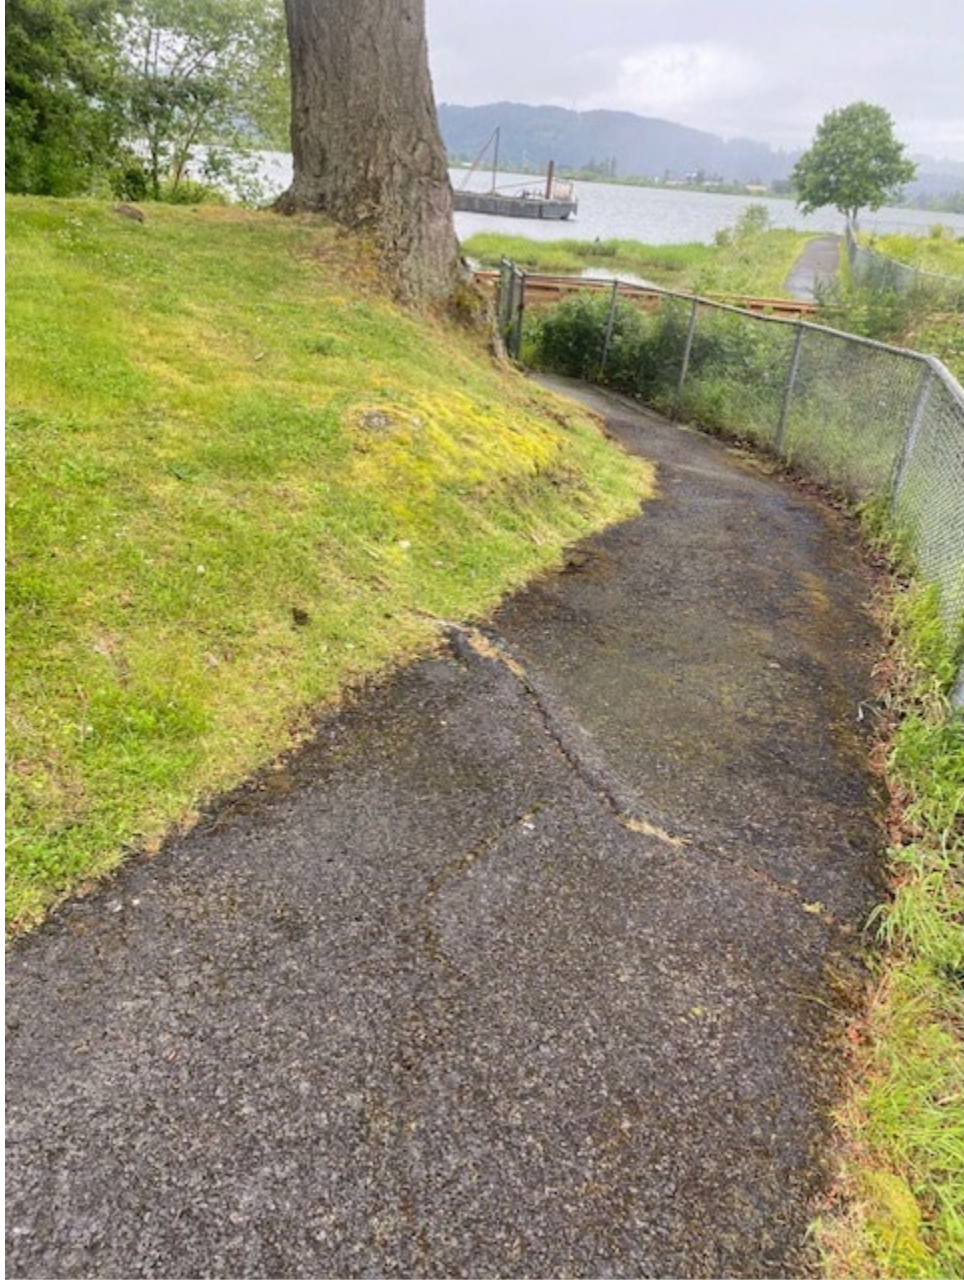
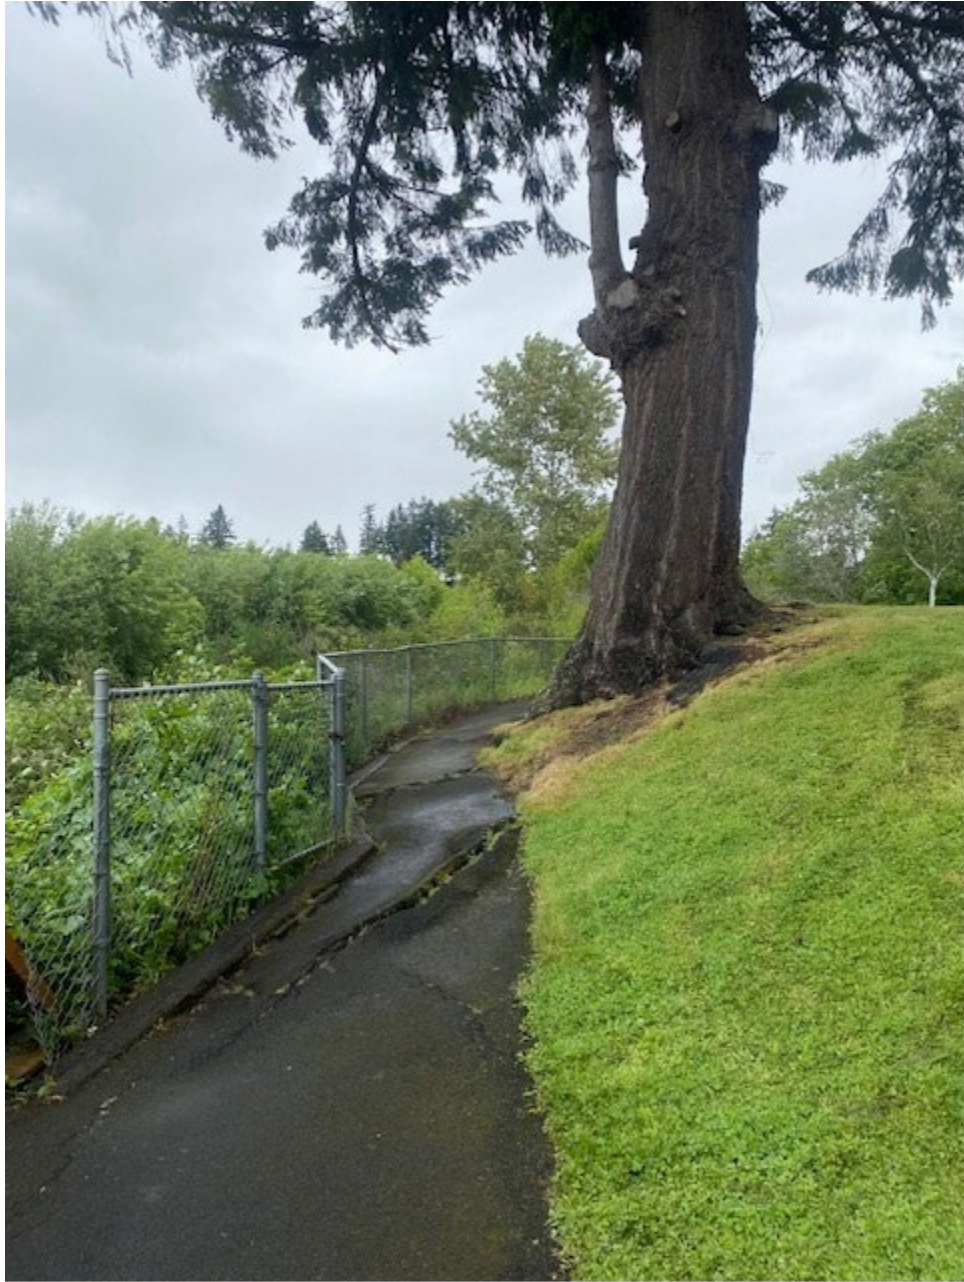
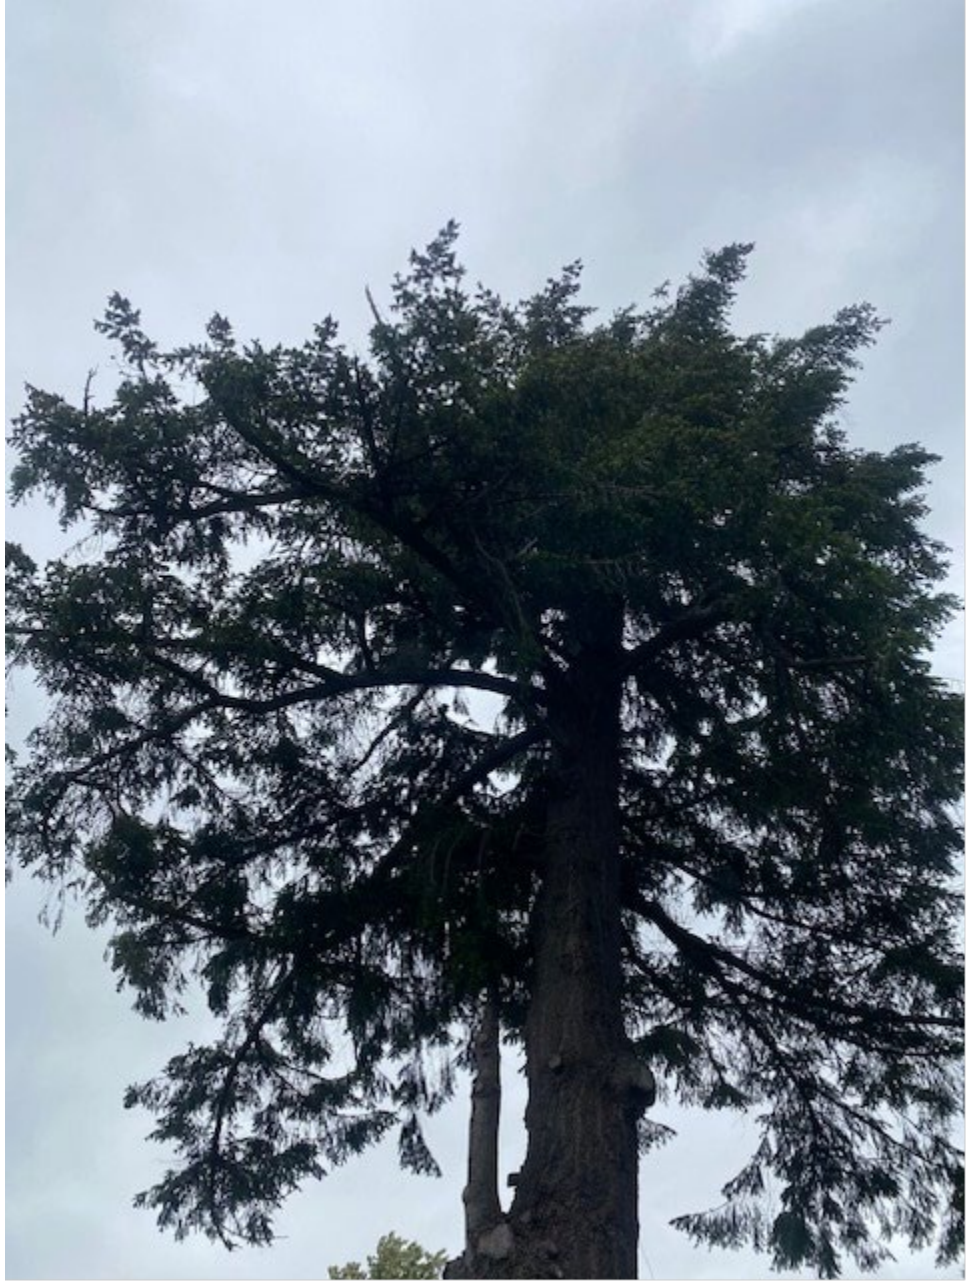
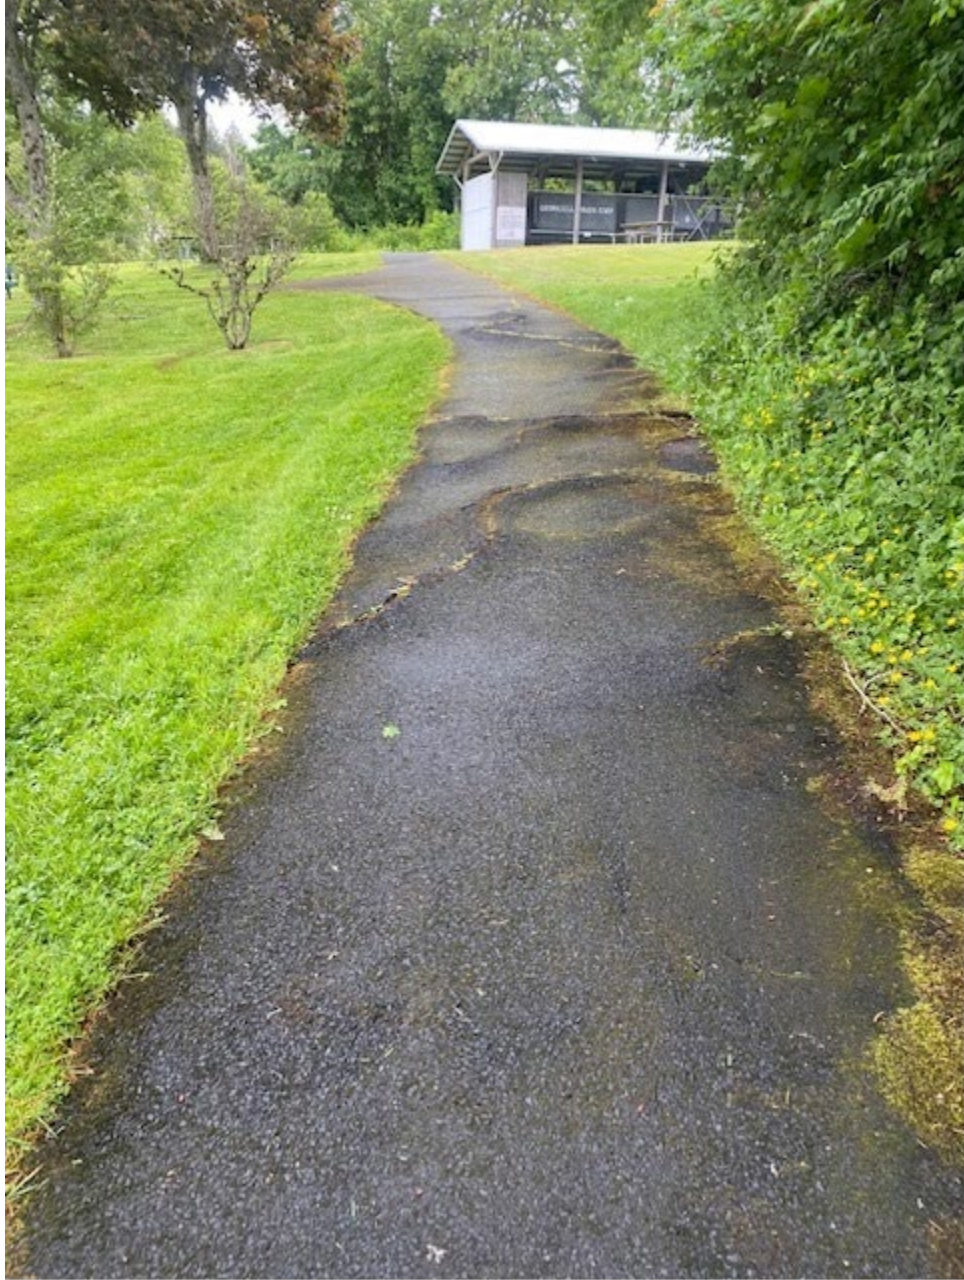
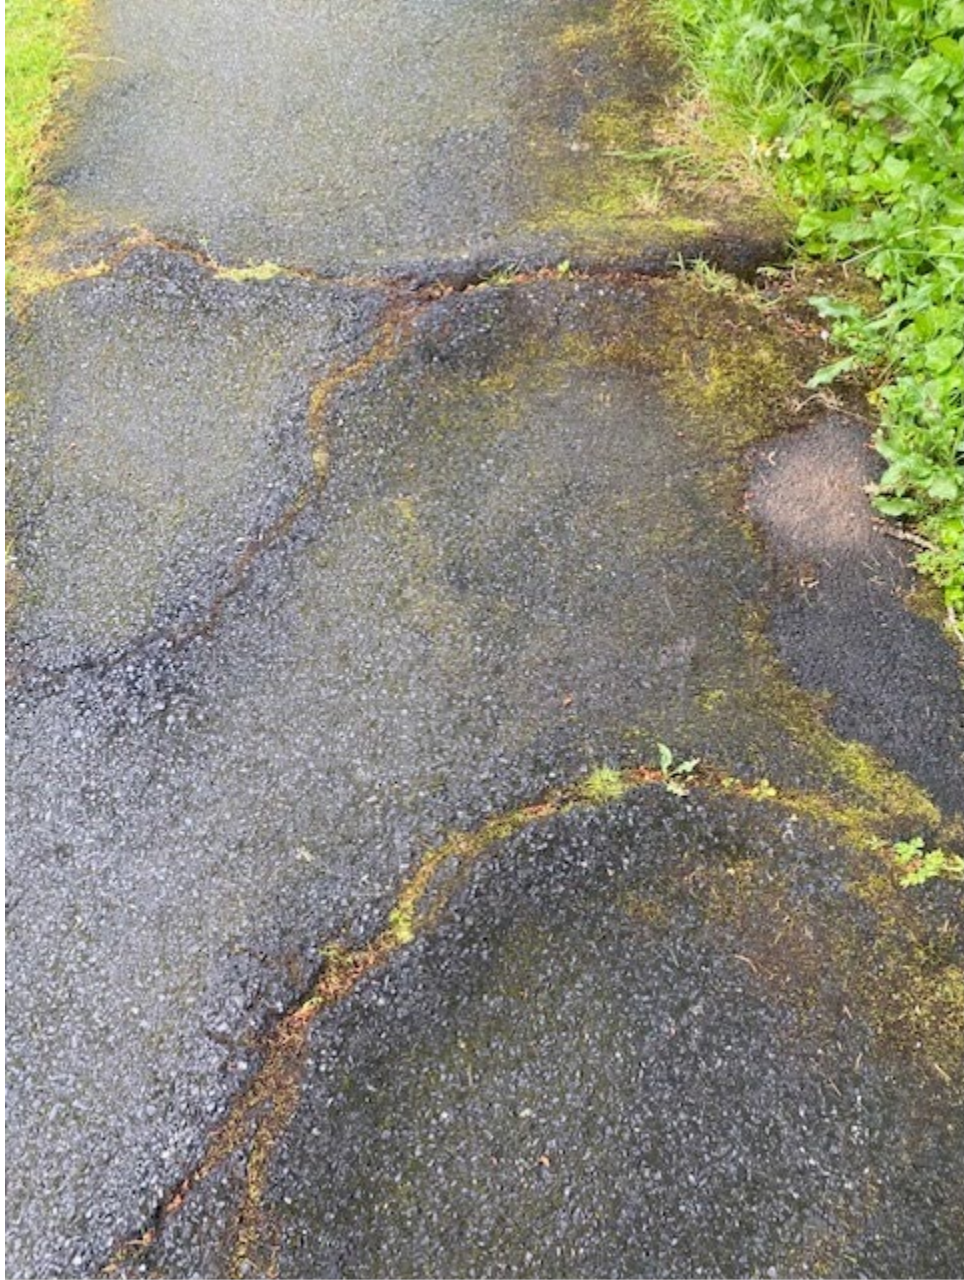
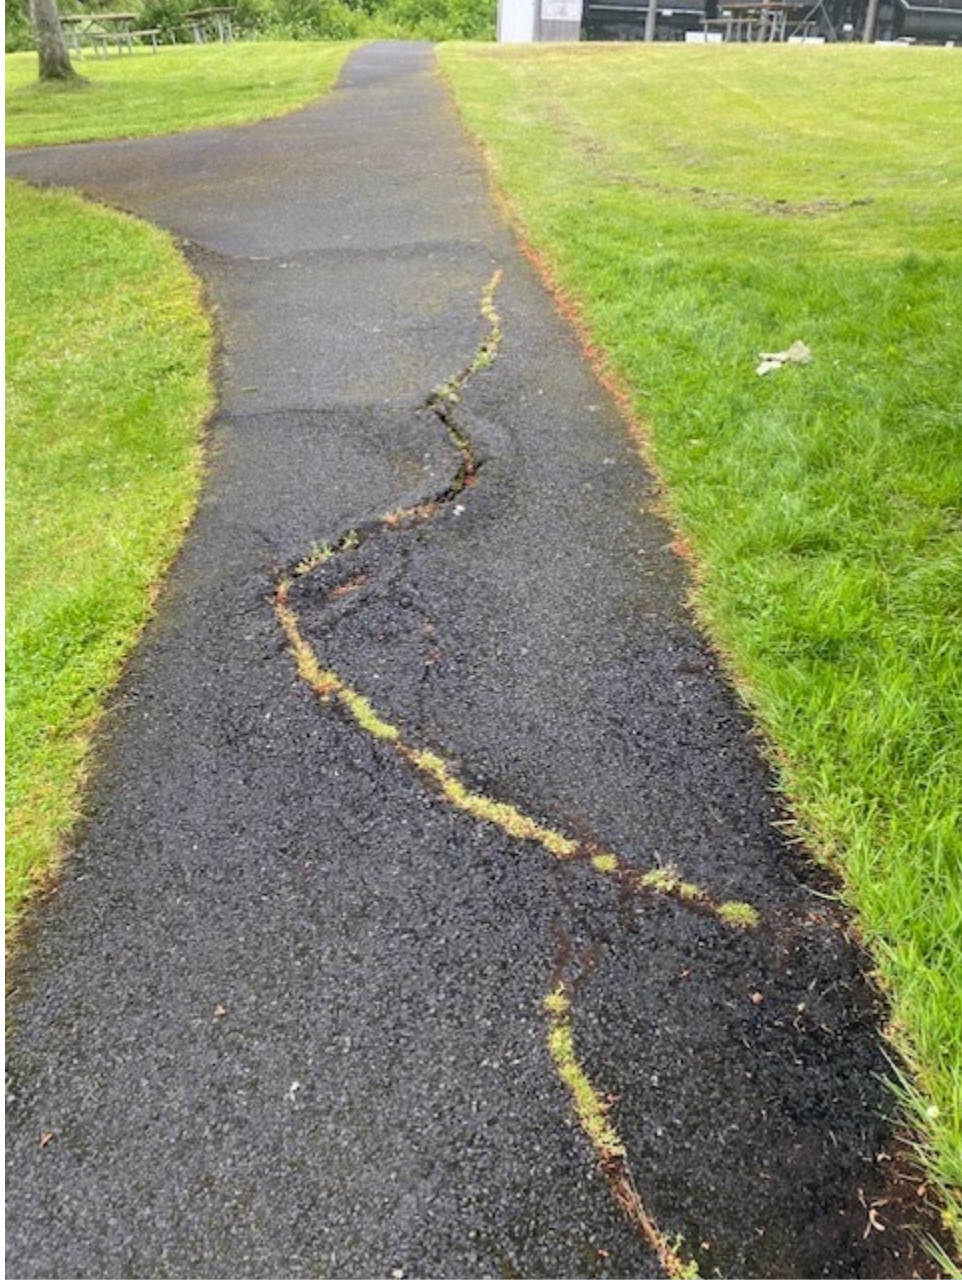
I was asked to give my evaluation of either having the tree in Strong Park removed or if it would remain healthy after work was performed to install an ADA approved trail. To install the trail properly would require to cut into the root system that the tree needs to keep in place and remain healthy. The roots must be removed to create a safe and ADA approved trail. The roots that need to be removed are quite large and will definitely put the tree in danger of blowing over in a high wind. The large roots are also a reason for the tree's survival. As you will notice in the pictures, the damage the roots have caused to the existing trail makes it very dangerous right now to even walk by.

I would recommend that the tree be removed for current and future safety of maintaining the pathway. Although, I was only asked to give a review of the Douglas Fir, I also observed three Cottonwood trees nearby that I would recommend be removed as well at the same time. As they are also making the walking path hazardous.
