QUATTRO

Newsletter 01-25

- Mandatory service bulletin

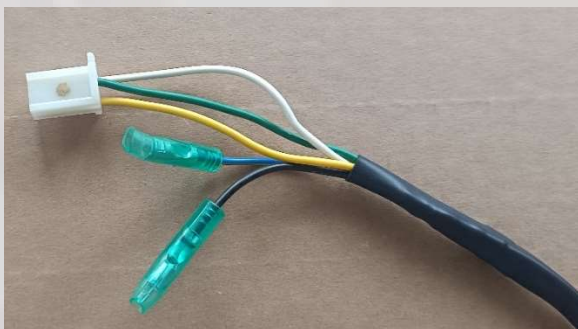
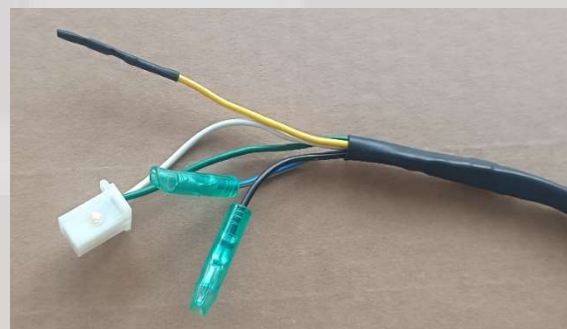
The QUATTRO generator can be damaged by incorrect wiring installation – Please pay attention to the following information:

- It is important to connect the battery negative to the engine ground when using a battery.
- The yellow cable can cause short circuit to the stator/generator when the engine is running. Users must remove the yellow wire from the connector. Please use a simple shrink wrap or something similar to protect the open end and prevent contact.

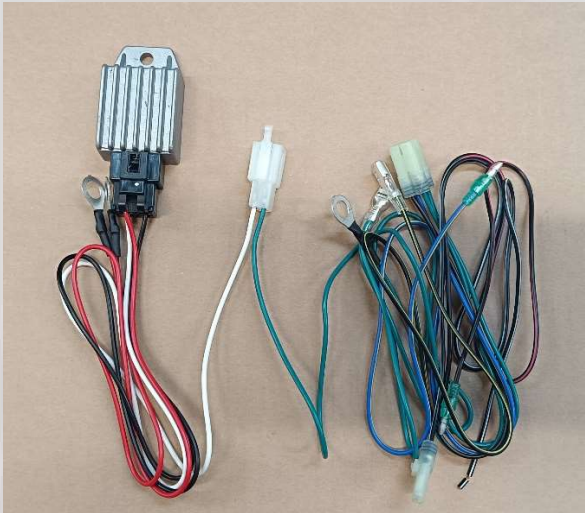
- The engine wiring is delivered as shown in the image below – to the left of the white connector is rectifier, used to to charge the battery. On the right side of the connector is the ignition system wiring harness.

If no battery charging is installed, the rectifier does not need to be installed.

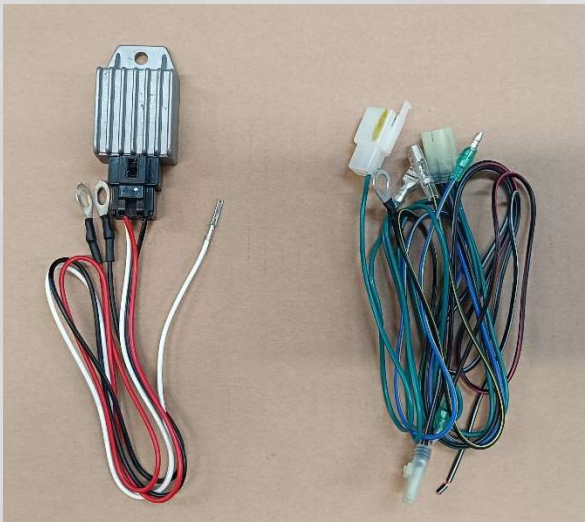
- If you don't wish to charge the battery you can disconnect the white cable from the connector and discard the rectifier.
